FINAL 2014 Annual Land Use Control Inspection Report

Former Mortar Range Munitions Response Area, Fort George G. Meade, Maryland

December 2014

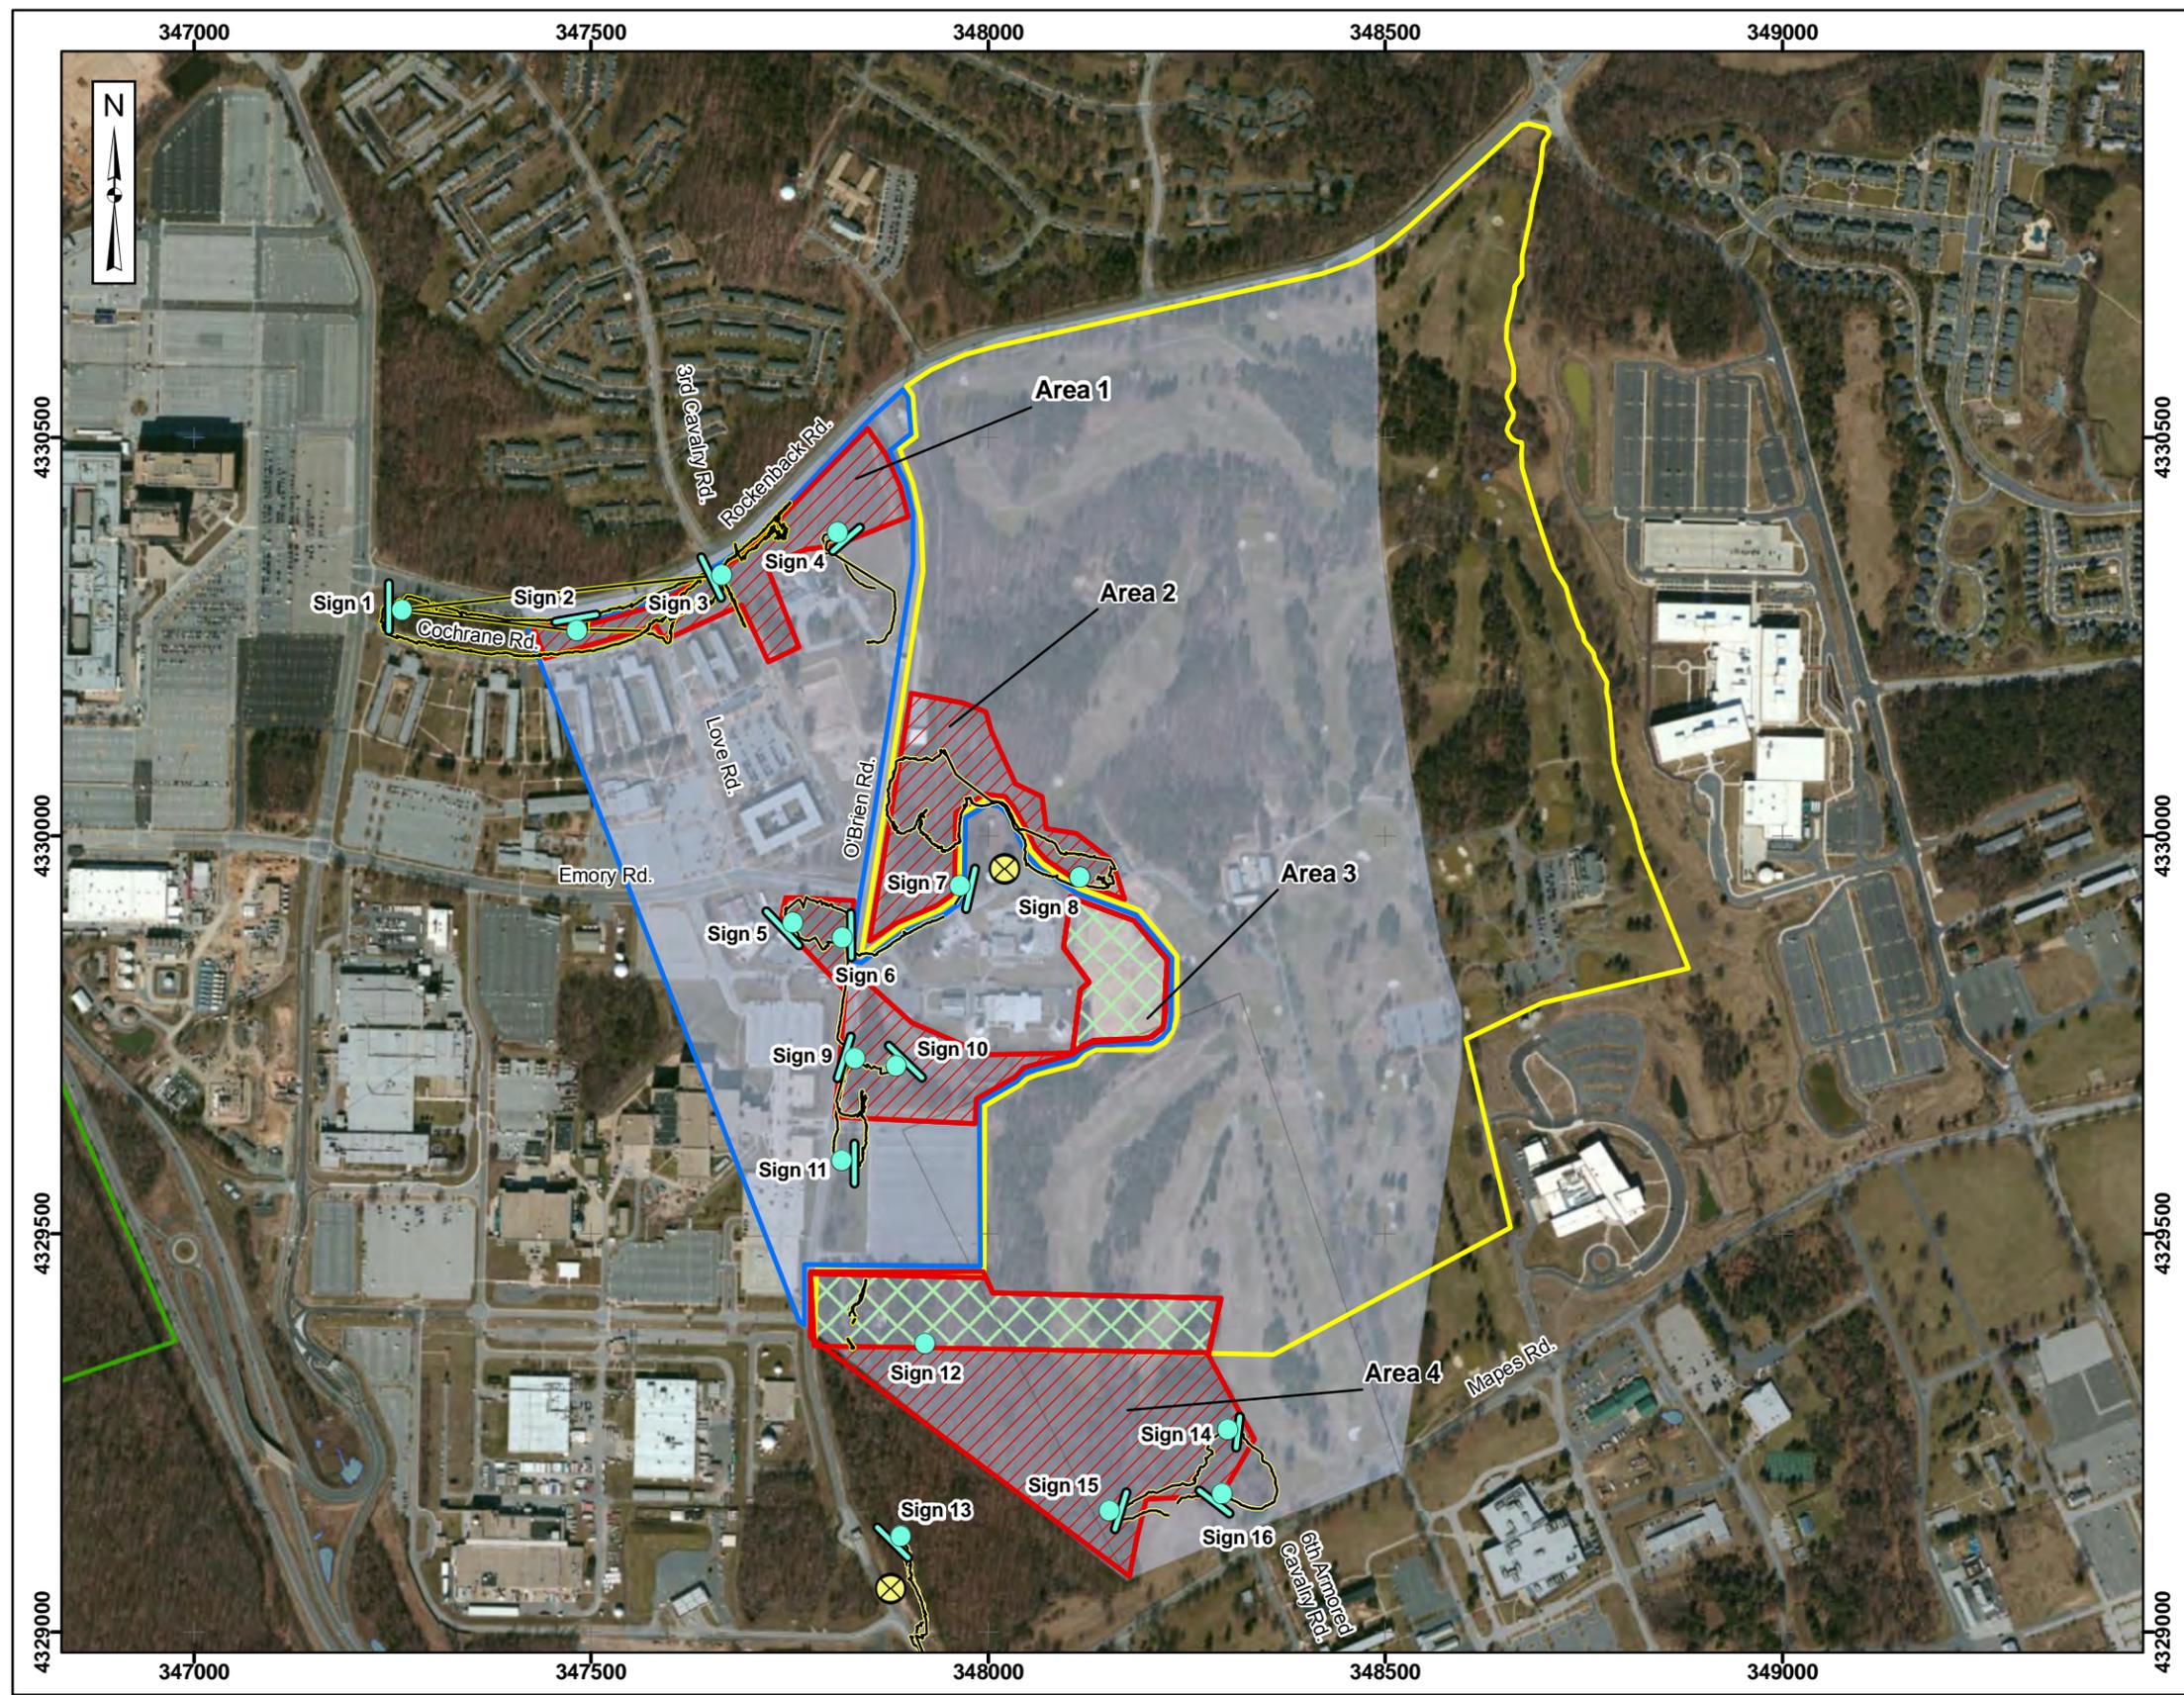
**Figure 1-1
2014 Land Use Controls
Annual Inspection**

- The text on Sign 2 is peeling and illegible;
- Sign 8 was missing (post remains); and,
- Sign 12 could not be located from the northwestern secure portion of the installation (GPS coordinates were inconsistent with the sign position). A second attempt to locate the sign from the FGGM side was made, but due to road closures associated with a water main break, the sign location was inaccessible.

Two erosional areas are depicted on **Figure 1-1**. The first erosional area was located near Sign 14 and was actively being eroded as a result of the water main break. As depicted on **Figure 1-1**, this erosional area is located outside of the MRA boundary. The second erosional area is located between signs 7 and 8 (East Campus side). This area is sloped towards the adjacent road (unnamed road) and appears to be runoff erosion as a result of construction activities.

Notes:
 Sign 2 - Sign Is Peeling / Illegible
 Sign 8 - Sign Missing / Post Remains
 Sign 12 - Inaccessible Road Closed Due to Water Main Break

A second site visit will be made on 17 December 2014 to locate Sign 12 (or replace as appropriate) and repair damaged or missing signs to ensure the effectiveness of the remedy in accordance with the ROD (ARCADIS, 2012).
