**FINAL 2014 Annual Maintenance Inspection Report  
INACTIVE LANDFILL No. 2 (FGGM-007-R)  
AT FORT GEORGE G. MEADE, MARYLAND**

*Prepared By:*  
**Fort George G. Meade  
Directorate of Public Works - Environmental Division  
4216 Roberts Ave, Suite 5115  
Fort Meade, Maryland 20755-7068**

**February 2015**

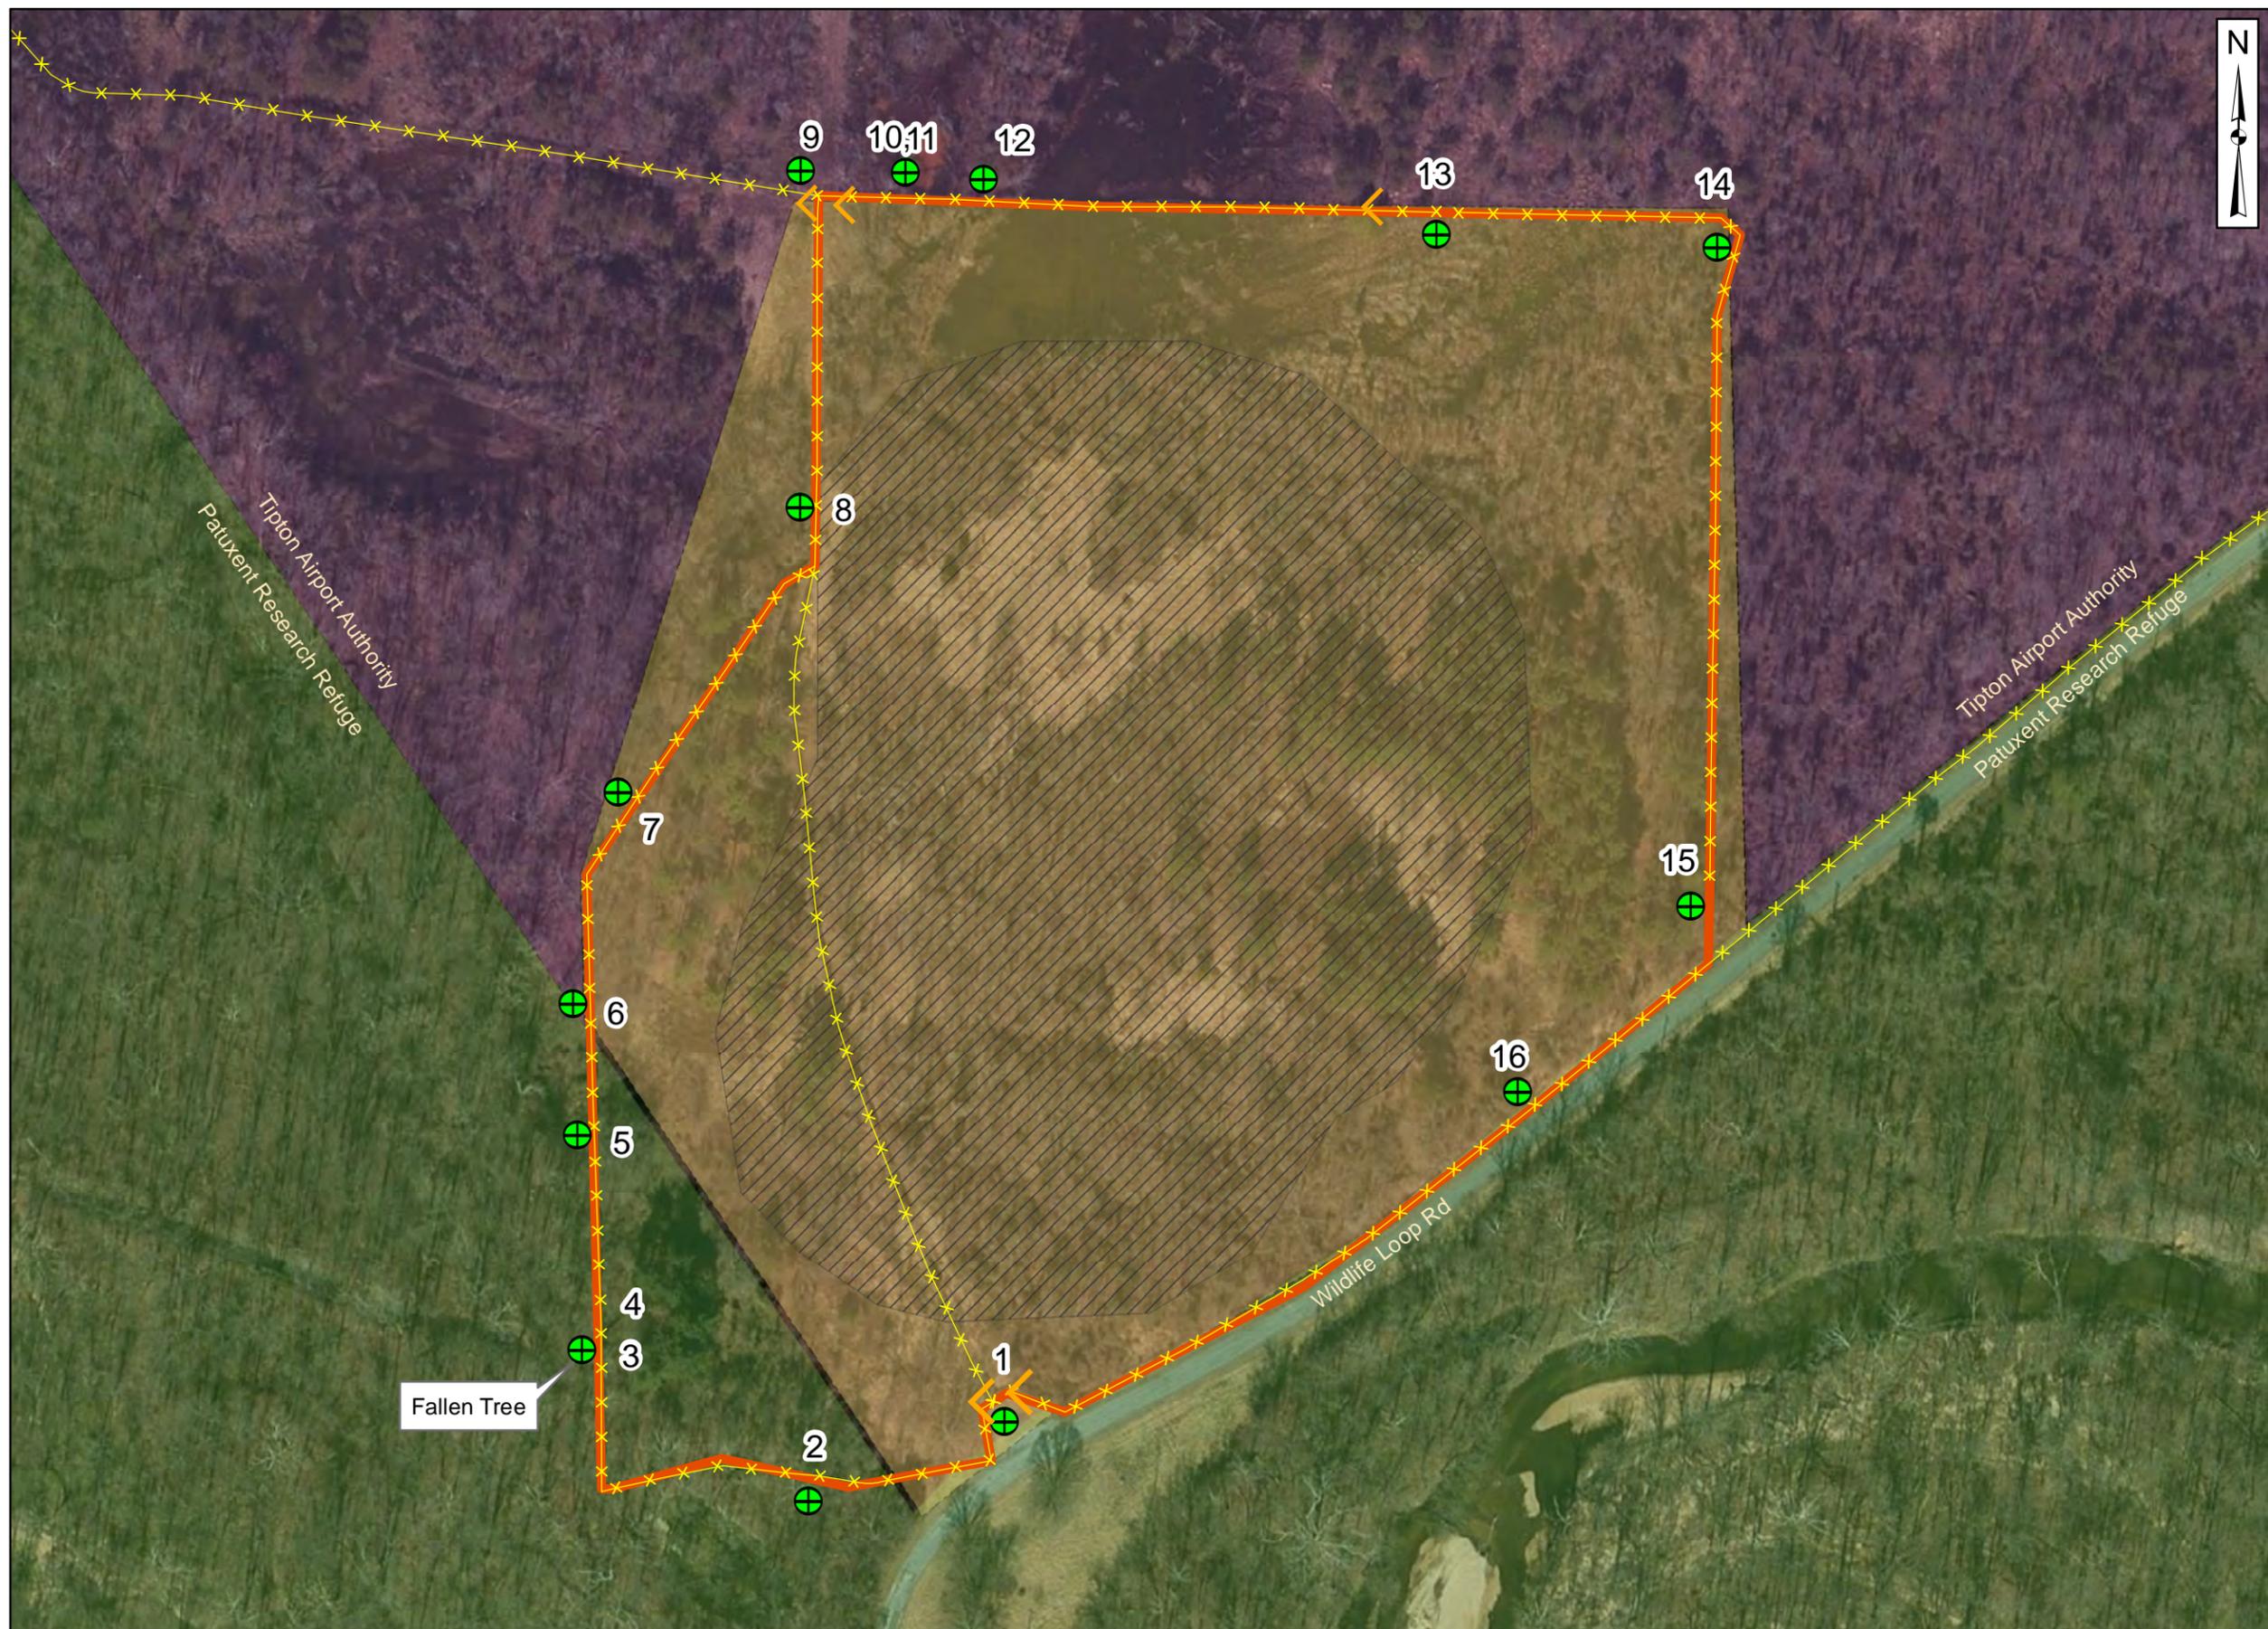
Figure 3-1  
Inactive Landfill 2 (IAL2)  
Field Activities

The IAL2 inspection included a visual inspection of the fence, the gates, and the warning signs posted at the site. The entire fence was traversed. Figure 3-1 presents a site map identifying key features and photograph locations. Photographs of IAL2 features are included in Appendix A. USEPA Site Inspection Checklist is included in Appendix B.

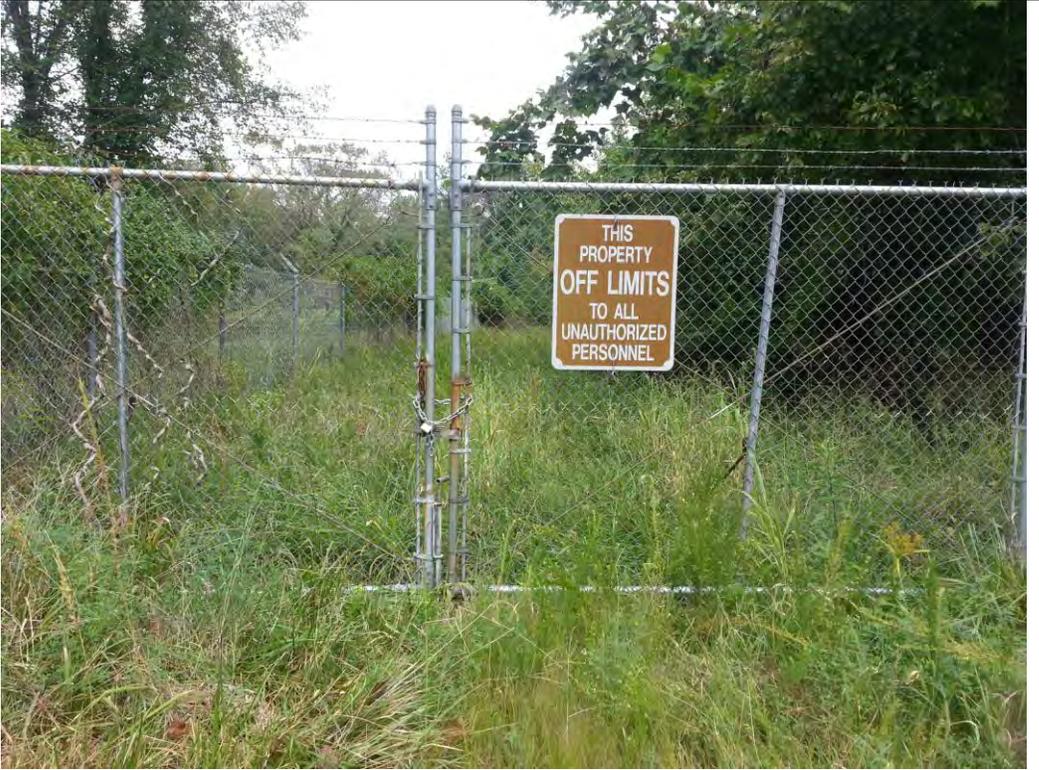
Photo No.: 1	Date: 9/10/2014

Photo 1 shows the gate at the southwest corner of IAL2 including signage stating that **the property is "Off Limits To All Unauthorized Personnel."** Several signs stating **"Danger: U.S. Government Property, Keep Out"** are also posted along the fence perimeter. Some signs along Wildlife Loop Rd are partially faded but remain legible and were not replaced.

Direction Photo Taken: North		
Description: View north along the southern exterior boundary showing the locked main access gate to IAL2 and the "Off Limits" signage. This area is adjacent to Wildlife Loop Road.

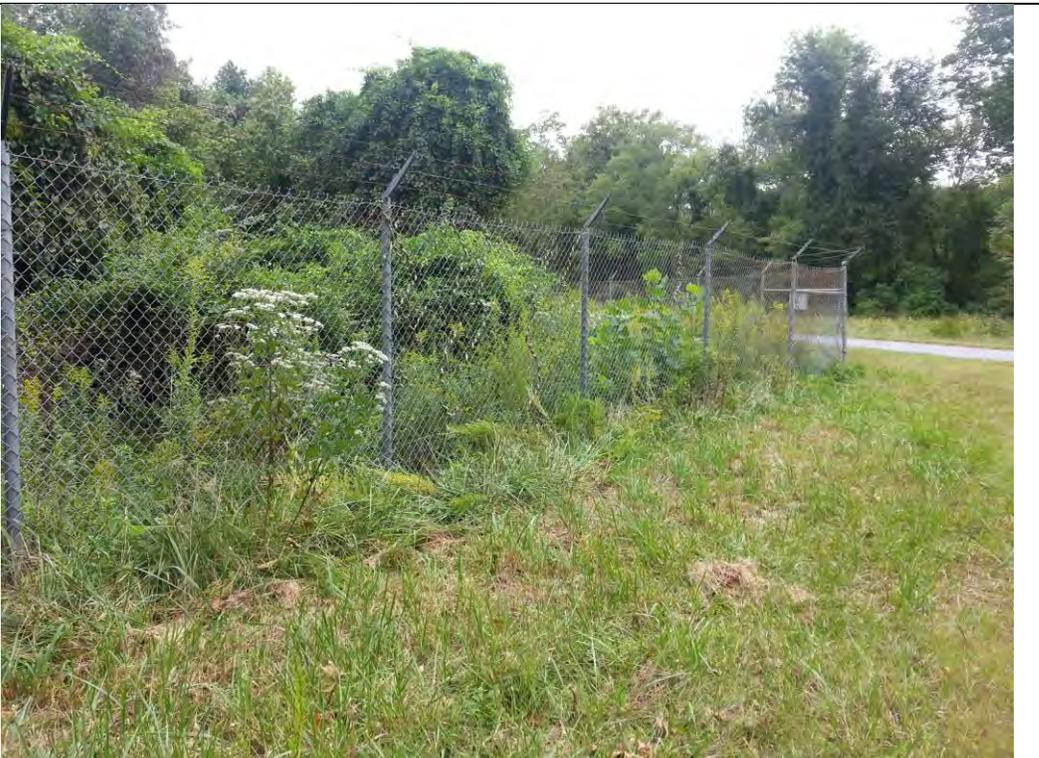
Photo No.: 2	Date: 9/10/2014

Direction Photo Taken: Southeast		
Description: View southeast along the southern exterior fence. This area is adjacent to Wildlife Loop Road.

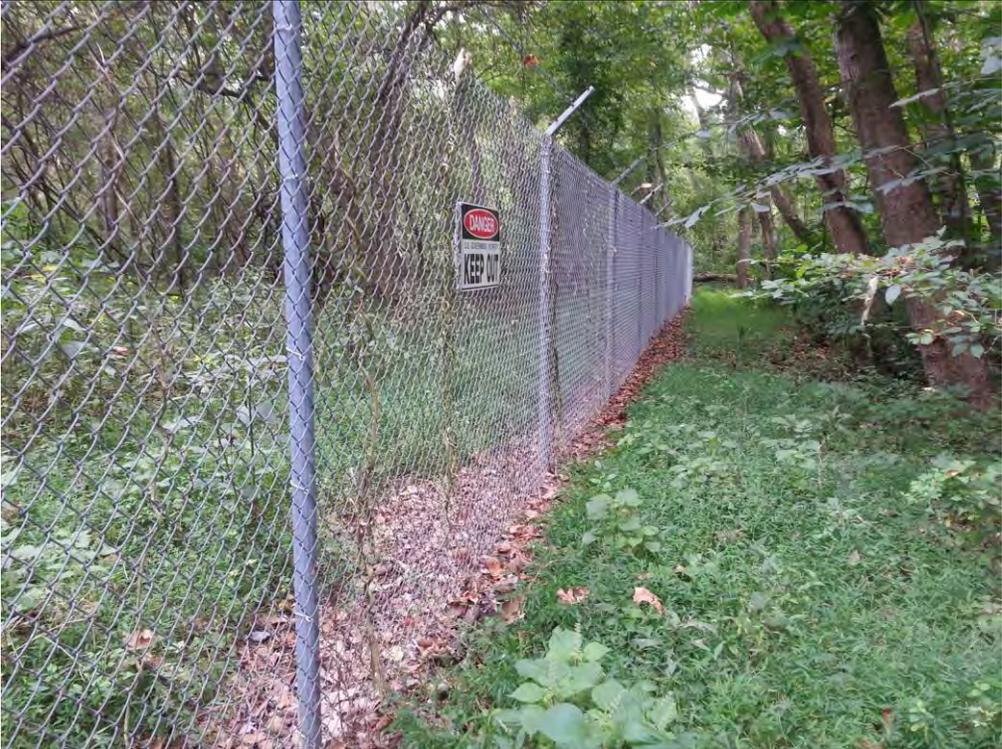
Photo No.: 3	Date: 9/10/2014

Direction Photo Taken: South		
Description: View south along the western exterior fence toward southwestern corner, showing low vegetation, recently repaired fence, and the <b>"Danger Keep Out"</b> signage.

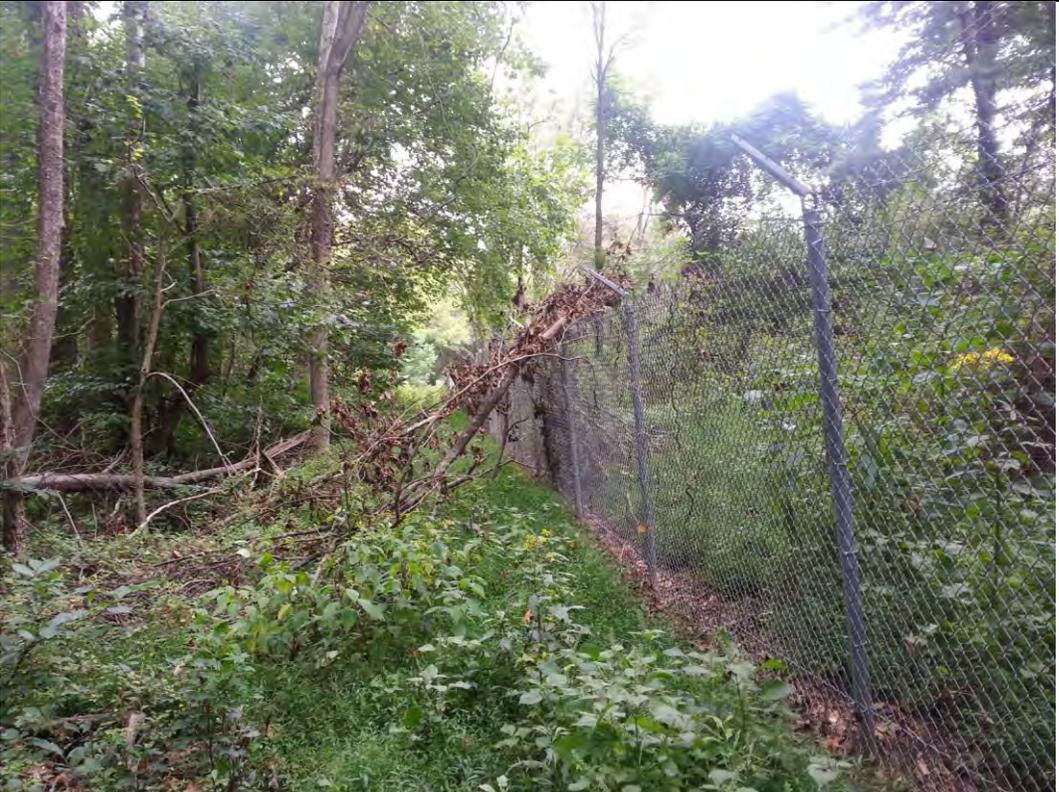
Photo No.: 4	Date: 9/10/2014

Conditions along the fence perimeter are shown in Photos 3 through 8 (western boundary), 9 through 13 (northern boundary), 14 and 15 (eastern boundary), and 1, 2, and 16 (southern boundary). Photo 4 shows the recent downed tree and associated fence damage along the western perimeter. Photo 8 shows evidence of small mammal burrows under the fence, as well as bending damage to the fence. Photos 5, 10, and 16 show significant vegetation regrowth since the spring maintenance event. Vegetation regrowth was observed on the fence and in the buffer area. Photos 10 through 13 show the wetland area along the northern perimeter. Given the low water levels in the pond/wetland, there is a gap between the fence and the ground surface at varying heights (Photo 12). The fence in this area is rusted but is intact.

The fence is damaged but intact along the western boundary. Additionally, there is significant vegetation growth at various locations on the fence and in the buffer area. Continued vegetation growth may impair future visual site inspections.

Direction Photo Taken: North		
Description: View north along the western exterior fence line showing tree branches damaging the fence. Tree recommended for removal and barb wire and brace recommended for repair.

- Remove the downed tree along the western boundary and repair or replace the respective damaged fence including the barbed wire and brace.
- Conduct future inspections during late fall, winter, or early spring when vegetation is low.
- Continue to monitor the northern section of fence spanning the pond that compromises the security perimeter (Photo 10 through 13), in order to determine frequency of dry periods and evaluate if the fence should be extended to the ground.
- The sun bleached signs along Wildlife Loop Rd should be replaced.
- Vegetation along portions of the fence line, especially in sunny areas, has overgrown since the spring maintenance event. More frequent, routine cutting of the vegetation

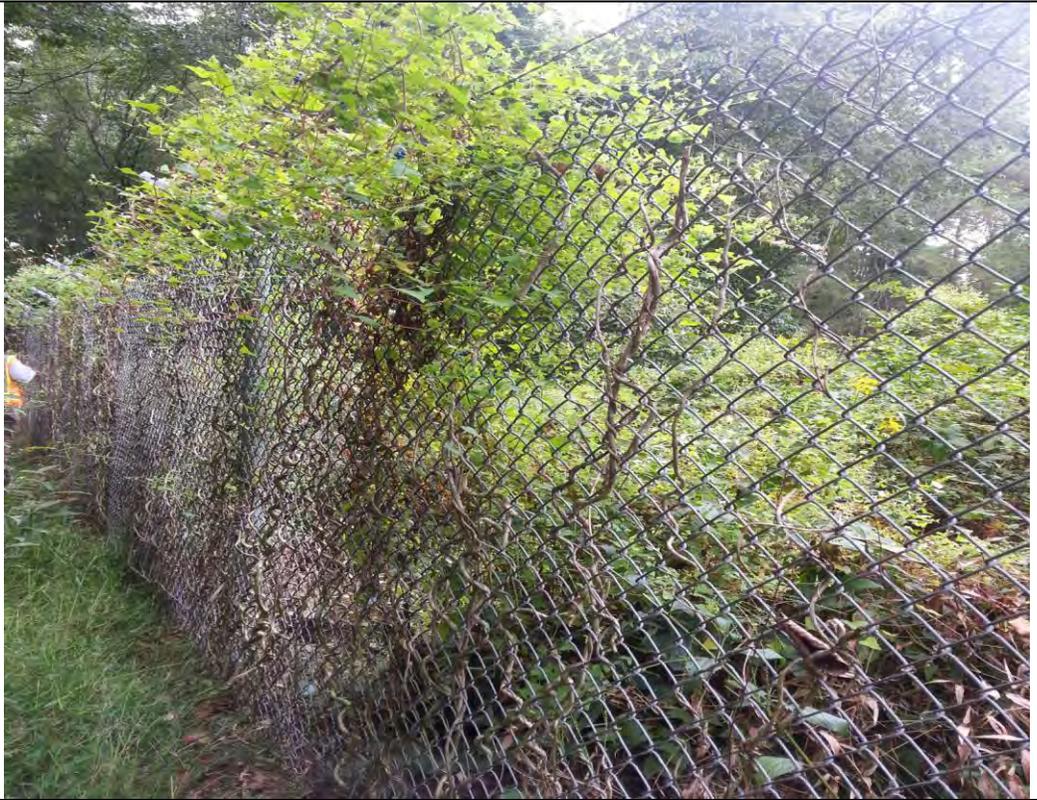
Photo No.: 5  
Date: 9/10/2014

Description: View north along the western fence boundary showing significant vine regrowth.

- Actions should be taken to reduce or remove vegetation re-growth in/on the fence to ensure the continued integrity of the fence as a land use control measure.
- Continue to inspect the fence line at IAL2 after significant storm events that cause damage on the installation and surrounding community.

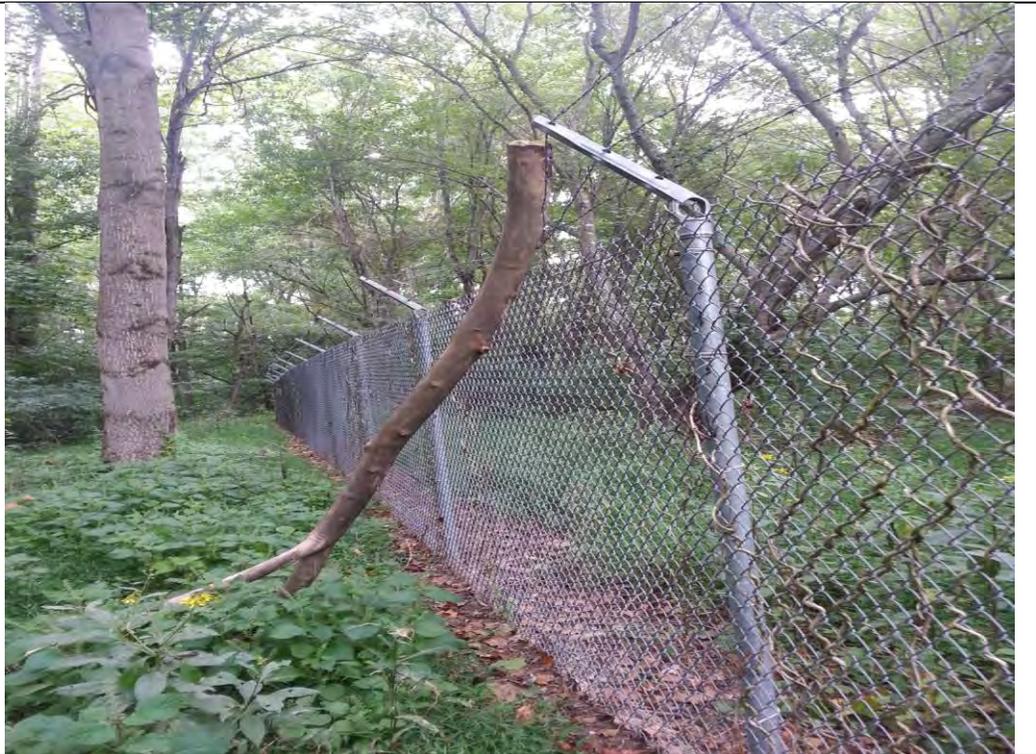
Photo No.: 6  
Date: 9/10/2014

Description: View north along the western fence line showing tree limb caught in the fence and some residual vines. The limb was removed during the annual inspection.

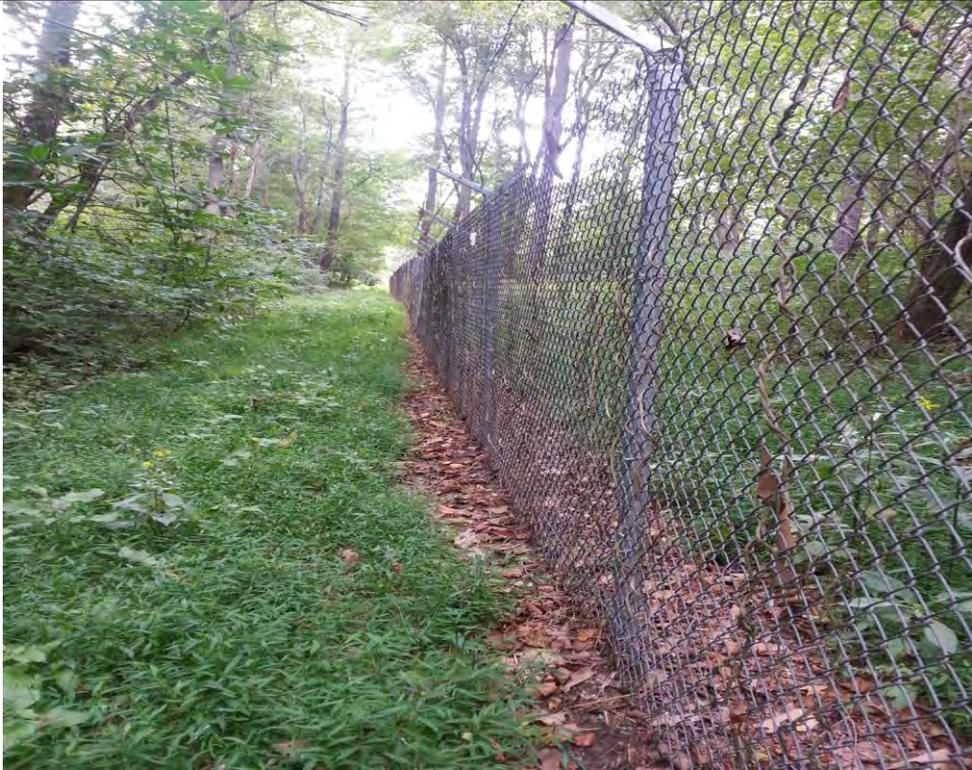
Photo No.: 7	Date: 9/10/2014

Direction Photo Taken: north		
Description: View north along the western fence line showing low vegetation and <b>6" herbicide</b> swath.

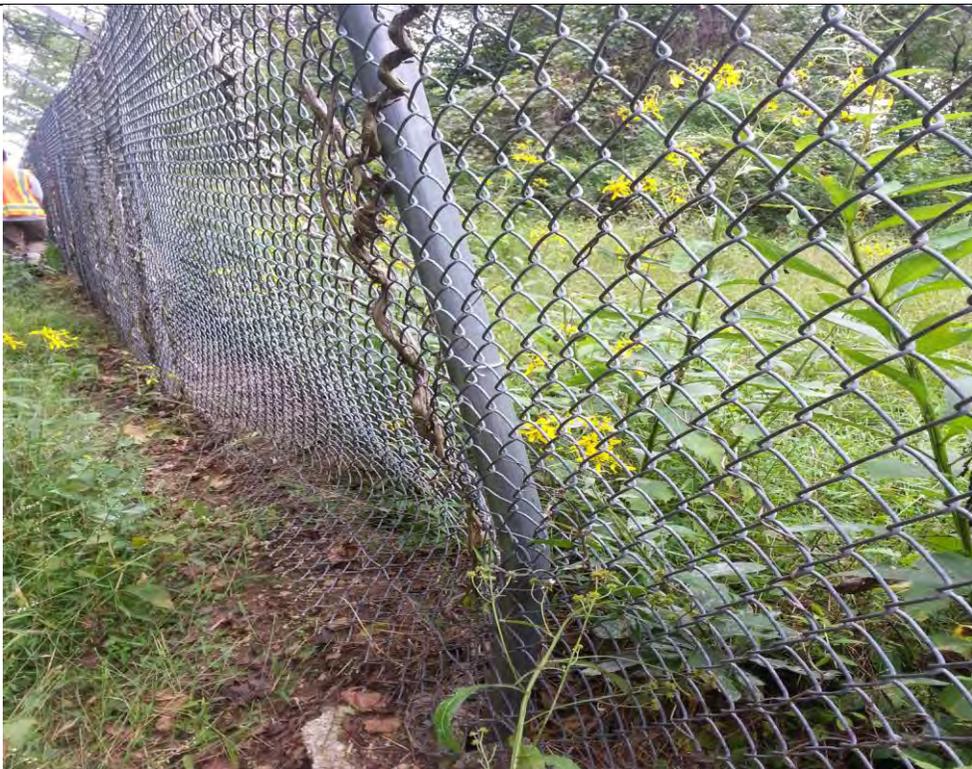
Photo No.: 8	Date: 9/10/2014

Direction Photo Taken: North		
Description: View north showing western fence damage. Bottom of fence is bent, possibly due to recent flooding. Also, there is evidence of animals burrowing.

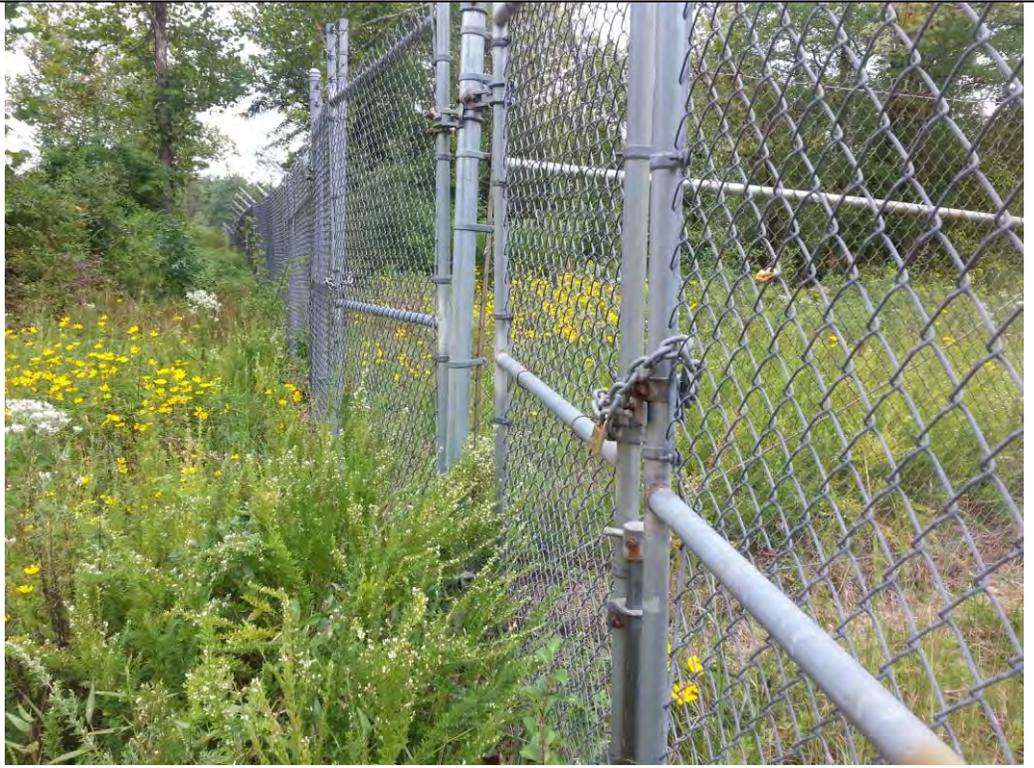
Photo No.: 9  
Date: 9/10/2014

Description:  
View east showing  
northwestern corner gate  
and vegetation growth  
along the northern  
exterior boundary of  
IAL2. Vegetation is  
approximately 3 feet tall.  
Gate locked.

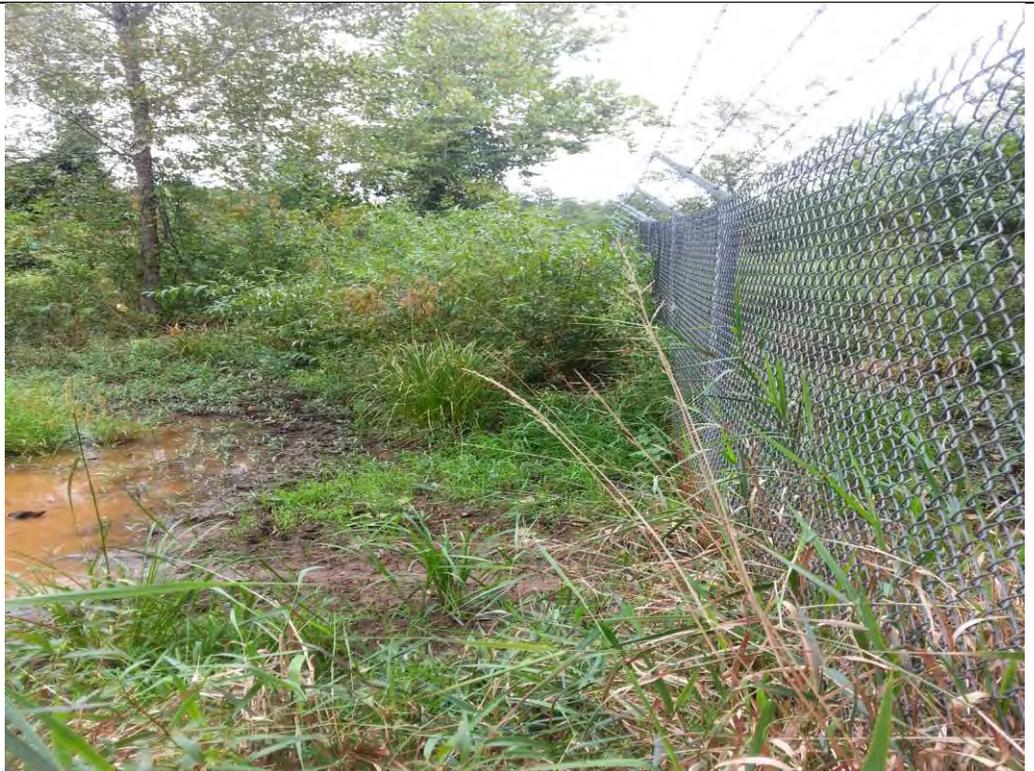
Photo No.: 10  
Date: 9/10/2014

Description:  
View east along the  
northern exterior  
boundary showing heavy  
vegetation near the  
pond/wetland area.

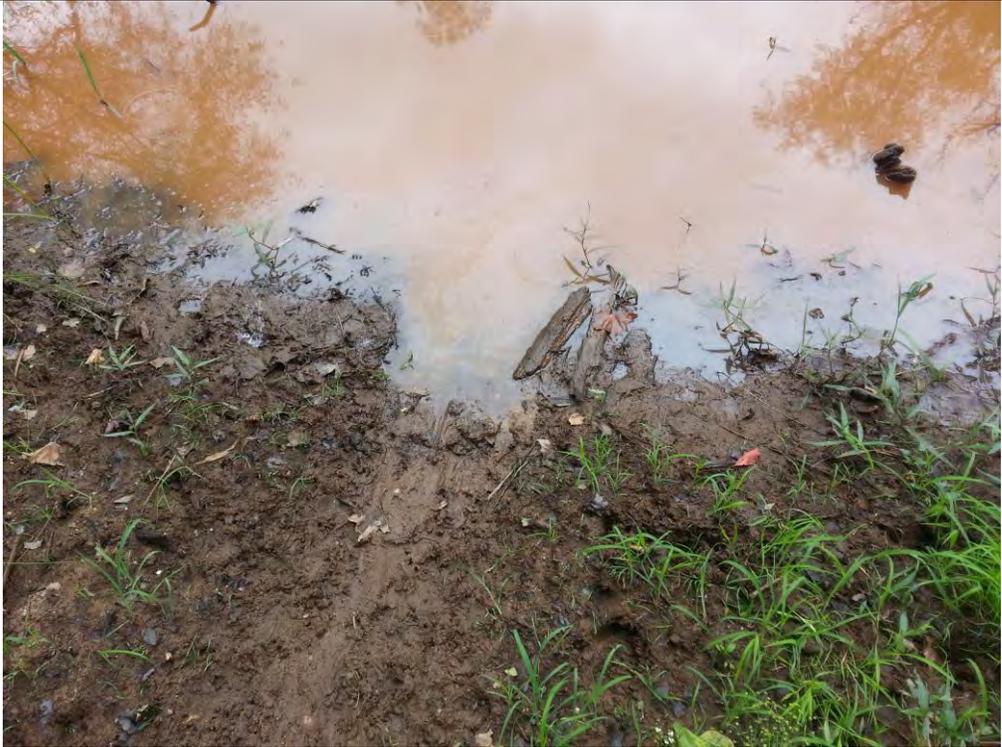
Photo No.: 11	Date: 9/10/2014

Direction Photo Taken: North		
Description: Standing water in the pond/wetland area.

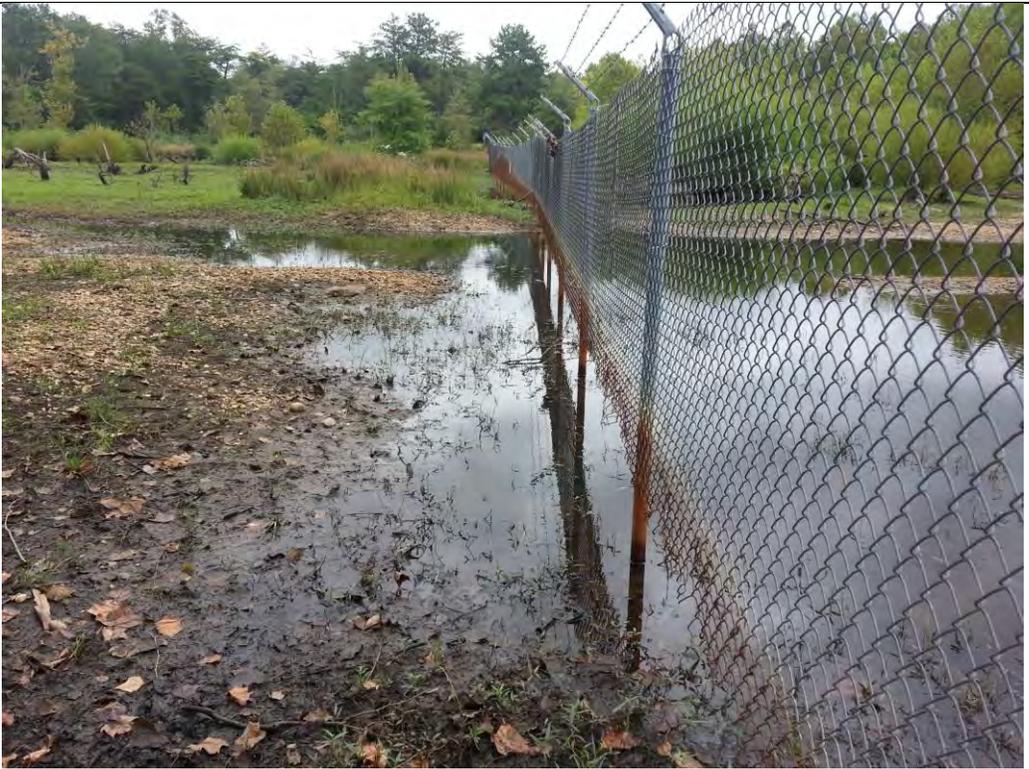
Photo No.: 12	Date: 9/10/2014

Direction Photo Taken: East		
Description: View east along the northern exterior boundary showing the pond/wetland area. This shows the approximately 2 foot gap between the fence and ground surface. In addition, rust is visible from the previous water line.

Portions of the fence line have overgrown vegetation, and if not addressed, it could impact the integrity of the fence and impair future visual inspections. At the time of the inspection, the area near the pond/wetland was mostly dry, resulting in a range of less than one foot to three foot gap between the ground and fence. During dry periods, the fence does not provide an adequate safety control. Recommend evaluating frequency of dry periods to determine if the current fence provides adequate protection.
