**FINAL 2015 Annual Maintenance Inspection Report
INACTIVE LANDFILL No. 2 (FGGM-007-R)
AT FORT GEORGE G. MEADE, MARYLAND**

Prepared By:
**Fort George G. Meade
Directorate of Public Works - Environmental Division
4216 Roberts Ave, Suite 5115
Fort Meade, Maryland 20755-7068**

March 2016

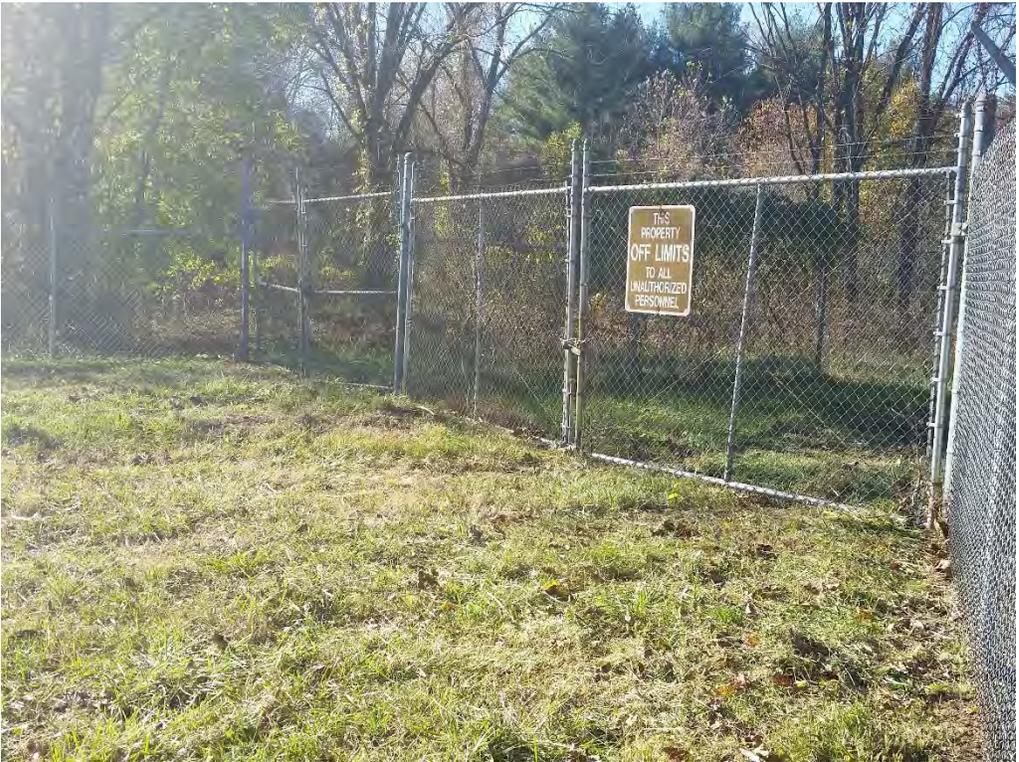
Photo No.: 1	Date: 11/4/2015

Direction Photo Taken: North		
Description: View north along the southern exterior boundary showing the locked main access gate to IAL2 and the "Off Limits" signage. This area is adjacent to Wildlife Loop Road.

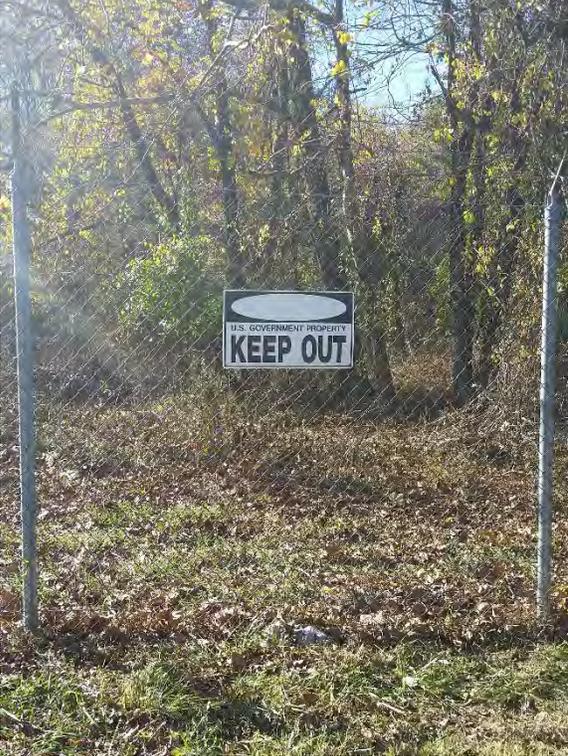
Photo No.: 2	Date: 11/4/2015

Direction Photo Taken: West		
Description: View west along the southern exterior fence. This area is adjacent to Wildlife Loop Road. "Danger" sign is faded and recommended for replacement.

The following items are recommended: conduct future inspections during late fall, winter, or early spring when vegetation is low, and recommend routine cutting of the vegetation to reduce and manage the growth rate of the vegetation. Faded signs should be replaced with updated UXO warning language.

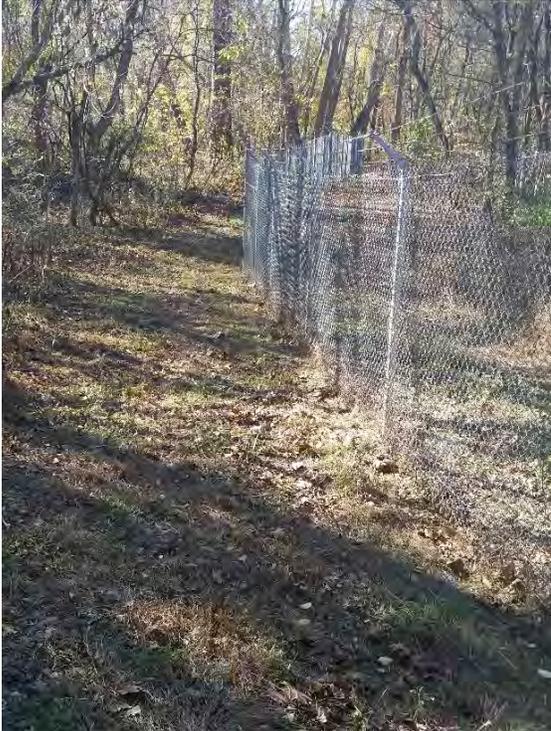
Photo No.: 3	Date: 11/4/2015

Direction Photo Taken: West		
Description: View west along the southern exterior fence toward southwestern corner.

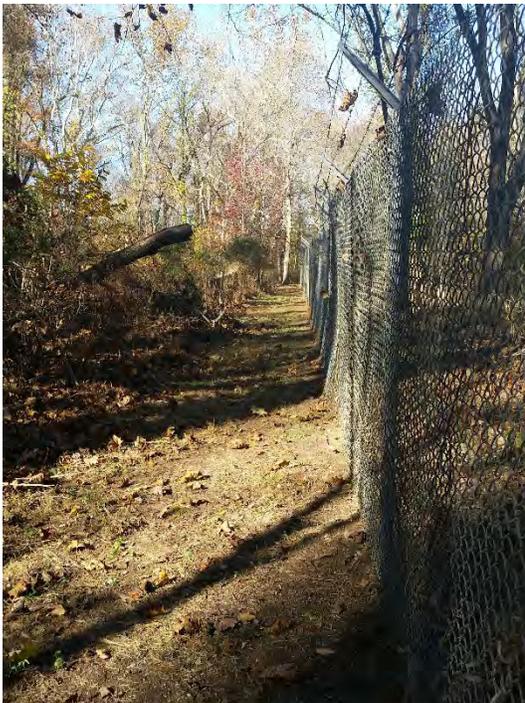
Photo No.: 4	Date: 11/4/2015

Direction Photo Taken: North		
Description: View north along the western exterior fence line showing repaired fence and cleared vegetation.

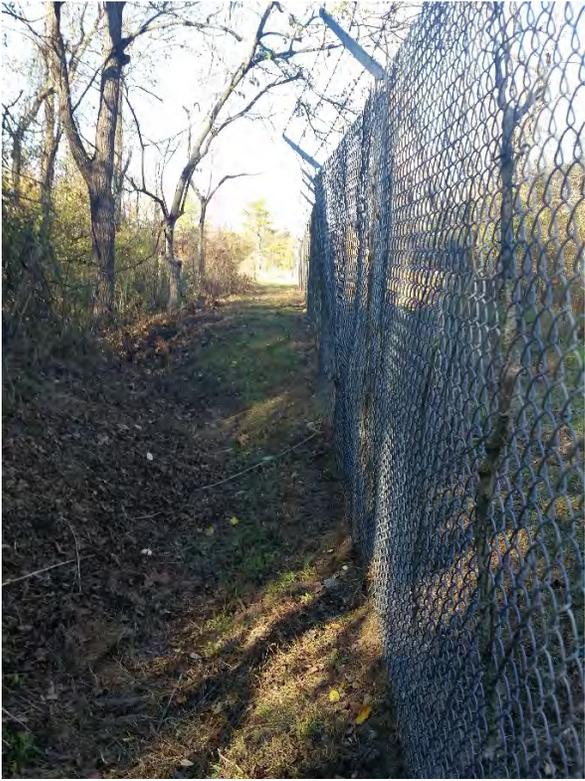
Photo No.: 5	Date: 11/4/2015

Direction Photo Taken: North		
Description: View north along the western exterior fence toward northern access gate.

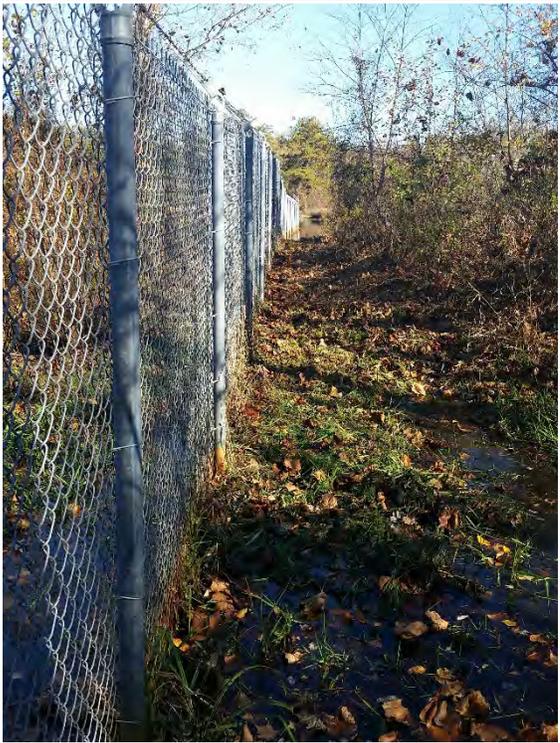
Photo No.: 6	Date: 11/4/2015

Direction Photo Taken: East		
Description: View east along the northern interior fence showing cleared vegetation and standing water in wetland area.

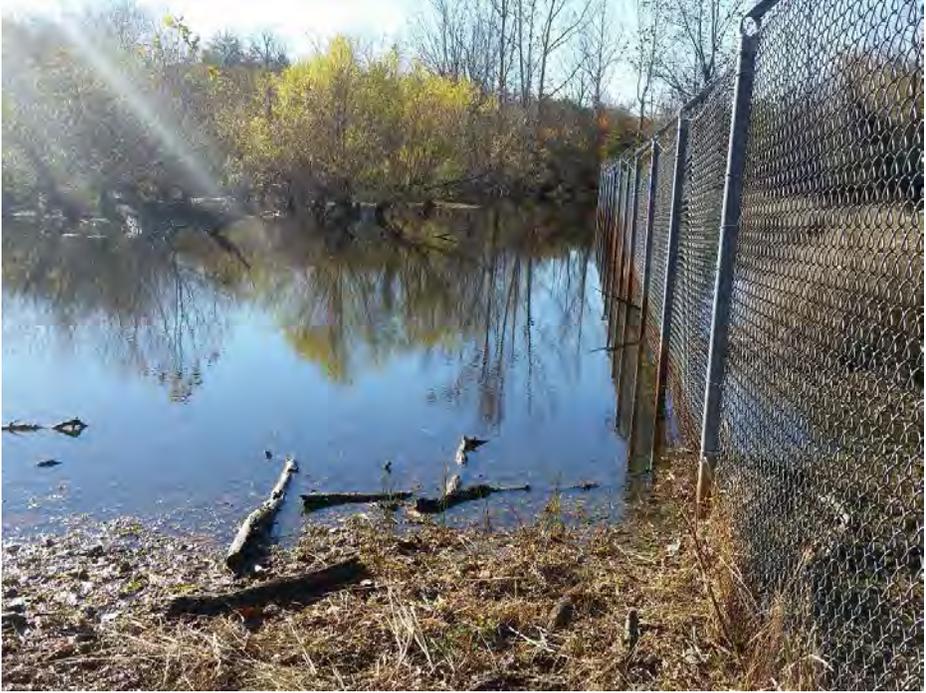
Photo No.: 7	Date: 11/4/2015

Direction Photo Taken: West		
Description: View west along the northern interior fence showing pond in wetland area. Rust is visible from the water line.

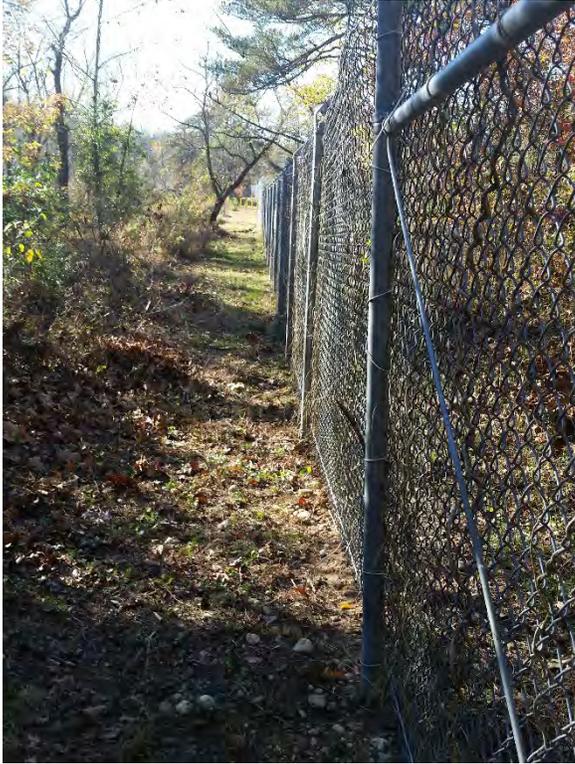
Photo No.: 8	Date: 11/4/2015

Direction Photo Taken: West		
Description: View west along northern interior fence toward monitoring wells.

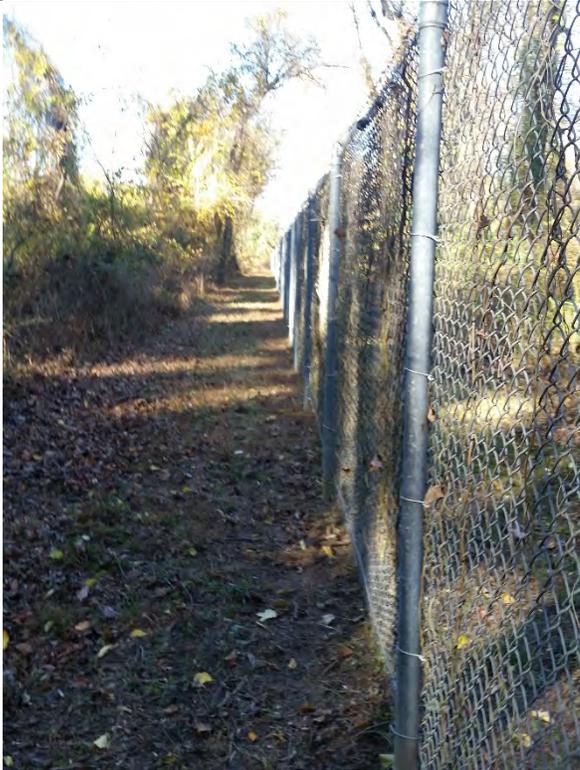
Photo No.: 9	Date: 11/4/2015

Direction Photo Taken: North		
Description: View north along the eastern interior fence showing recently cleared vegetation.

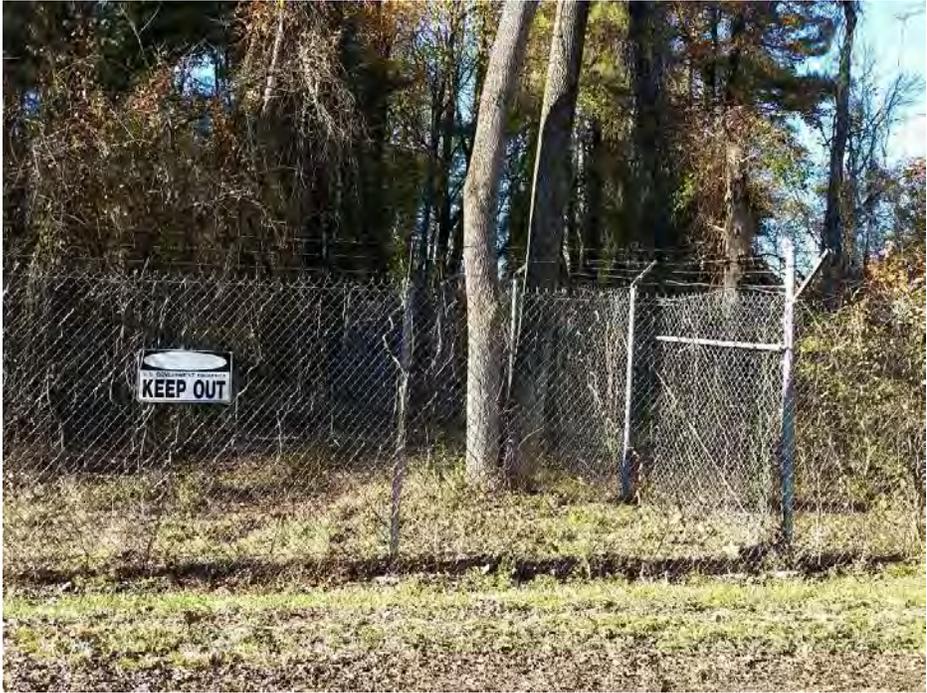
Photo No.: 10	Date: 11/4/2015

Direction Photo Taken: North		
Description: View north at the southeastern corner exterior boundary. "Danger" sign is faded and recommended for replacement.

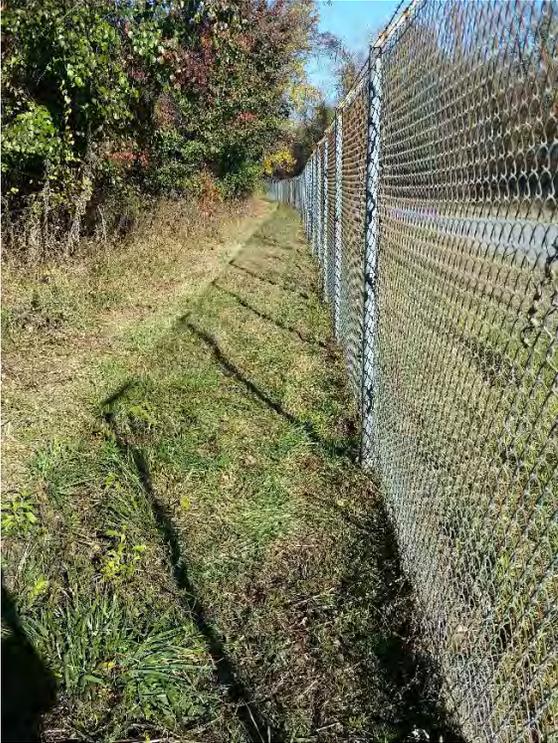
Photo No.: 11	Date: 11/4/2015

Direction Photo Taken: East		
Description: View east along the southern interior fence showing recently cleared vegetation.

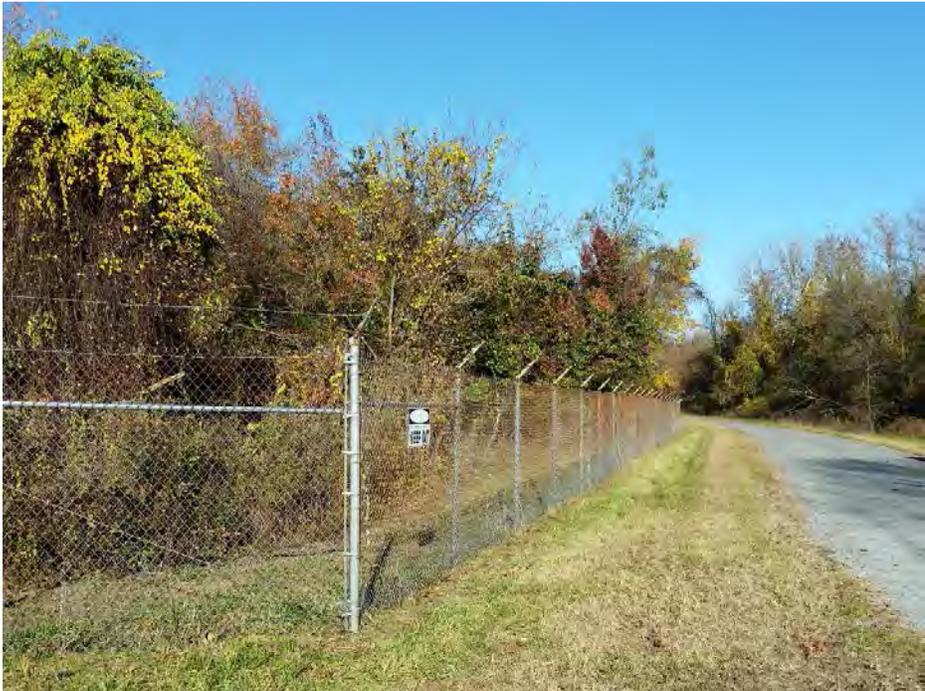
Photo No.: 12	Date: 11/4/2015

Direction Photo Taken: East		
Description: View east along the southern exterior boundary showing cleared vegetation and faded "Danger" signage recommended for replacement.
