## REVISED FINAL Remedial Action Completion Report

FGGM 93, Manor  
View Dump Site,  
Fort George G.  
Meade, Maryland

December 2015

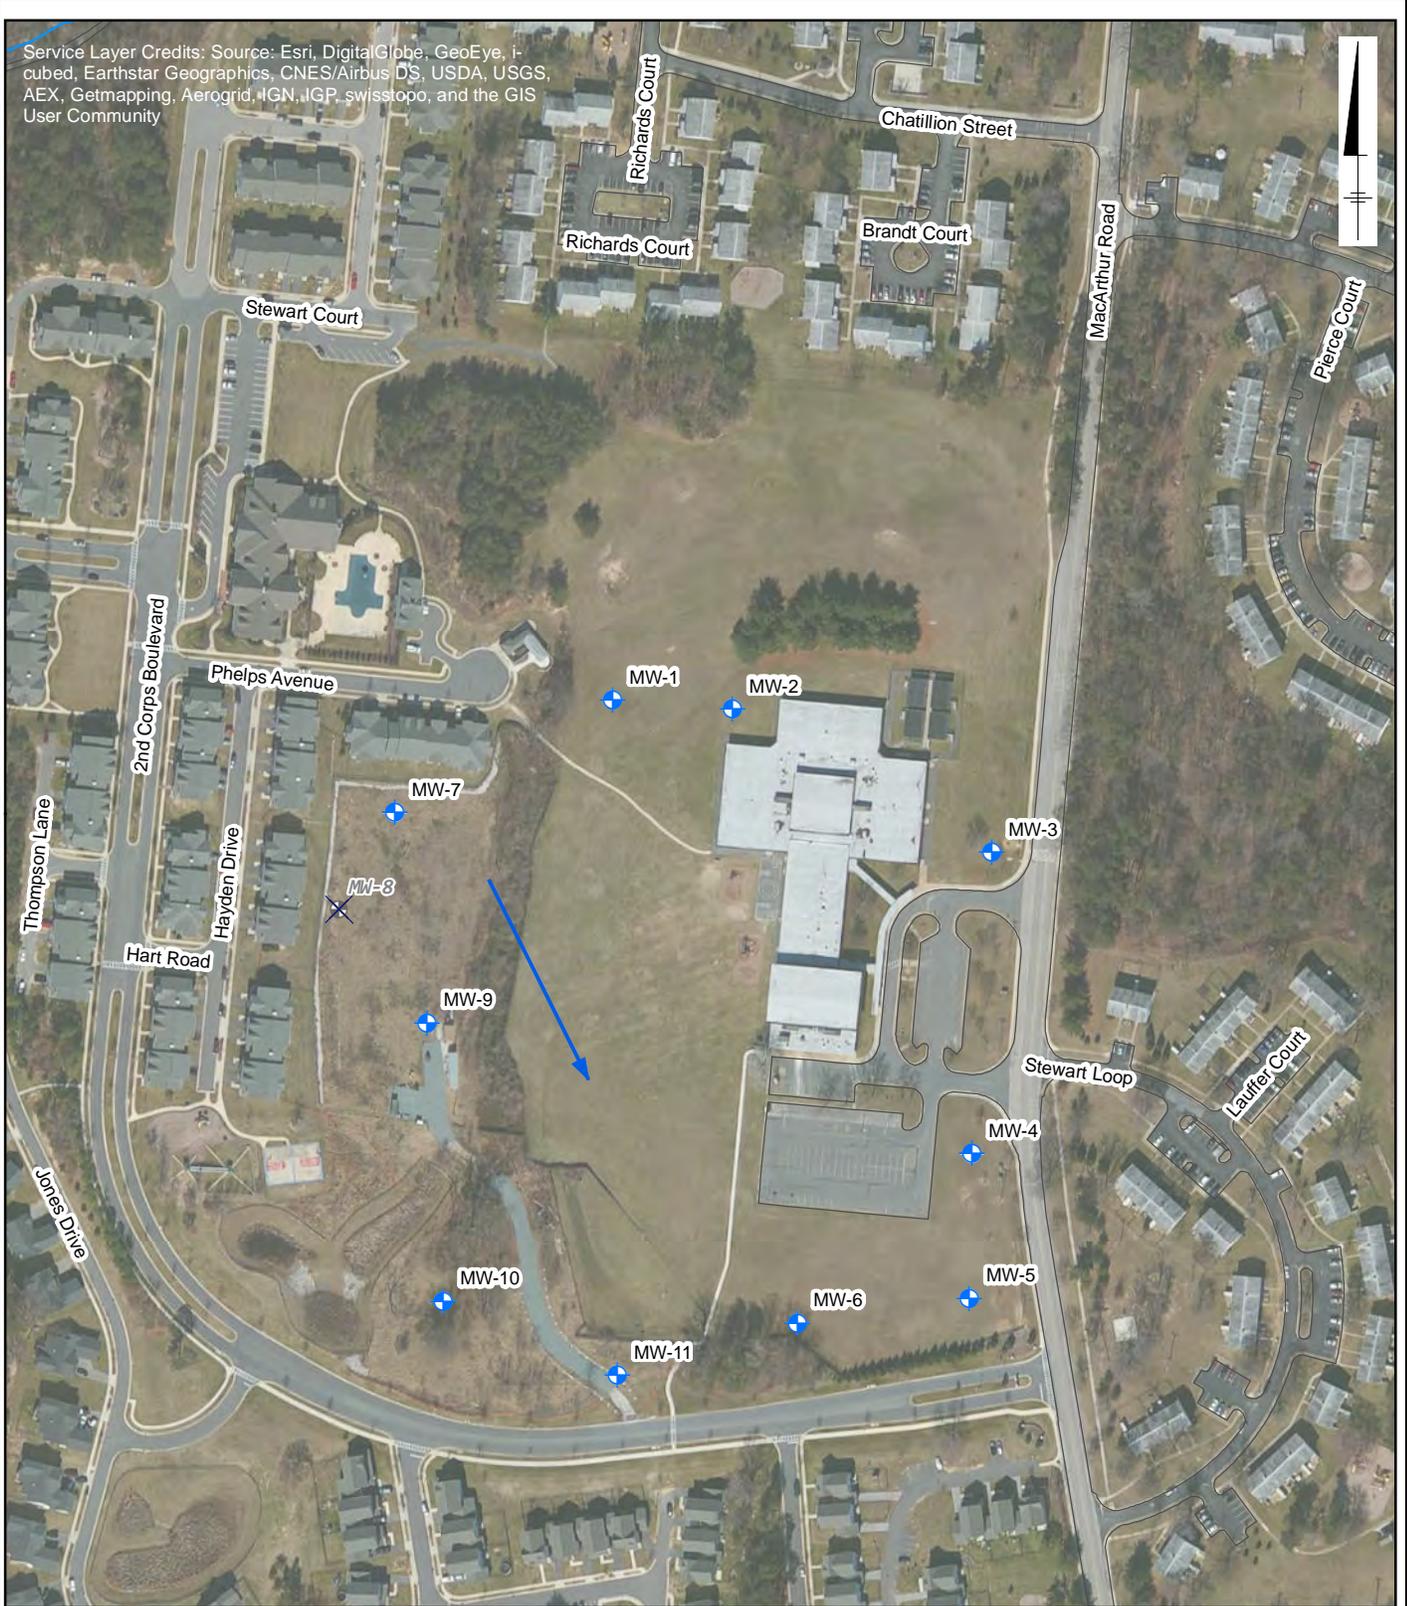
**FIGURE  
 5**

DAMAGED, WELL ABANDONED  
OCTOBER 2014
-

- **Monitoring Locations:** As part of the annual inspection all of the monitoring locations (i.e., monitoring wells and soil gas monitoring points) were evaluated with respect to integrity of construction and security. During the inspection, MW-08 was observed outside of its manhole vault and it is assumed that it likely shifted due to settling following completion of the NTCRA in 2012 (Refer to Photo 1 of **Appendix A**). Thus, as proposed in the RD (U.S. Army, 2015) MW-8 was abandoned on October 3, 2014 by a driller licensed in the State of Maryland. The well abandonment report is provided in **Appendix F**.

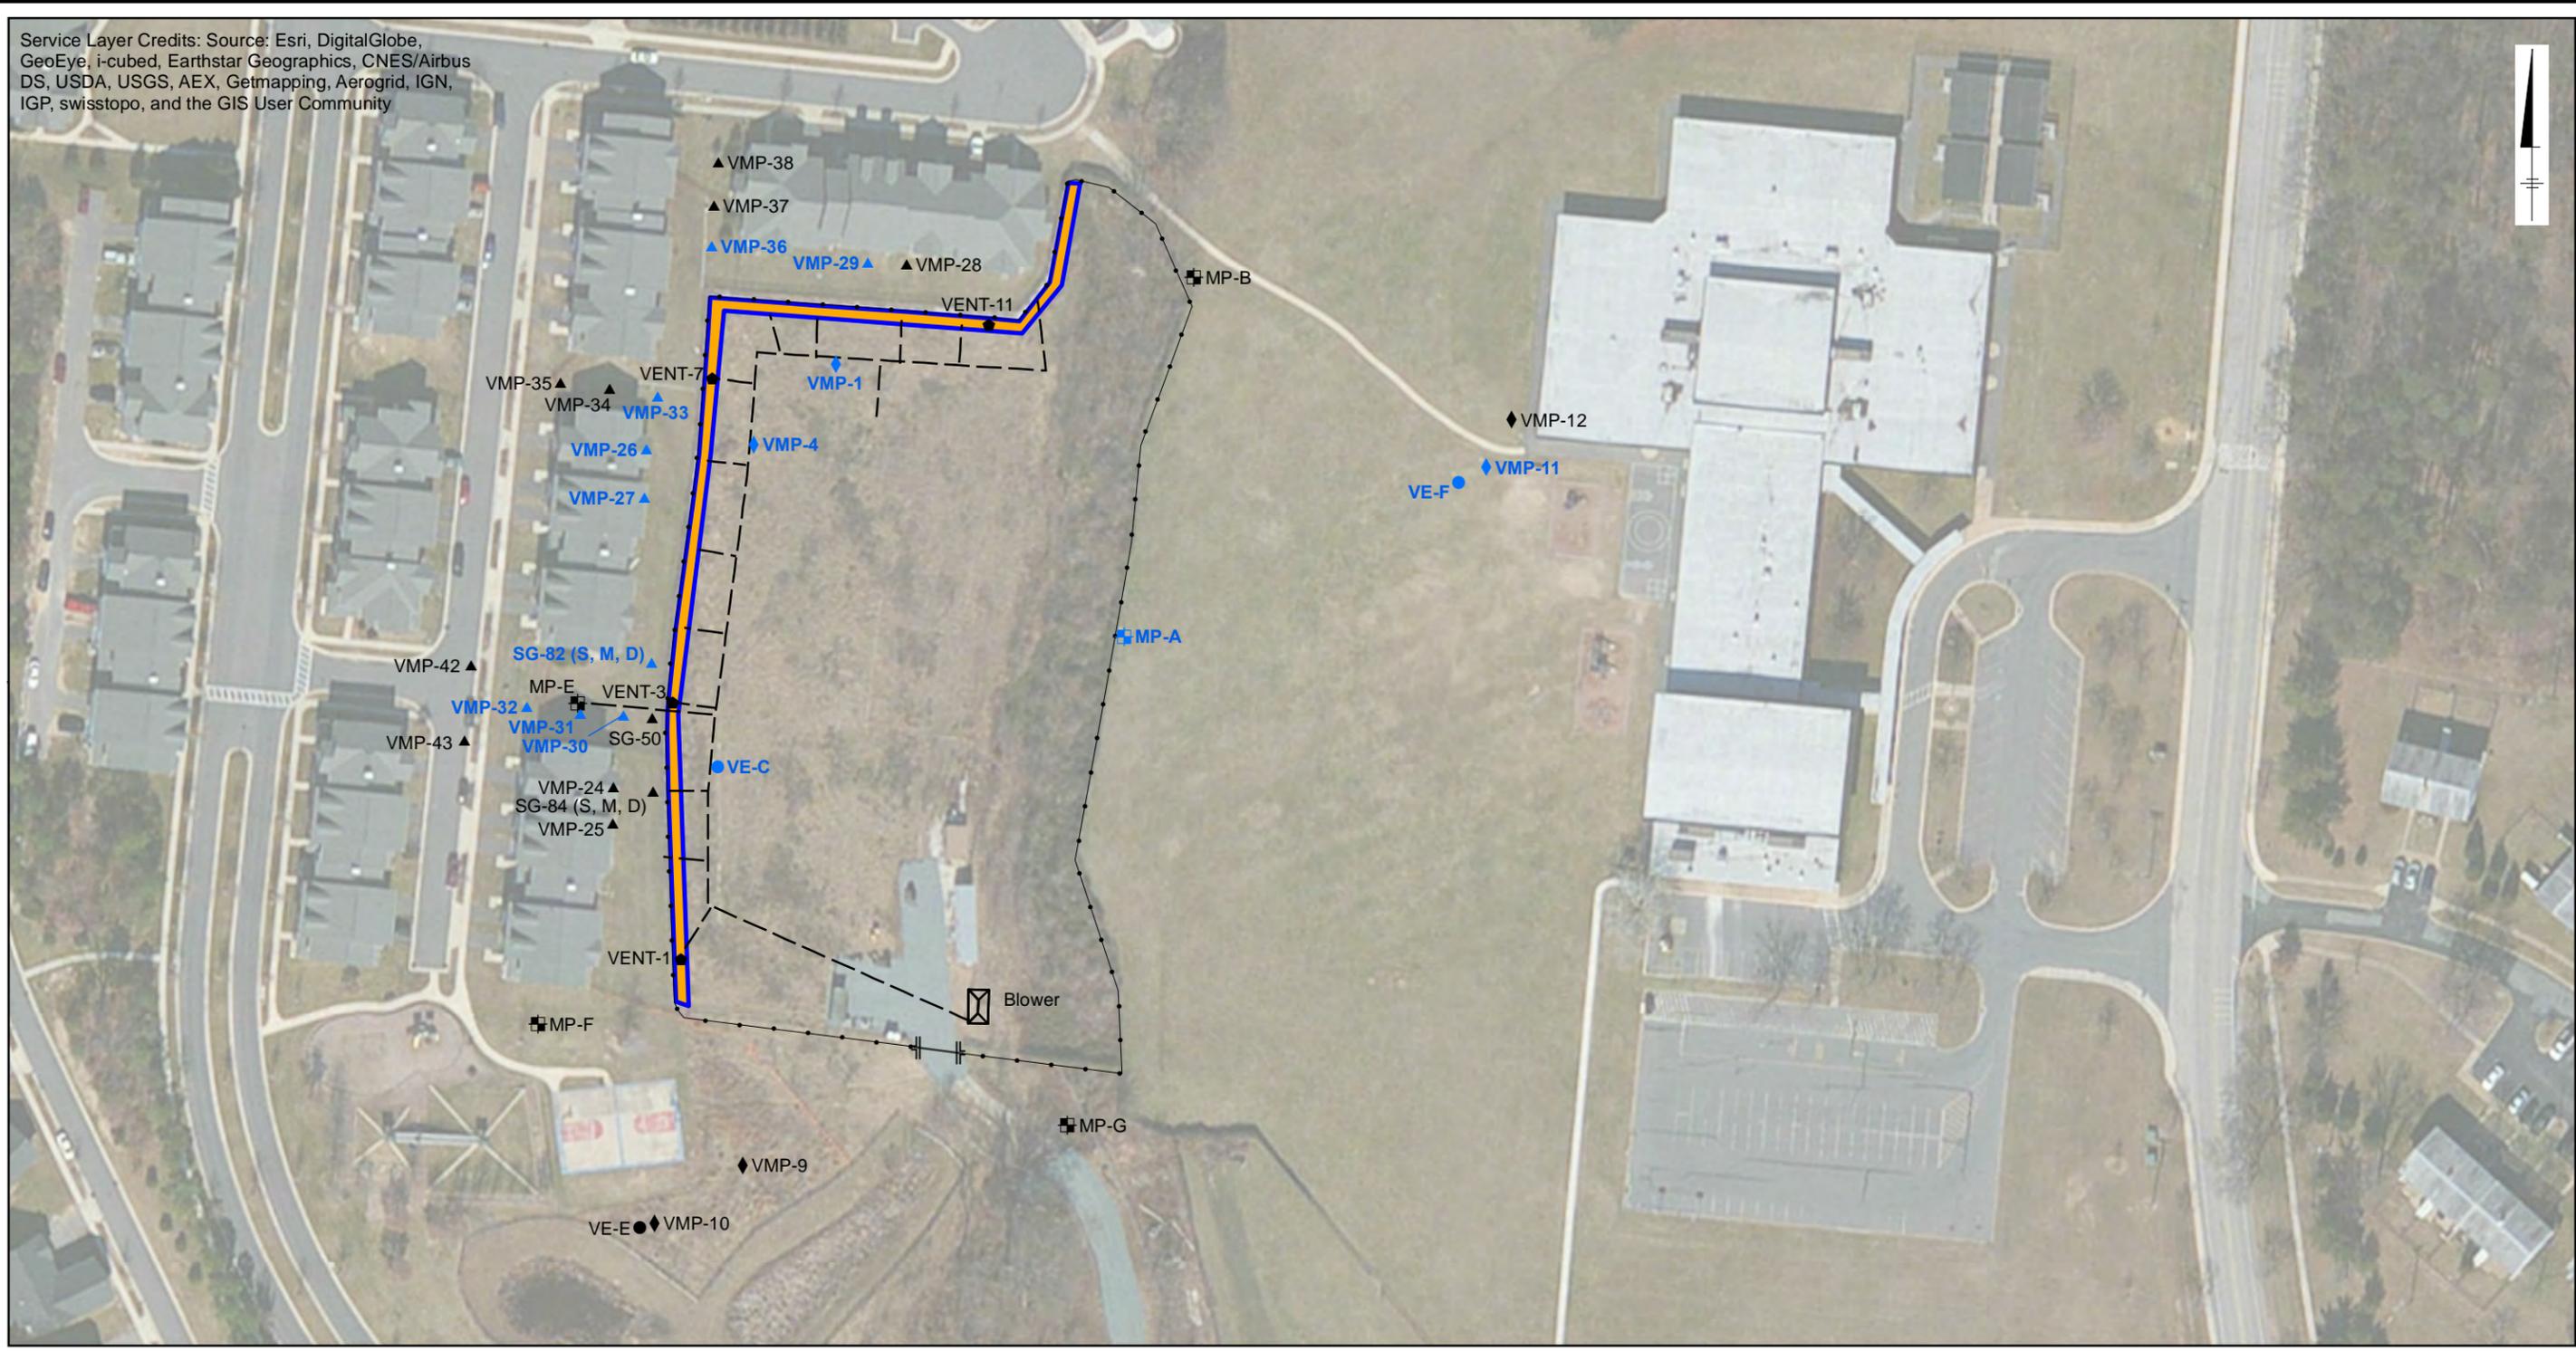
Notes:  
1. The soil vapor extraction system was shutdown on August 17, 2012. The system has remained off but in an operational status.  
2. Monitoring locations included in the long-term monitoring program are displayed as a blue symbol with blue labels.

- **Soil Vapor Extraction System:** The soil vapor extraction system was started October 2, 2014. The system was shut down immediately following the completion of the operational testing. No operational issues were noted.

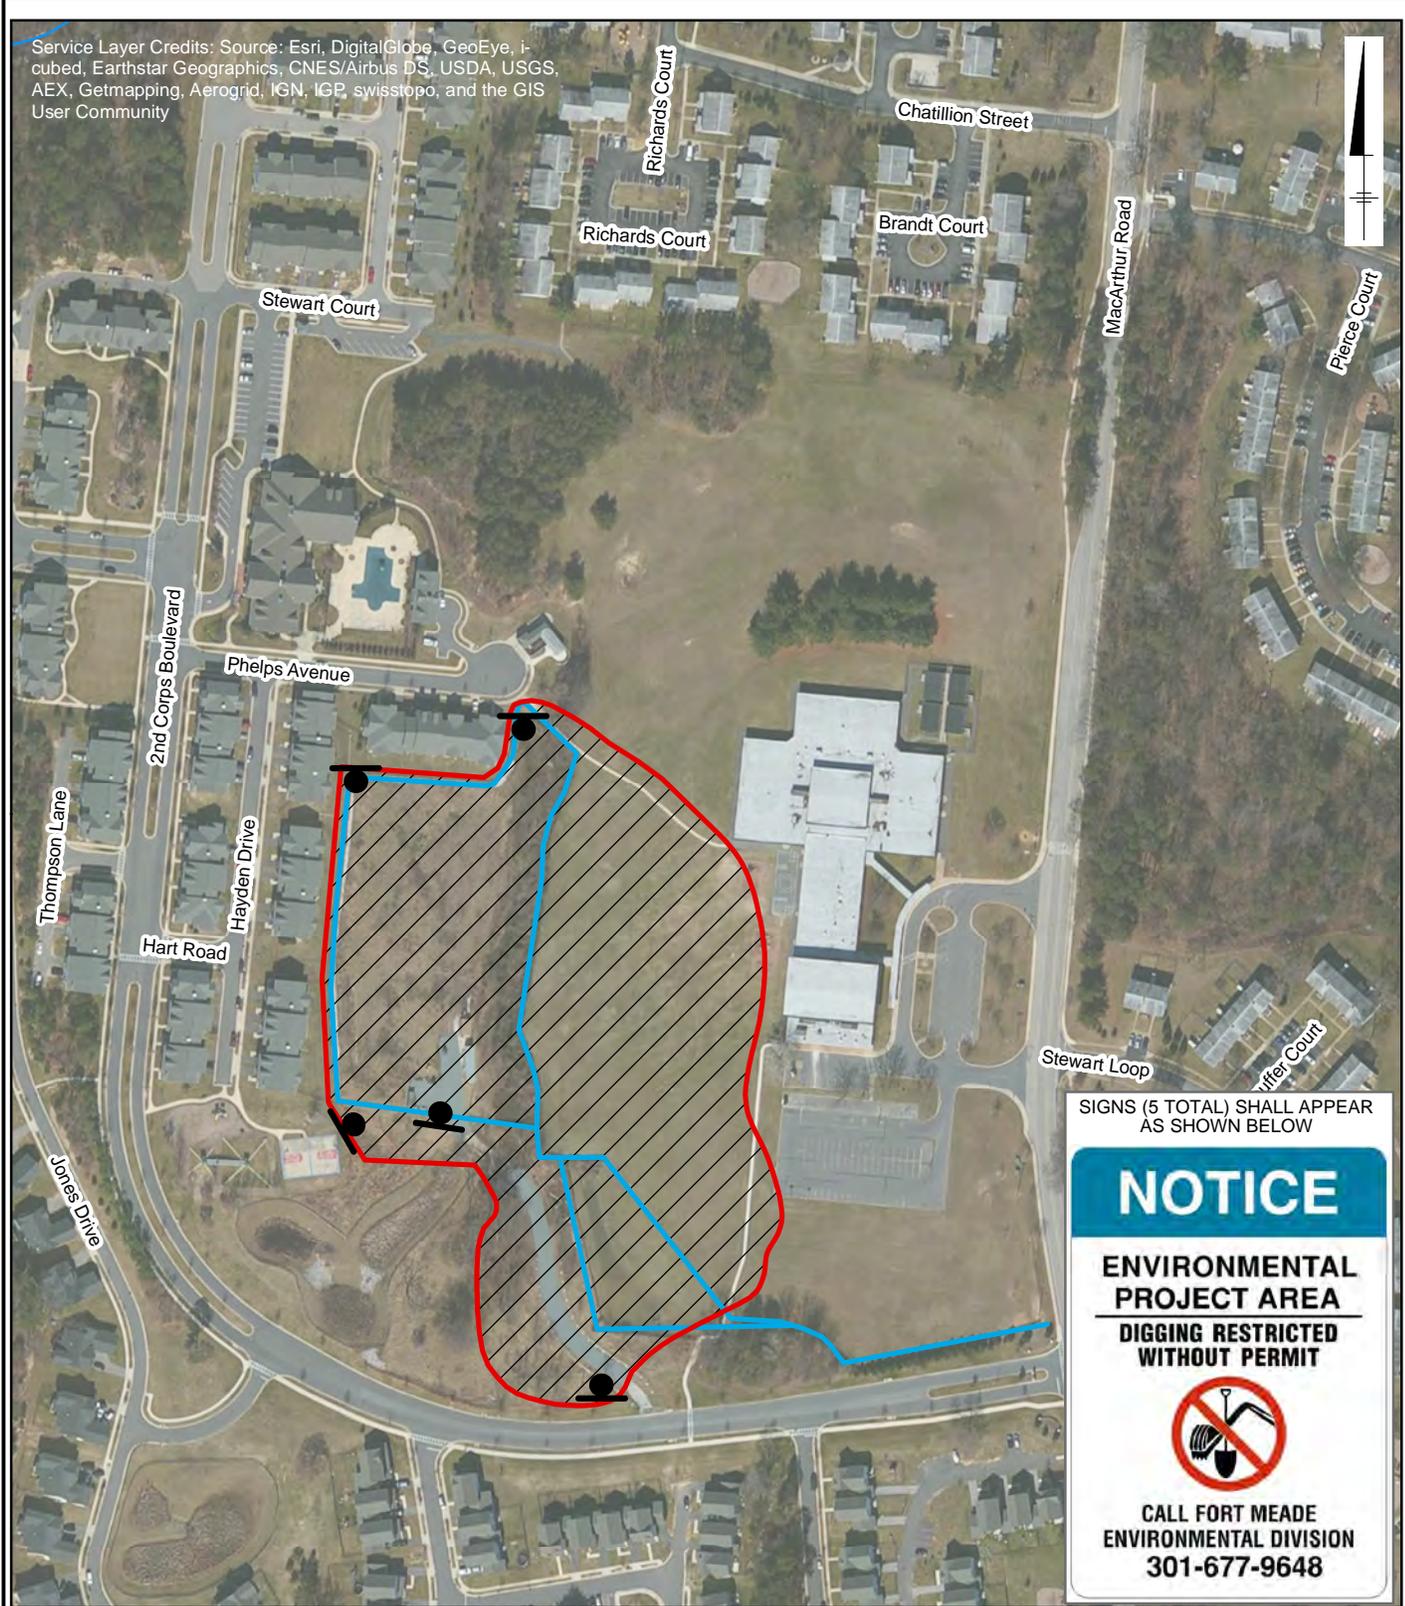
**FIGURE 8**

SIGNS (5 TOTAL) SHALL APPEAR AS SHOWN BELOW

- **Land Use:** No changes in land use were observed at the Site including the crawl space of the Manor View Elementary School.
- **LUC Signage:** Five LUC signs were installed on October 2, 2014 utilizing U-steel channel posts. The signs were installed 3 to 4 ft below ground surface and stand approximately 7 ft above the ground surface. The signs were installed at the locations depicted on **Figure 8** and are depicted on Photos 3 through 7 of **Appendix A**. Following installation, the signs were inspected to document sign locations and conditions.

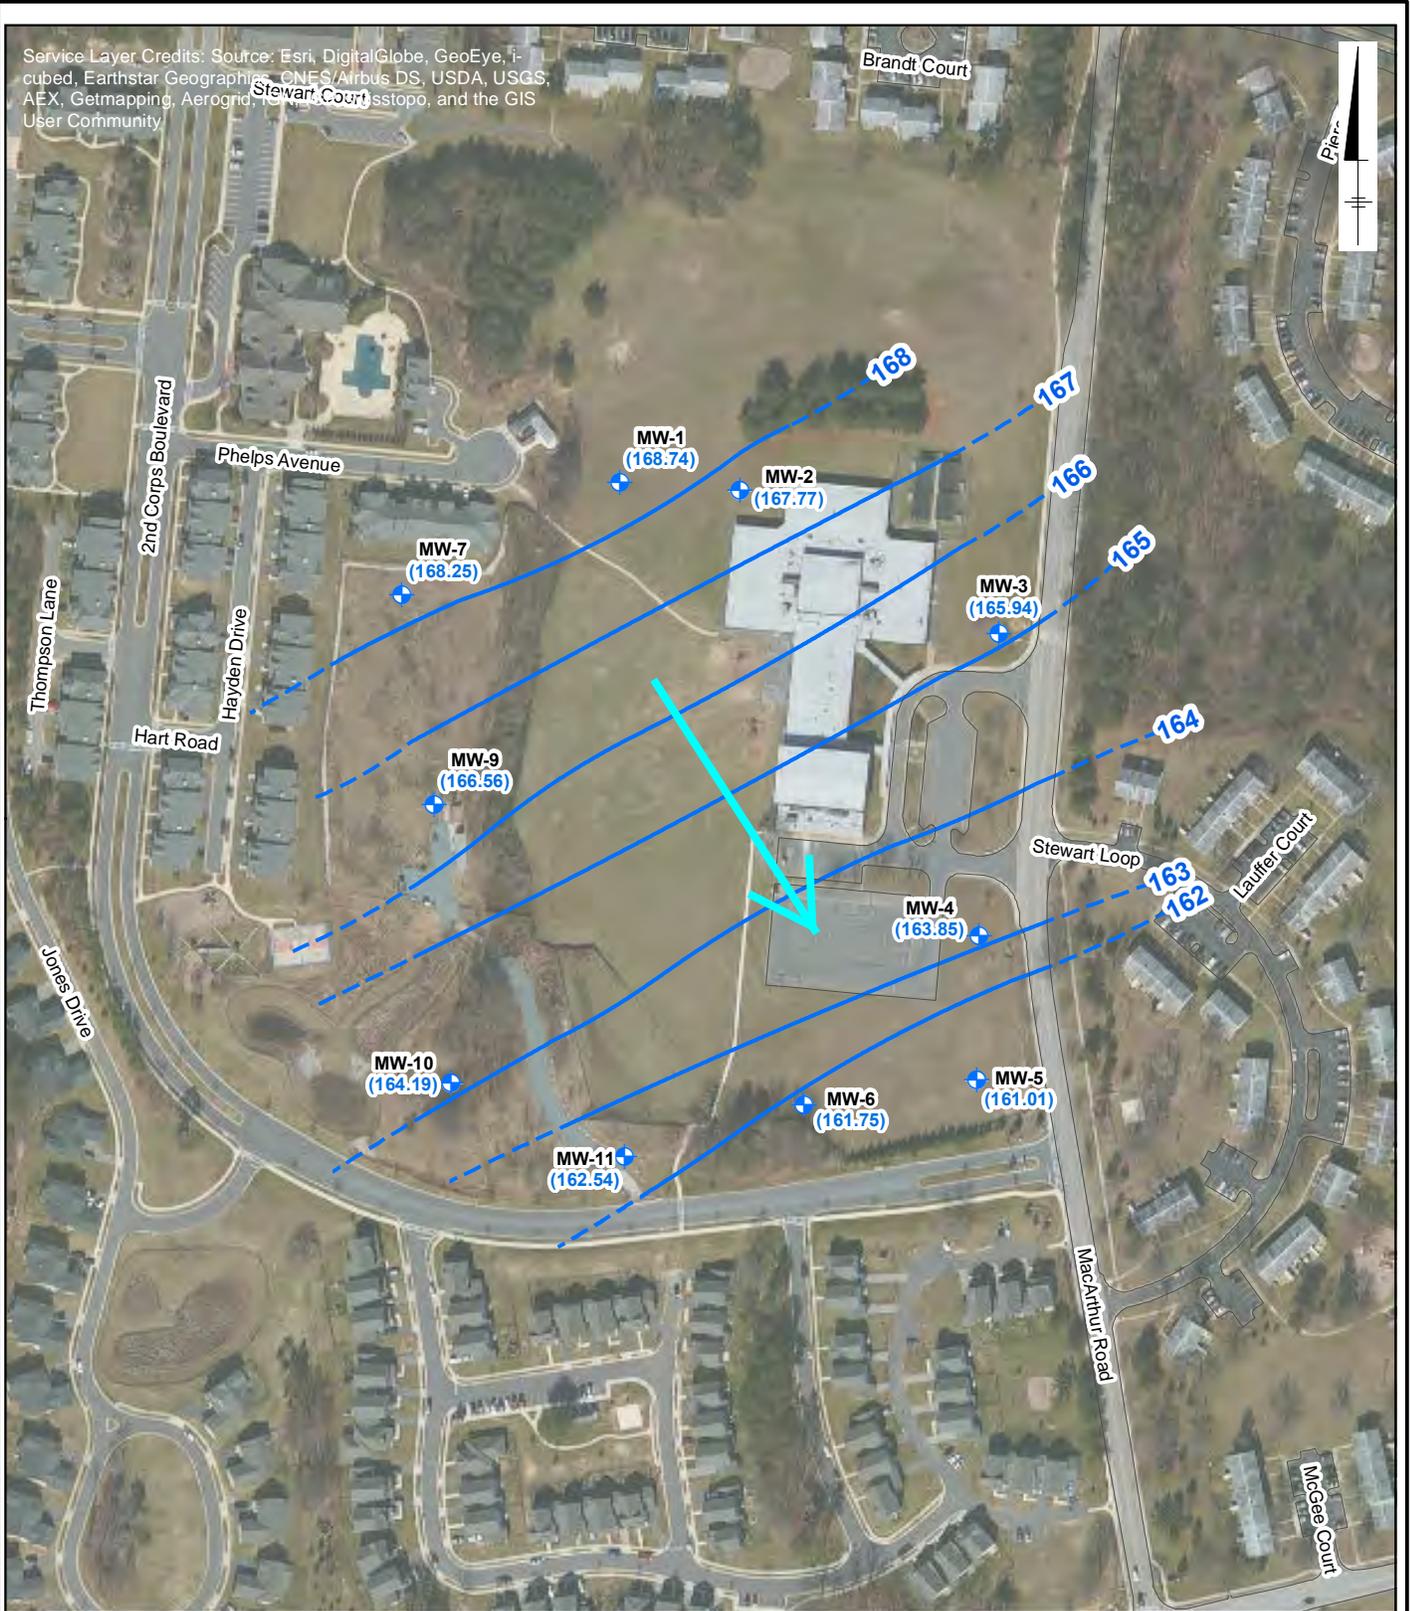
**FIGURE  
9**

- Monitoring Well
- (166.50)** Groundwater Elevation (Feet Above Mean Sea Level)
- Groundwater Elevation Contour Line (Dashed Where Inferred)
- Groundwater Flow Direction

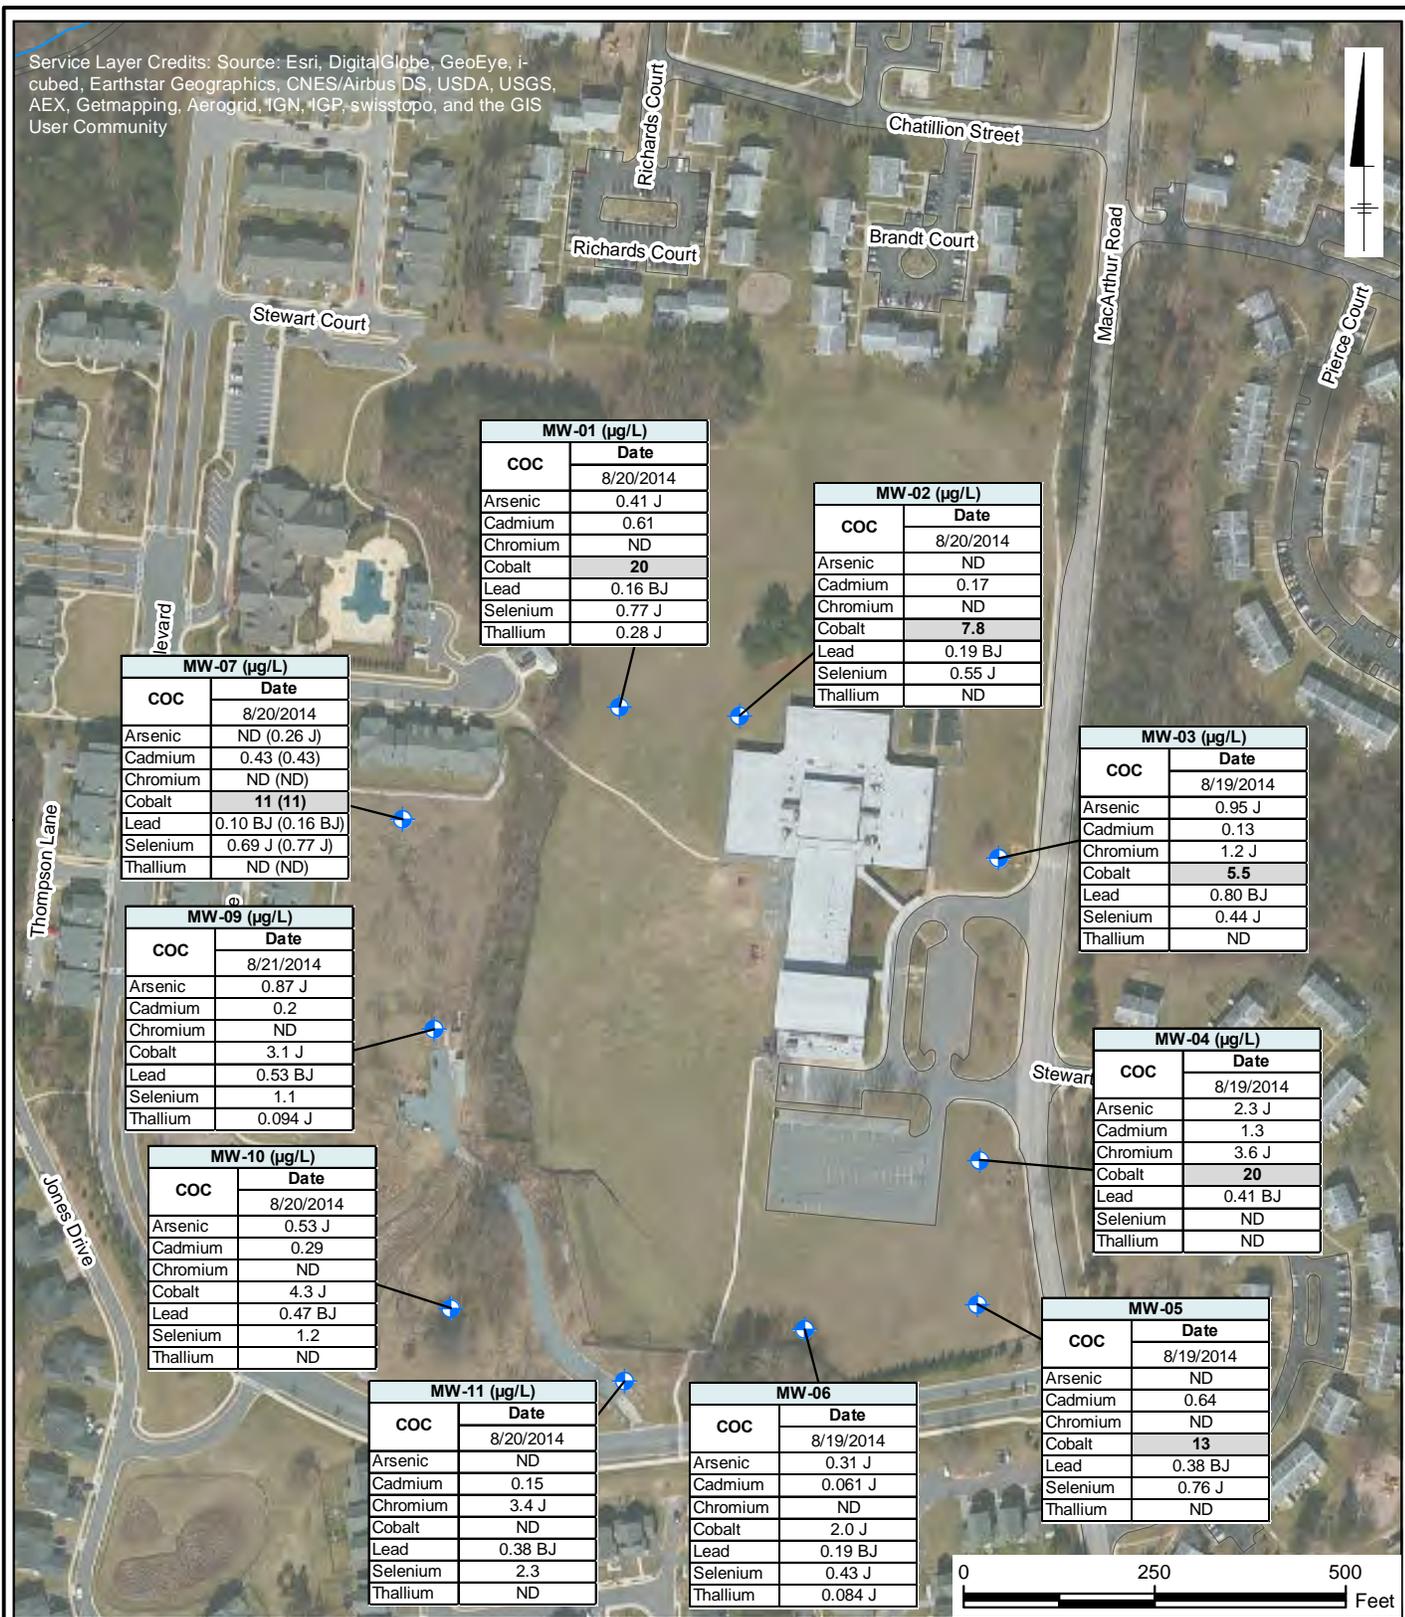
MW-01 (µg/L)	
COC	Date
	8/20/2014
Arsenic	0.41 J
Cadmium	0.61
Chromium	ND
Cobalt	<b>20</b>
Lead	0.16 BJ
Selenium	0.77 J
Thallium	0.28 J

MW-02 (µg/L)	
COC	Date
	8/20/2014
Arsenic	ND
Cadmium	0.17
Chromium	ND
Cobalt	<b>7.8</b>
Lead	0.19 BJ
Selenium	0.55 J
Thallium	ND

Notes:  
1. Bolded and grey shaded values indicate concentrations above the Remedial Goal (RG).  
2. Duplicate sample results are provided in parenthesis adjacent to results presented for the parent sample.

Groundwater analytical results for Site COCs are provided in **Table 3** and also on **Figure 10** (metals) and **Figure 11** (volatile organic compounds). A summary of the COC concentrations observed during the August 2014 sampling event is discussed below:

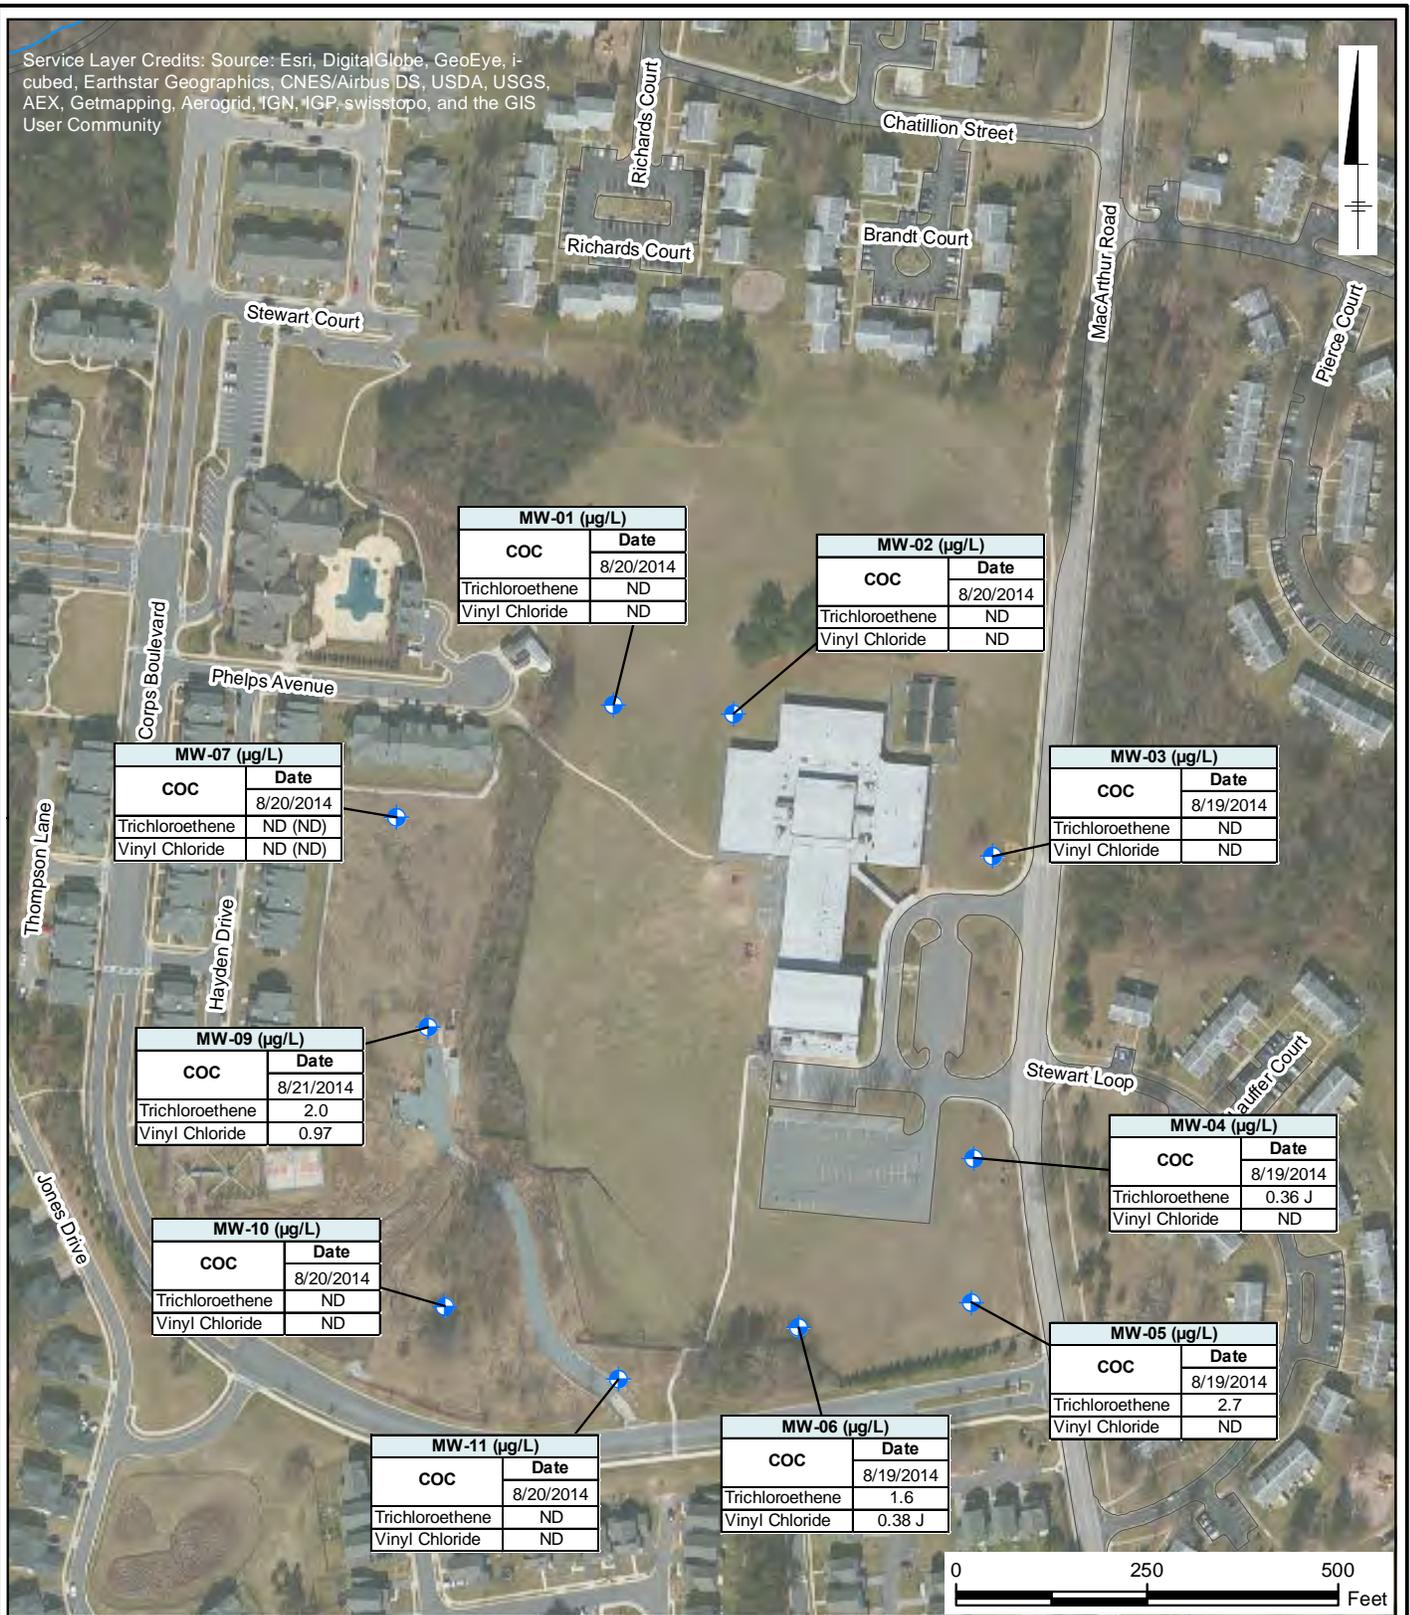
1. Duplicate sample results are provided in parenthesis adjacent to results presented for the parent sample.

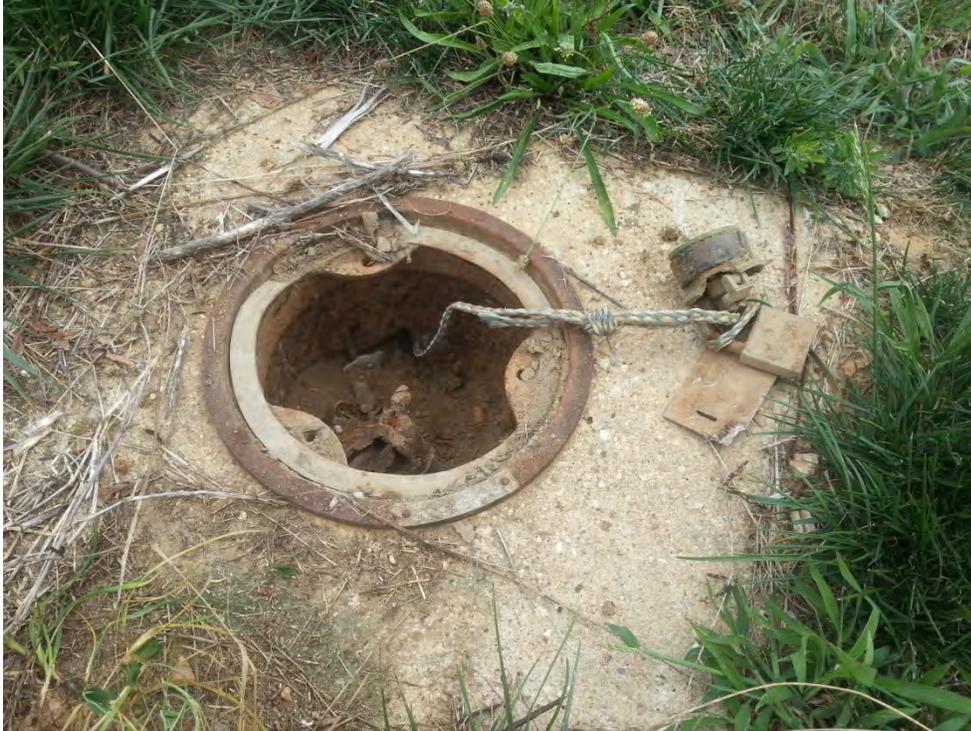
**Photo 1:** Damage at MW-8  
**Date:** August 18, 2014  
**Location Taken:** MW-8  
**Direction Facing:** Ground surface

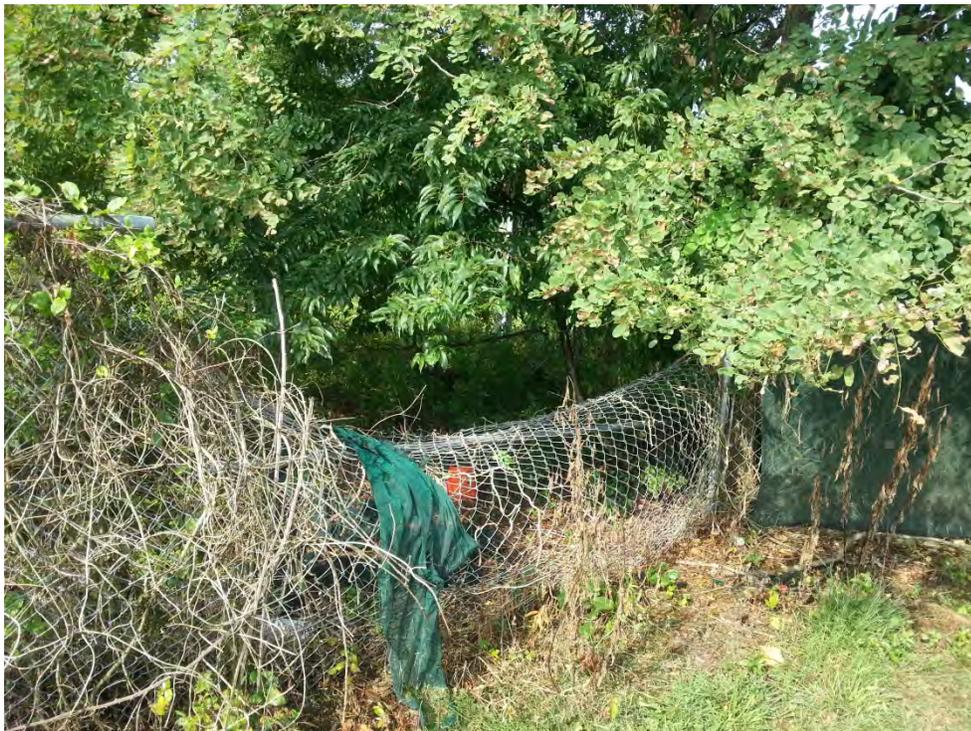
**Photo 2:** Fence damage  
**Date:** August 21, 2014  
**Location Taken:** Southwest corner of Manor View Elementary School play yard. Damaged fence is not part of the fence enclosing the western portion of the Site; rather, damaged fence runs parallel to the site access road.  
**Direction Facing:** Northwest

- **Fence:** In general, the fence was observed in good condition and was locked upon arrival to the Site. Small animal passages were noted at multiple locations along the fence line. Additionally, vegetation overgrowth along the access road has collapsed a 10 ft section of fencing extending past the southwest corner of the school yard along the east side of the access road. This fence collapse does not allow access to the western portion of the Site and continues to delineate the land

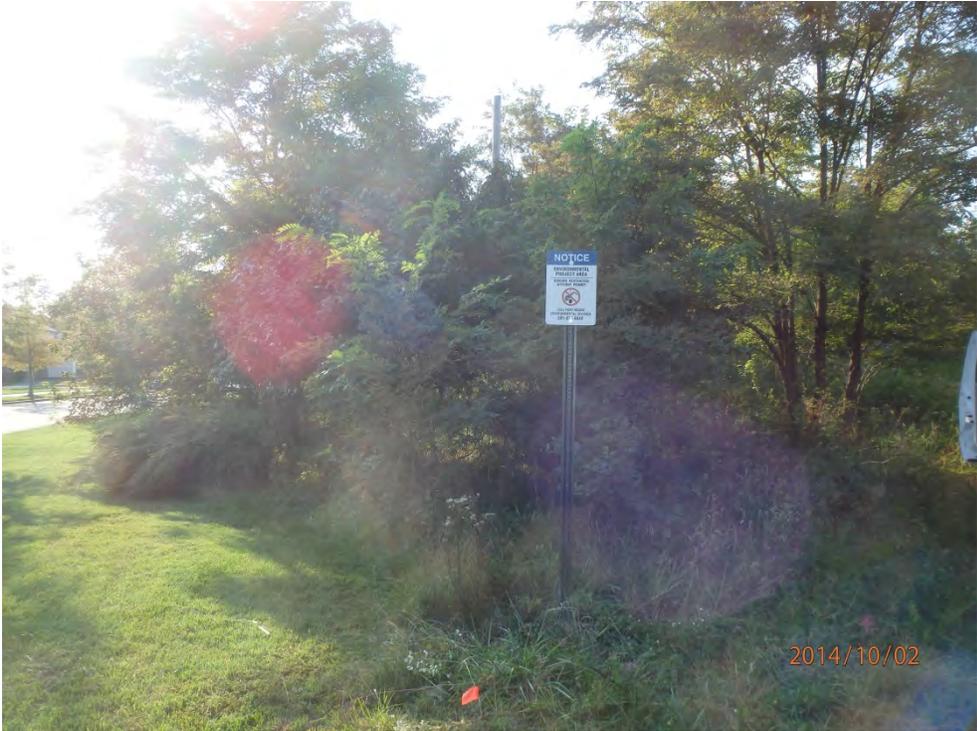
**Photo 3:** Sign Location #1  
**Date:** October 2, 2014  
**Location Taken:** Site access road and 2<sup>nd</sup> Corp Blvd.  
**Direction Facing:** West

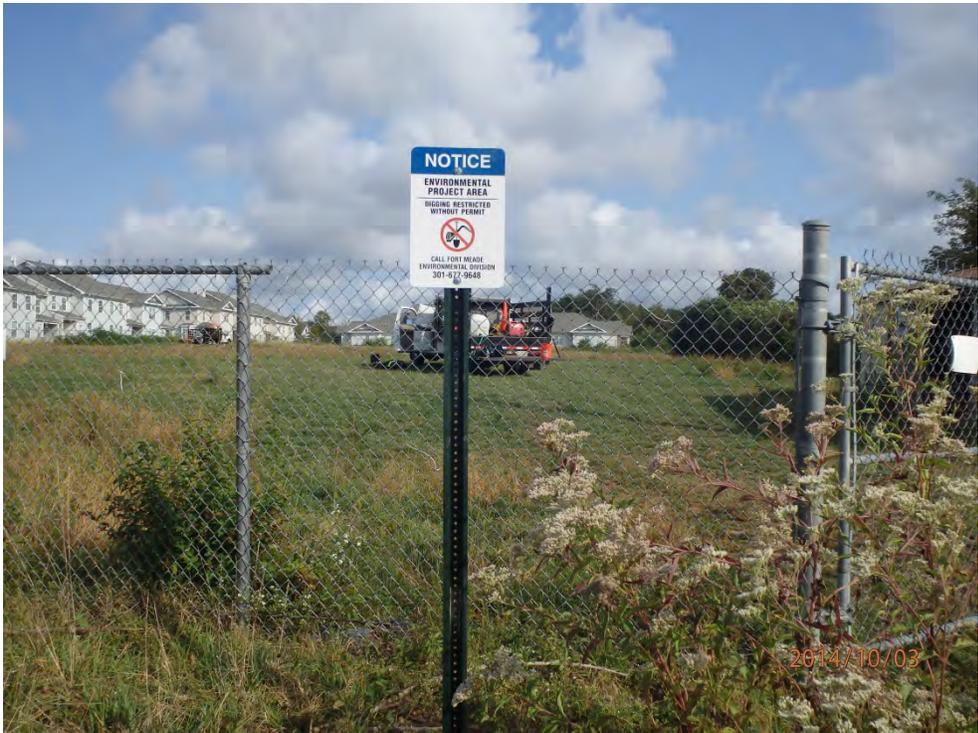
**Photo 4:** Sign Location # 2  
**Date:** October 3, 2014  
**Location Taken:** South gate entrance to the Site.  
**Direction Facing:** North

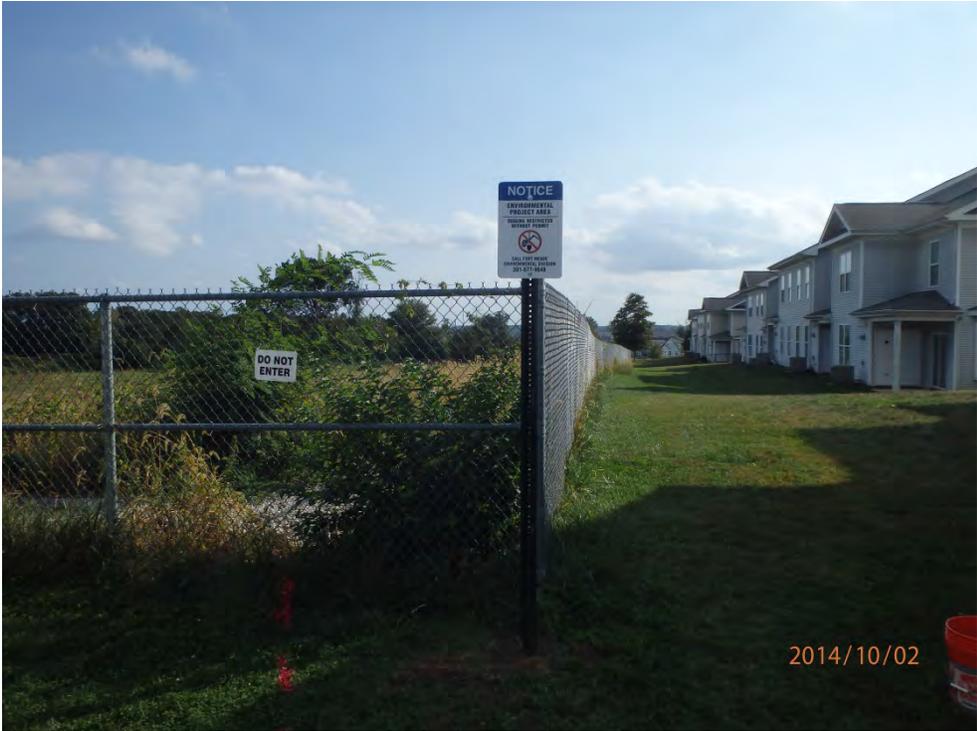
**Photo 5:** Sign Location #3  
**Date:** October 2, 2014  
**Location Taken:** Northwest corner of the Site  
**Direction Facing:** South

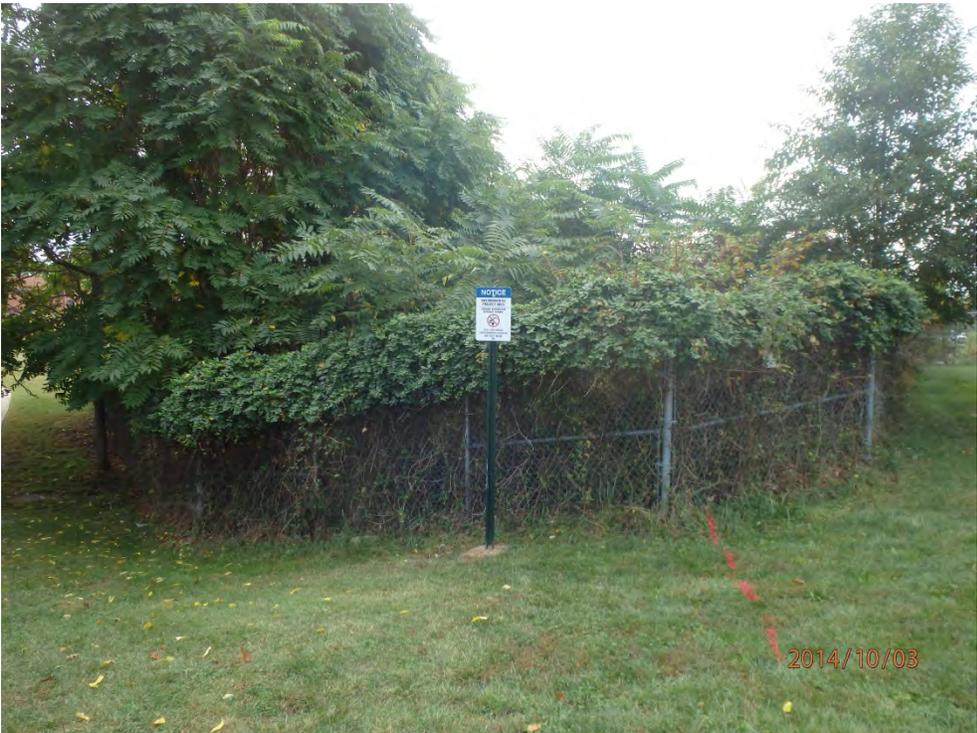
**Photo 6:** Sign Location #4  
**Date:** October 3, 2014  
**Location Taken:** Walking path from Phelps Drive to Manor View Elementary School play yard, north most fenced portion of Site  
**Direction Facing:** South

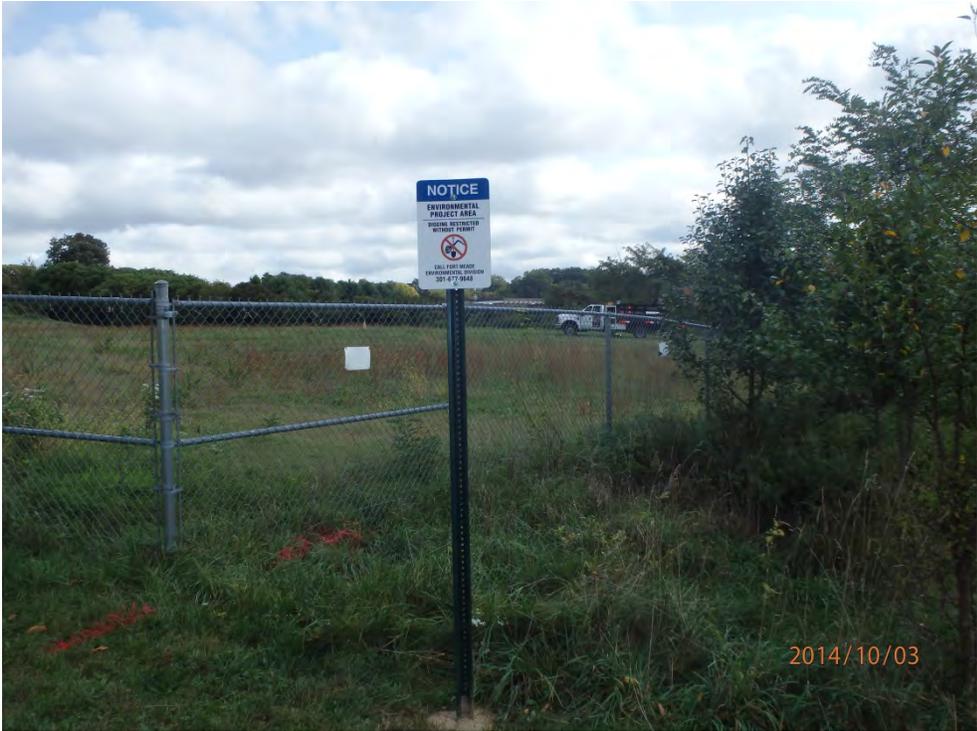
**Photo 7:** Sign Location # 5  
**Date:** October 3, 2014  
**Location Taken:** Southwest corner of the Site.  
**Direction Facing:** Northeast

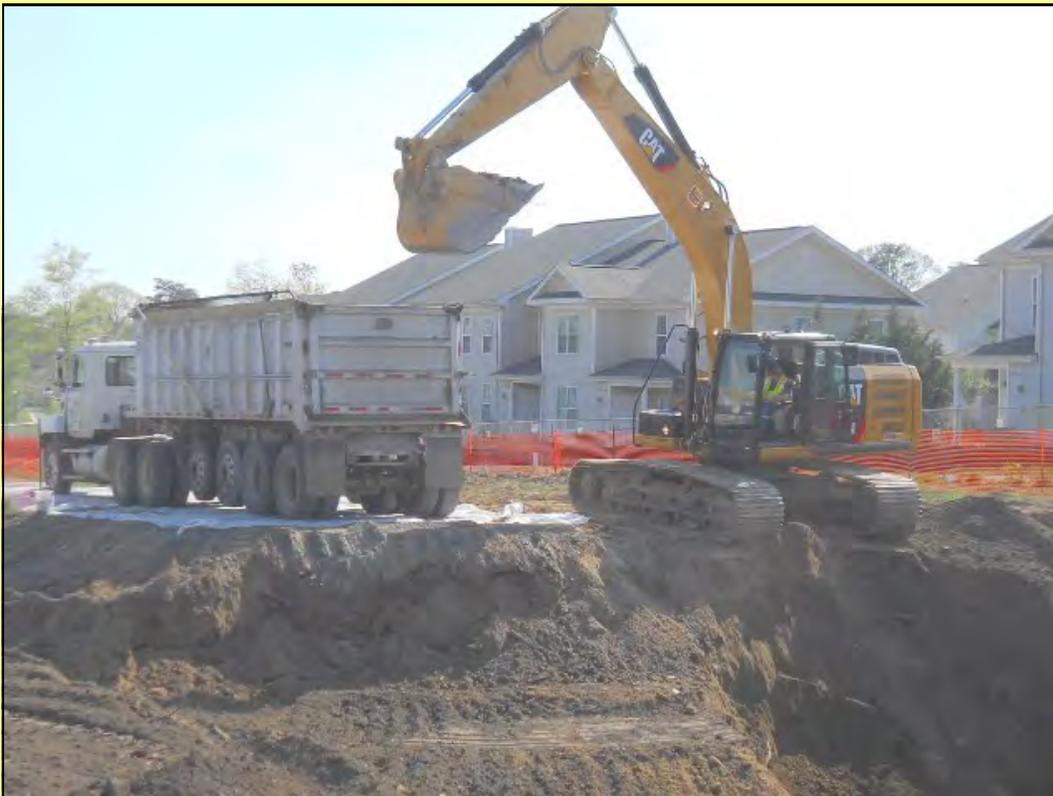
*Photo of the site during the excavation of the approximately 30,000 tons of waste.*

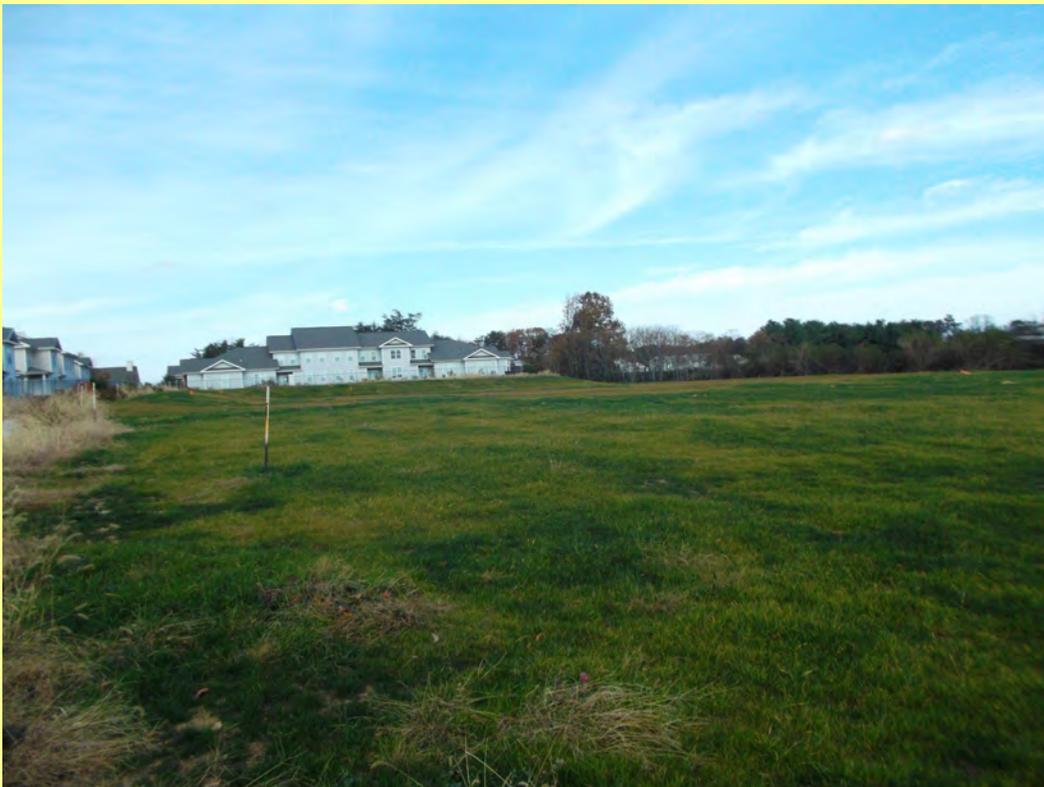
*Photo of the site after the removal action*
