FORT GEORGE G. MEADE

Overview of BRAC Cleanup Program at the Transferred Properties

September 11, 2008

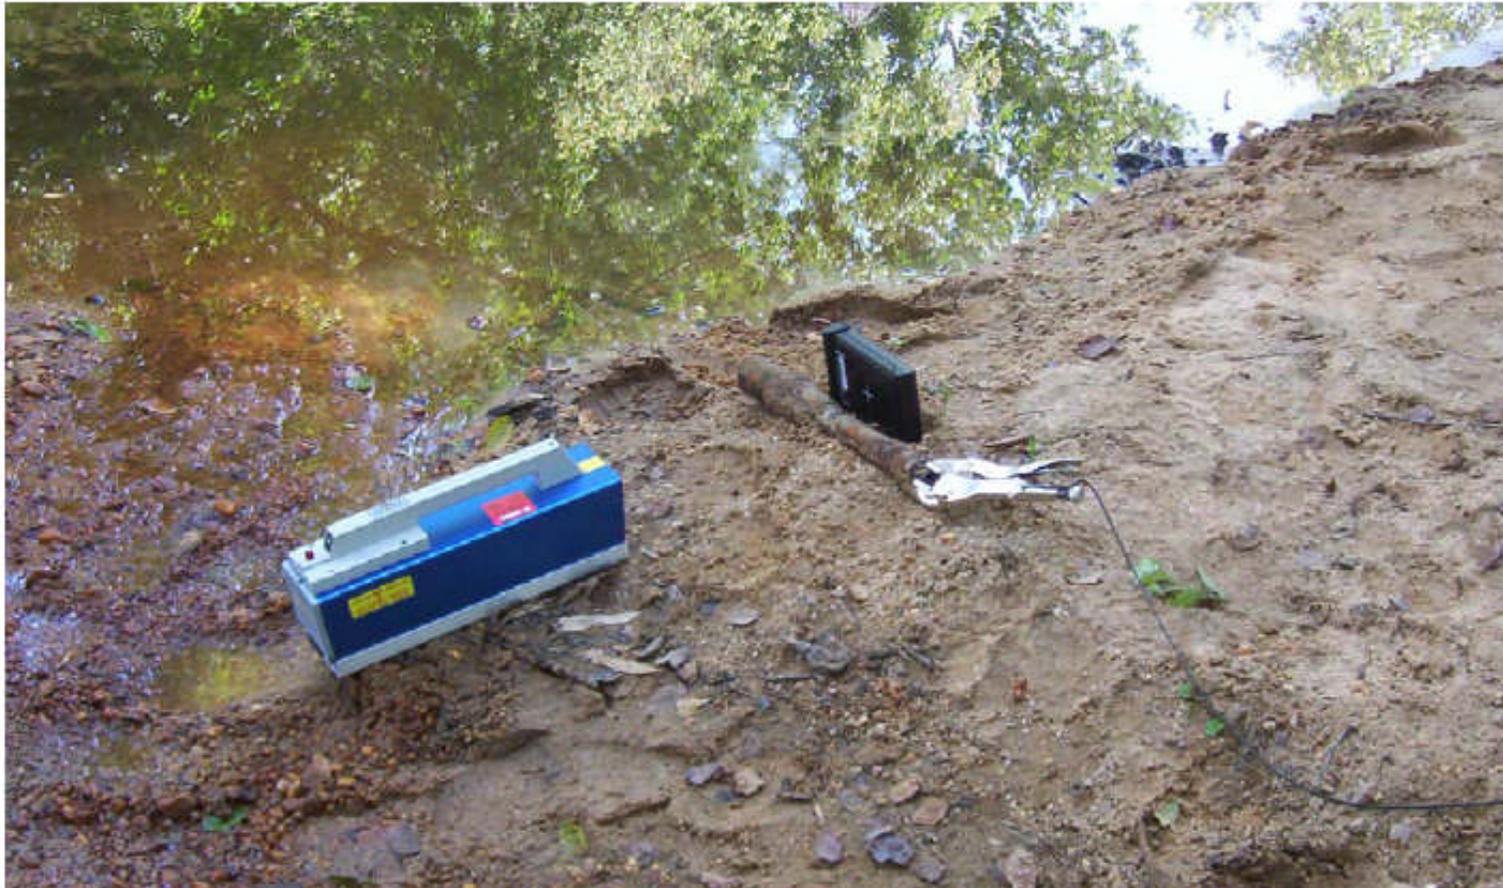
River Sweep X-ray Operation

Picture 2-3: X-Ray of 2.36-inch Rocket - LTM 2007

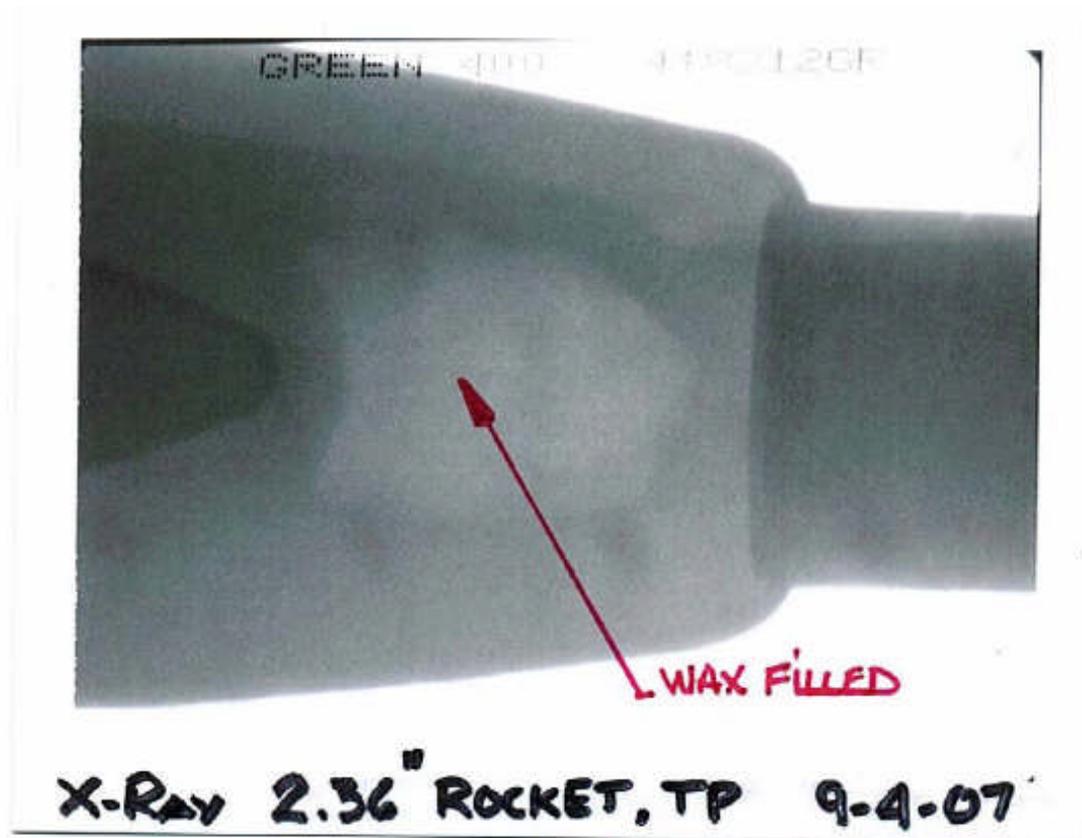
River Sweep X-Ray Image

Picture 2-4: X-Rayed Image of 2.36-inch Rocket TP – Wax Filled

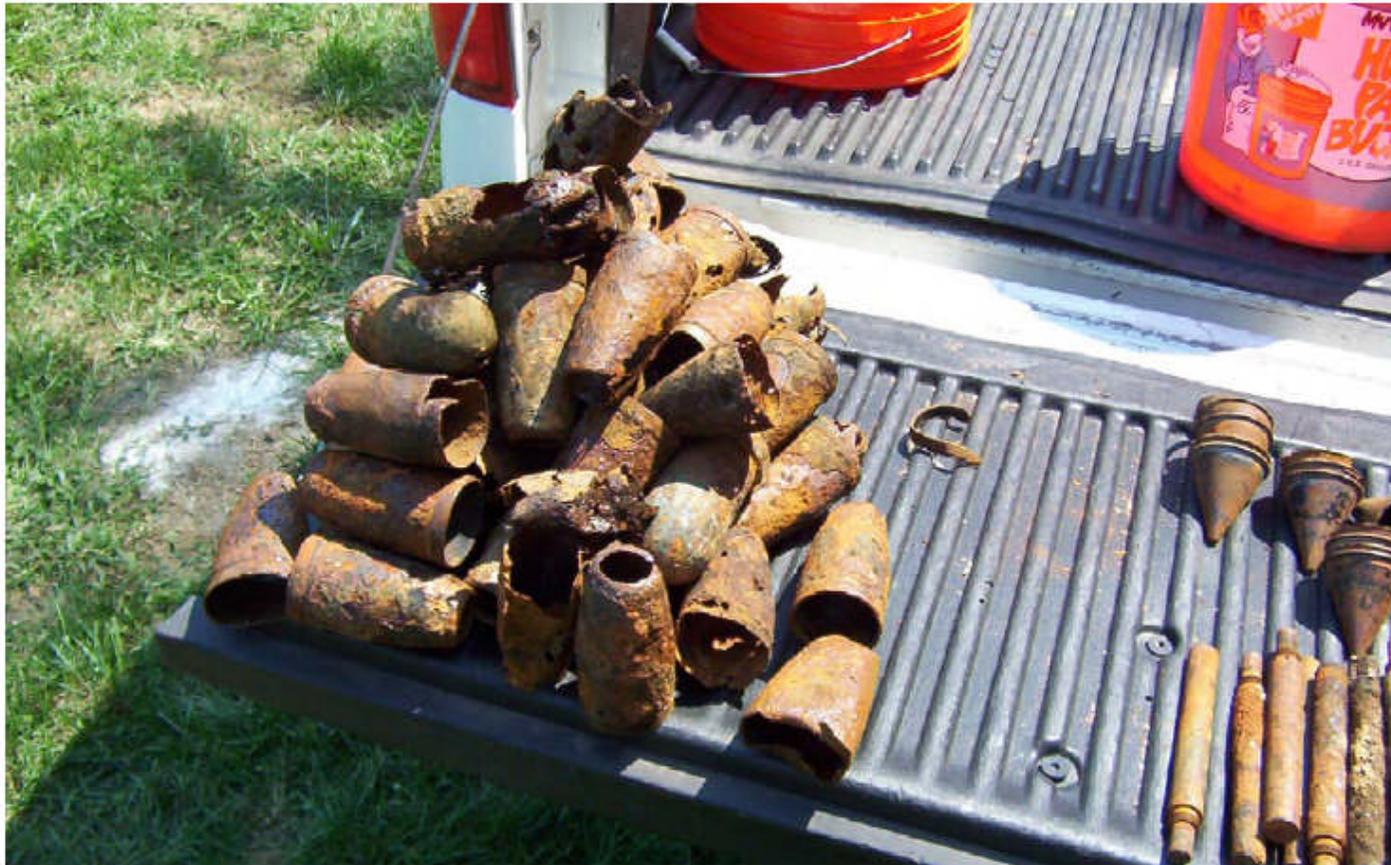
River Sweep Typical Inert Debris

Picture 2-7: Warhead Body and Cones of 2.36-inch Rocket TP (Munitions Debris)

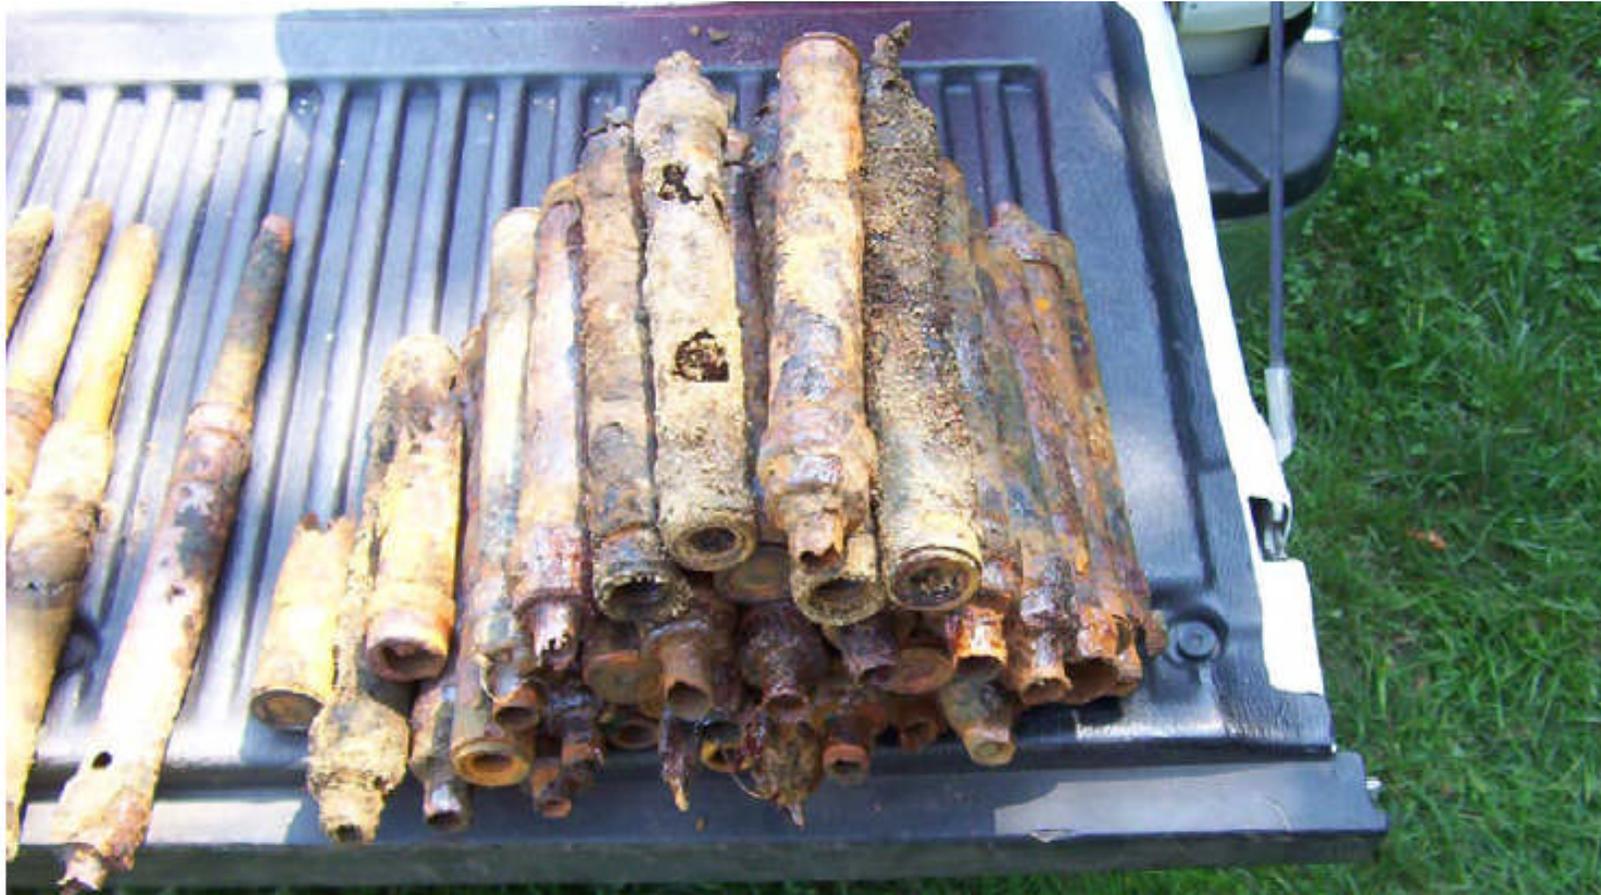
River Sweep Typical Inert Debris

Picture 2-9: Rocket Motors (Munitions Debris)
