**Re: April 2011 Final Tipton Airfield Parcel Five-Year Review;  
Fort George G. Meade, Maryland**

**SECOND FIVE-YEAR REVIEW REPORT  
FOR  
FORT GEORGE G. MEADE  
LEGACY BASE REALIGNMENT AND CLOSURE  
PROGRAM**

**Tipton Airfield Parcel**

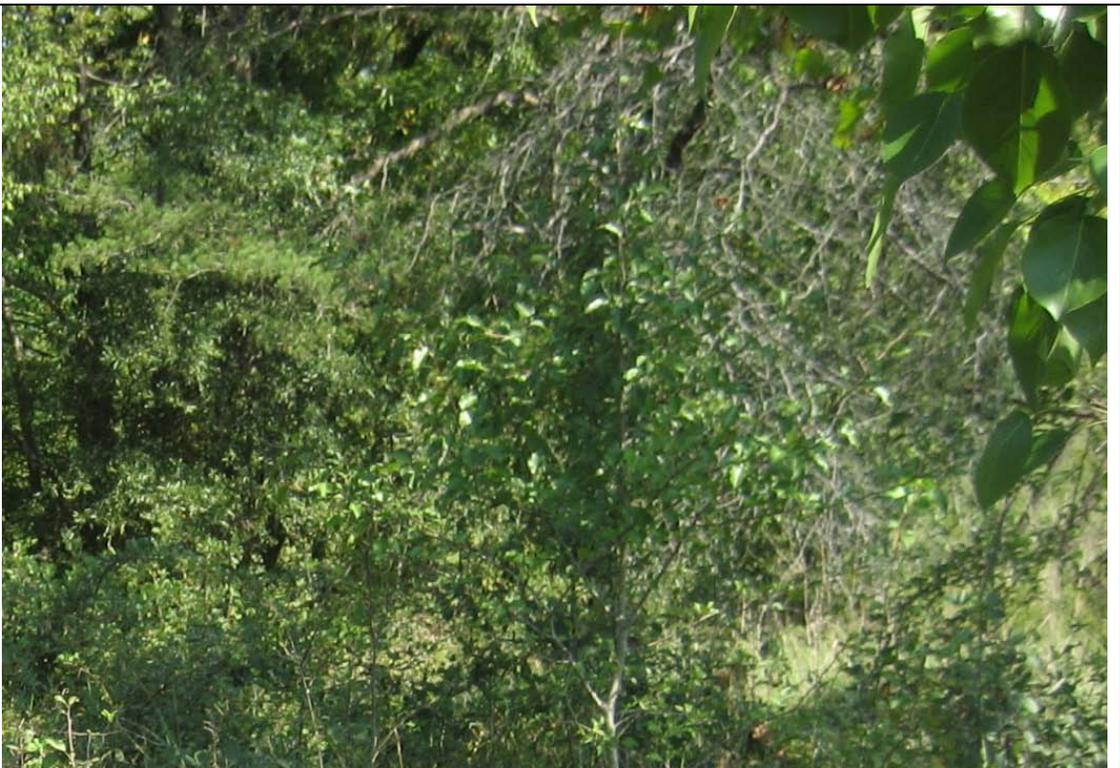
<b>Photo No.</b> P2	<b>Date:</b>
------------------------	--------------

**Description:**  
View to the North from the entrance to IAL 1 on Bald Eagle Drive

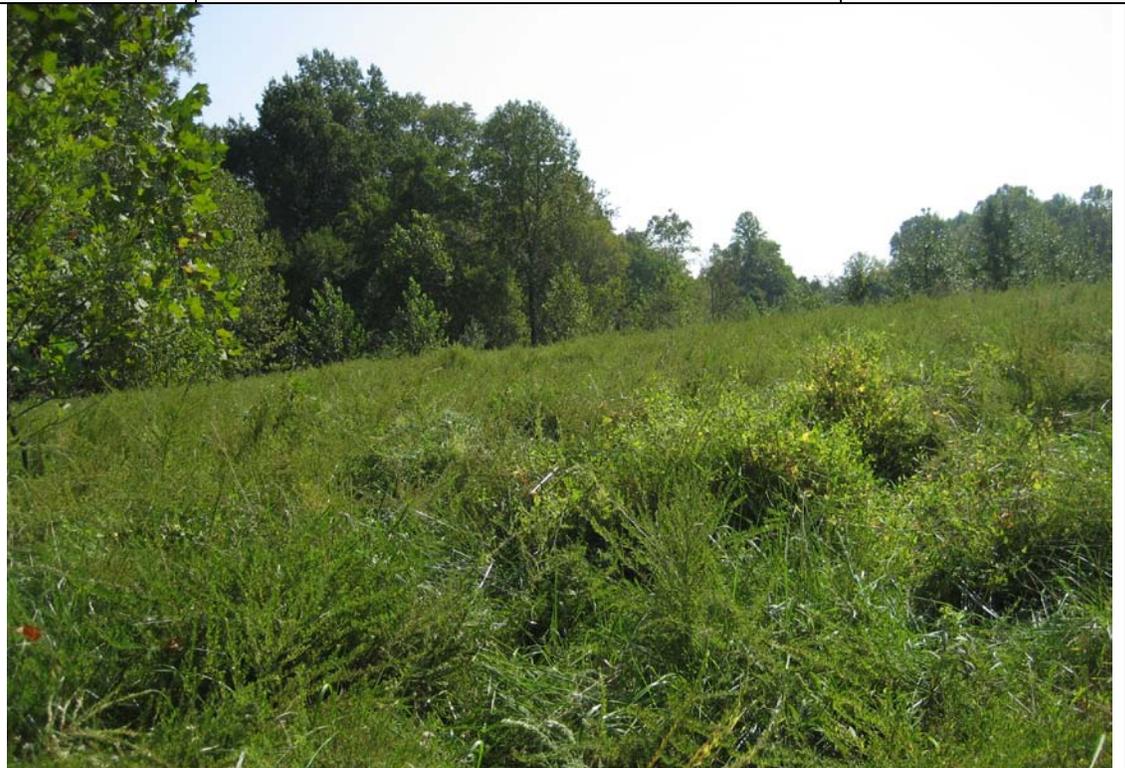
**Description:**  
View to the east/southeast from the northwest corner of IAL 1. Safety cover along northwest tree line is intact.

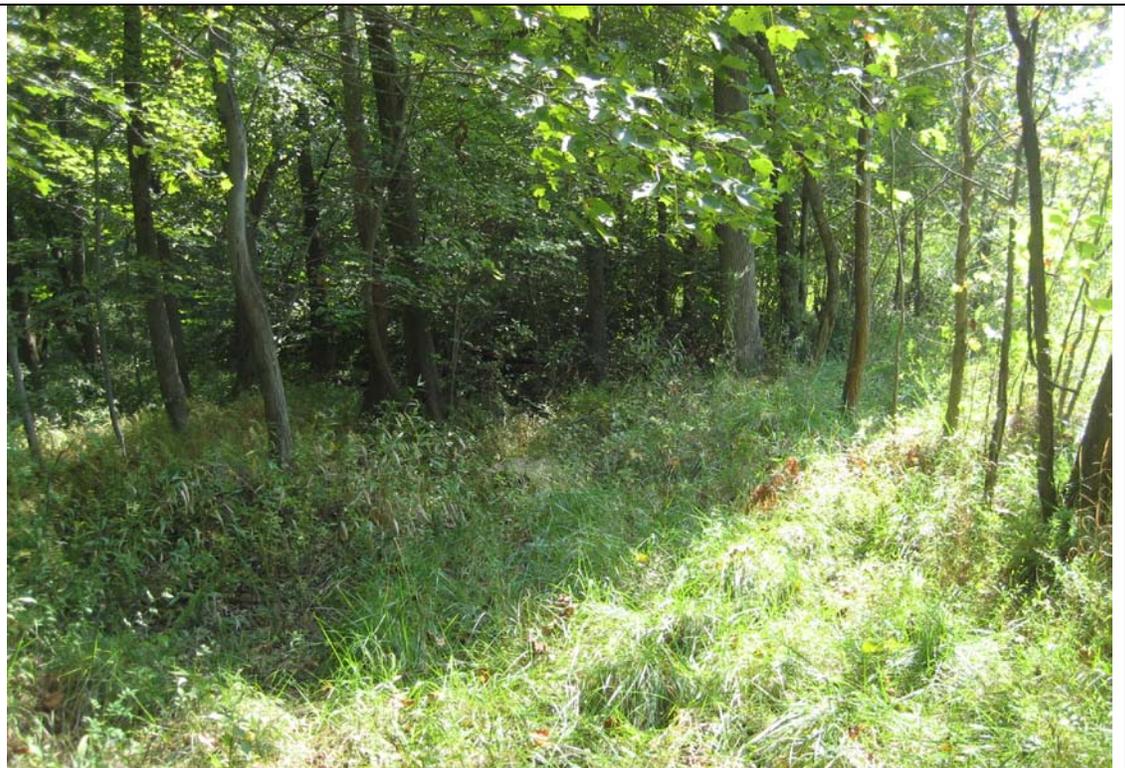
<b>Photo No.</b> P4	<b>Date:</b>
<b>Direction Photo Taken:</b> East/Southeast

**Description:**  
Edge of safety cover / tree line along northwest corner of IAL 1. Some concrete debris visible in center of photograph.

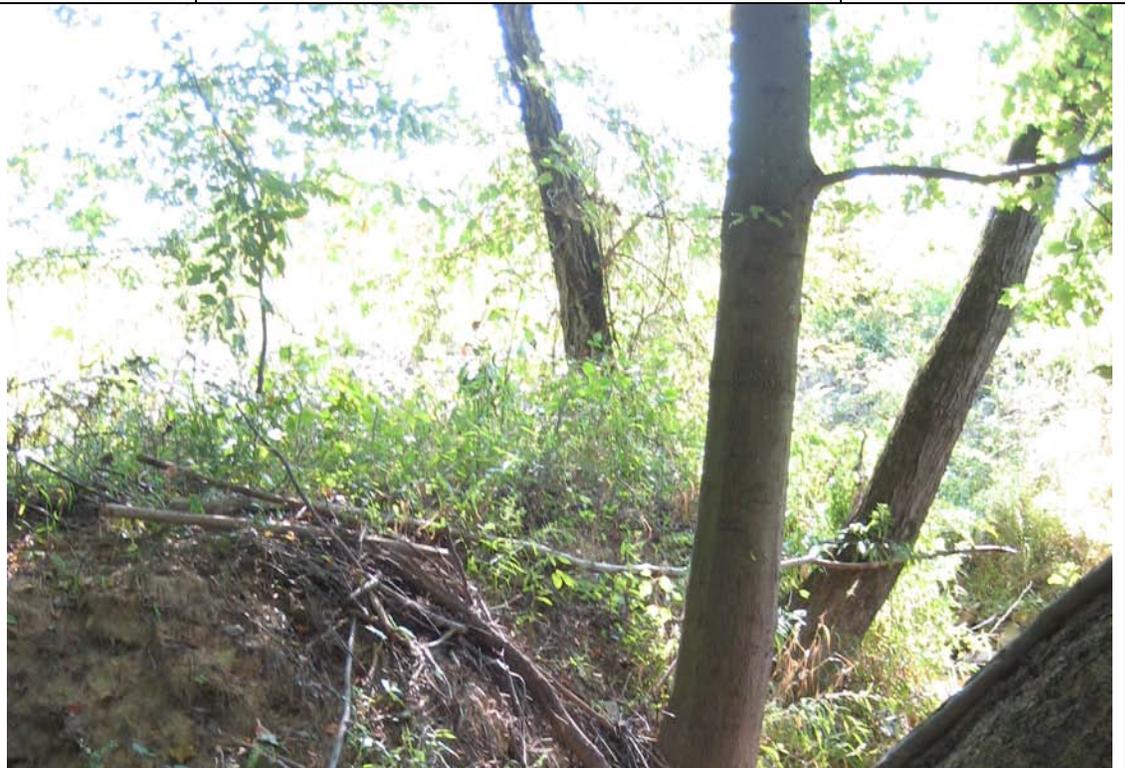
**Description:**  
Edge of safety cover looking south along the northern perimeter of IAL 1. Cover appears to be resisting erosion and remains intact.

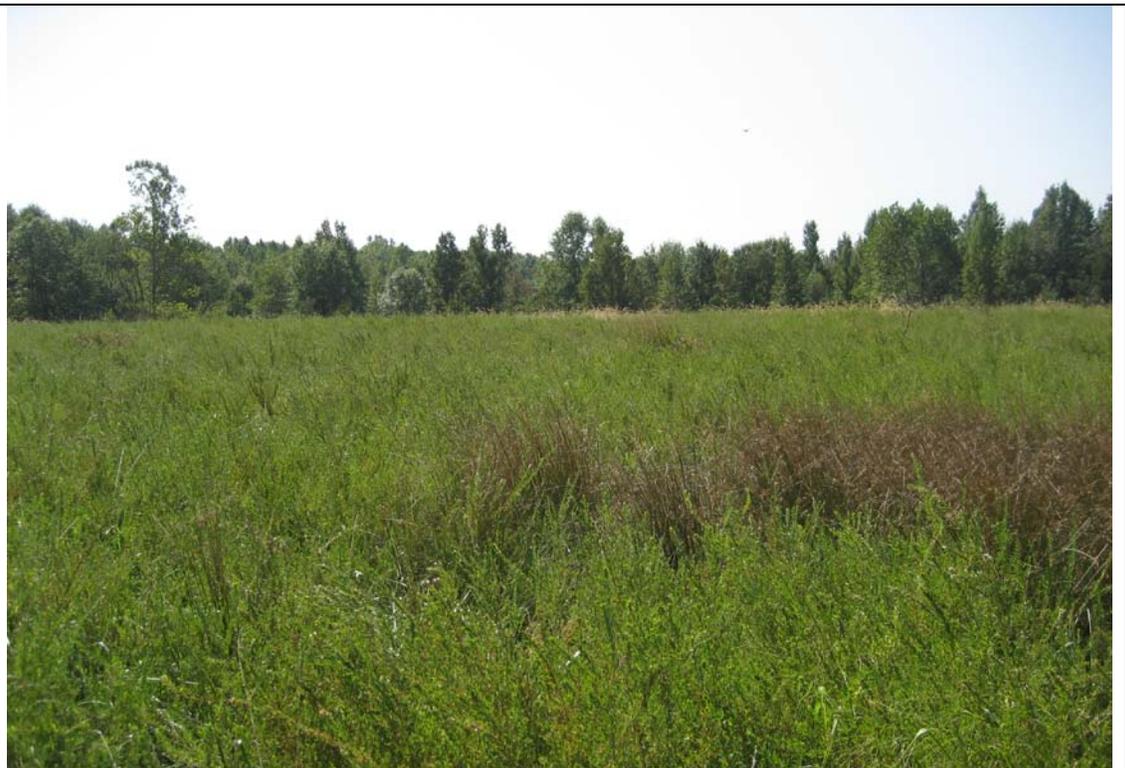
<b>Photo No.</b> P6	<b>Date:</b>
<b>Direction Photo Taken:</b> South

**Description:**  
View south from northern perimeter of IAL 1. Safety cover is intact. Lespedeza is the dominant vegetation.

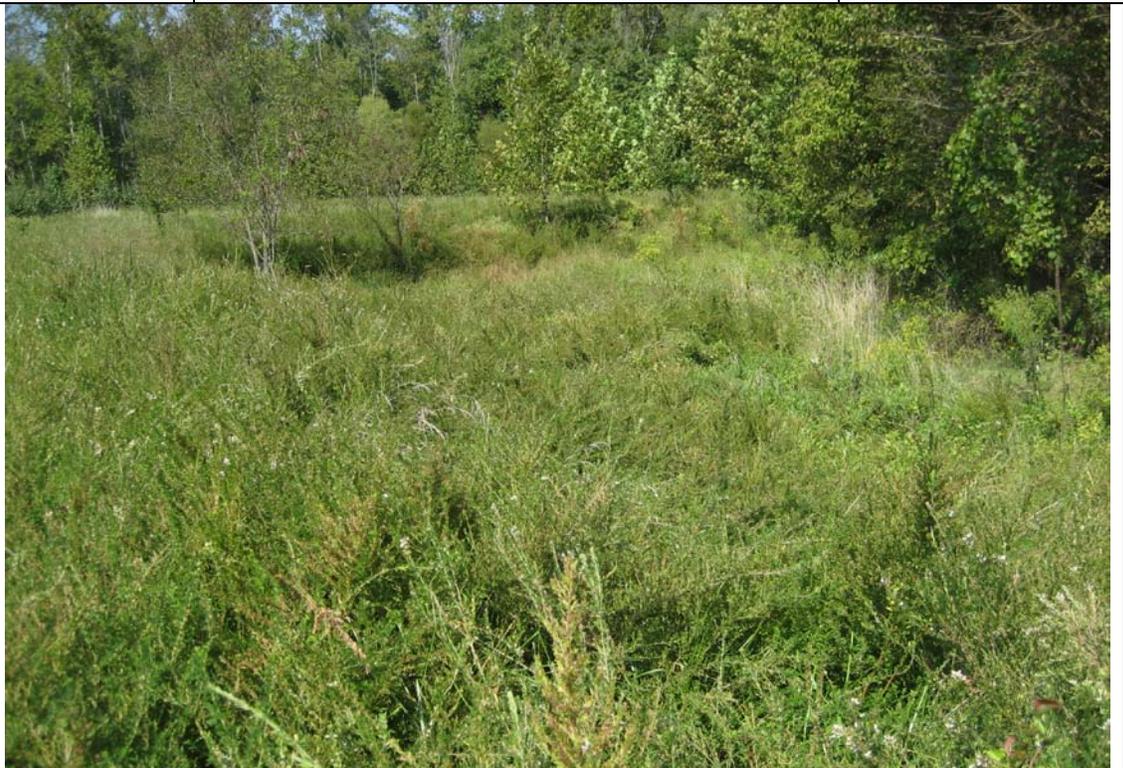
**Description:**  
View to the northwest along northern perimeter of IAL 1. Safety cover is intact. Small trees are succeeding lespedeza in some areas.

- 1 Use fill to repair the ruts and implement a grubbing program in fiscal year 2012 to remove vegetation that might disturb the soil safety cover at the IAL1; perform inspection in fall/winter when vegetation is less dense to verify that the integrity of the soil cover remains intact.

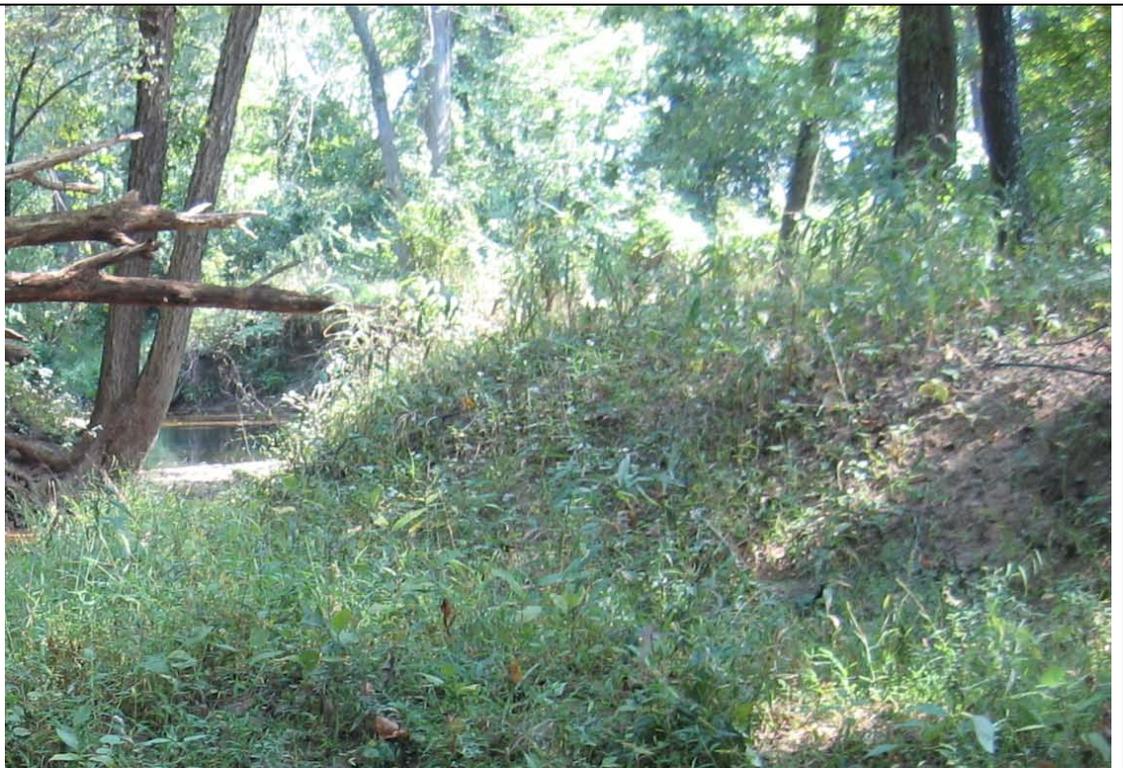
<b>Photo No.</b> P8	<b>Date:</b>
<b>Direction Photo Taken:</b> East/Southeast

**Description:**  
Edge of safety cover appears intact and resisting erosion. Little Patuxent River seen middle left.

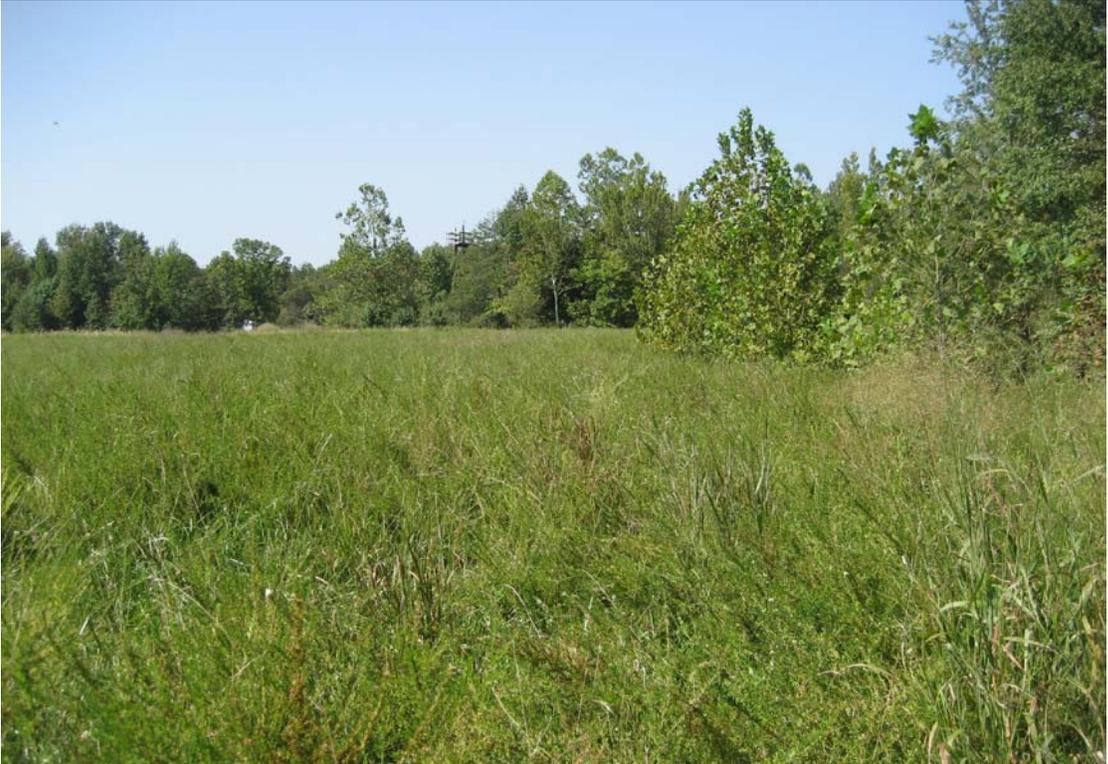
<b>Client Name:</b> USACE-Baltimore District		<b>Site Location:</b> FGGM Inactive Landfill No. 1	<b>Project No.</b> 15302389.40000
<b>Photo No.</b> P9	<b>Date:</b> 9-2010

<b>Direction Photo Taken:</b> West			
<b>Description:</b> View along northern tree line of IAL 1, towards Bald Eagle Drive. Soil Safety cover appears intact.  Photo by: URS

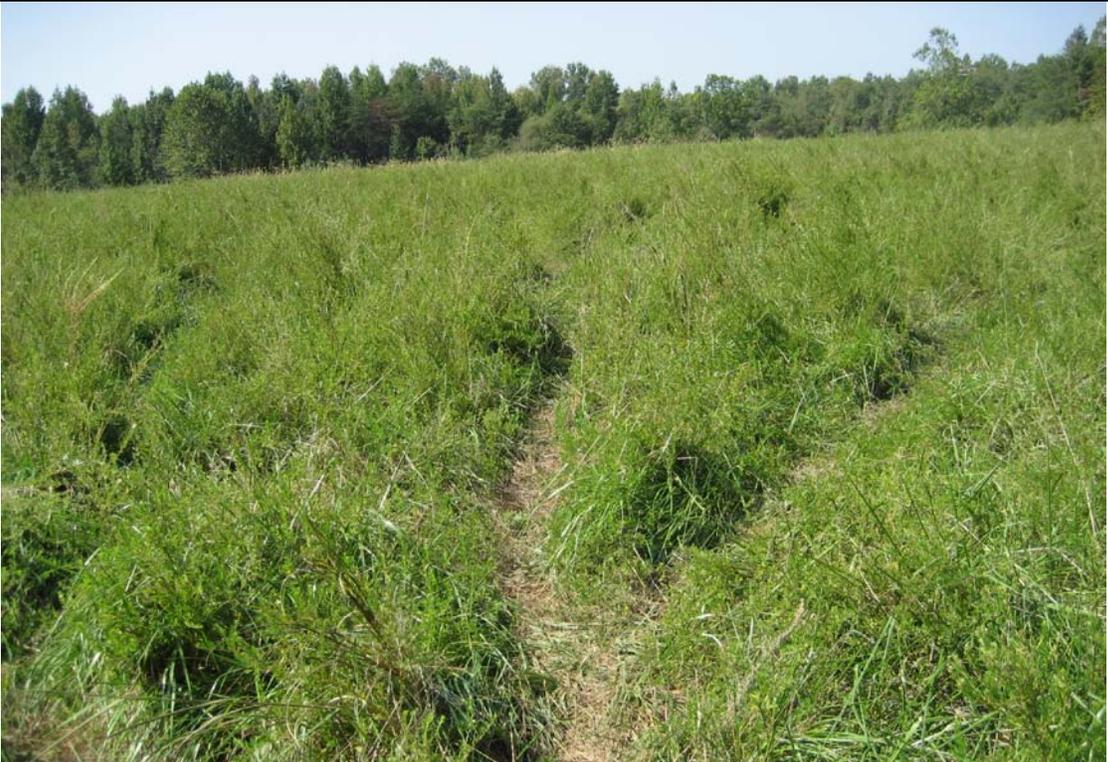
<b>Photo No.</b> P10	<b>Date:</b>

<b>Direction Photo Taken:</b> West			
<b>Description:</b> View west from the eastern edge of the safety cover. Game trails from the Little Patuxent River lead towards the center of IAL 1.  Photo by: URS

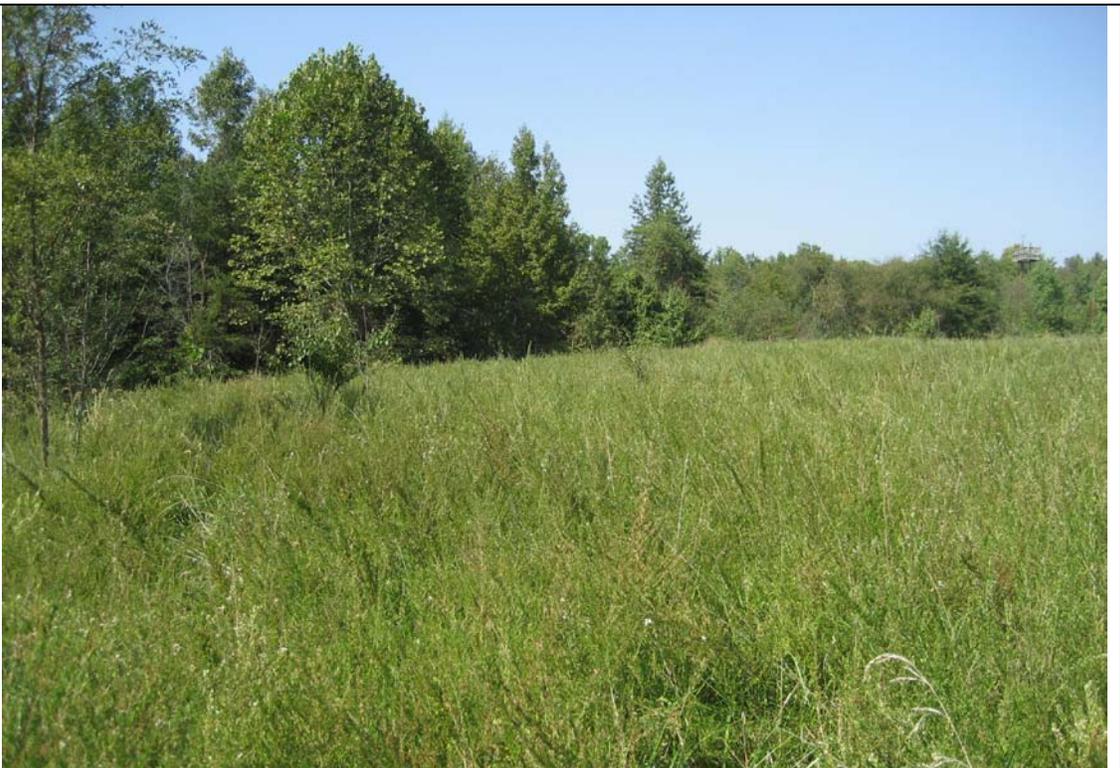
<b>Photo No.</b> P12	<b>Date:</b>
-------------------------	--------------

**Description:**  
View west of southern tree line. Safety cover appears intact. Some small trees and woody growth succeeding lespedeza in some areas.

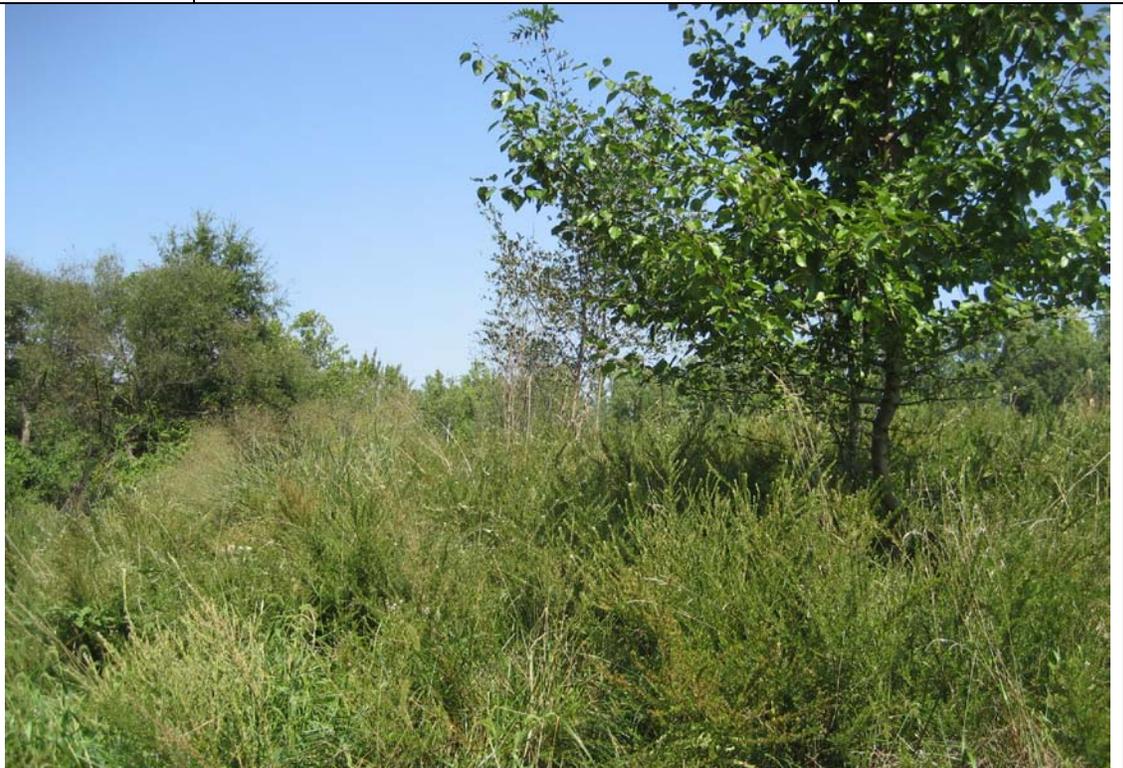
**Description:**  
View north/northwest towards entrance on Bald Eagle Drive. Small trees <4 inches have taken root. Vegetation is mix of lespedeza and grasses. Safety cover appears intact.

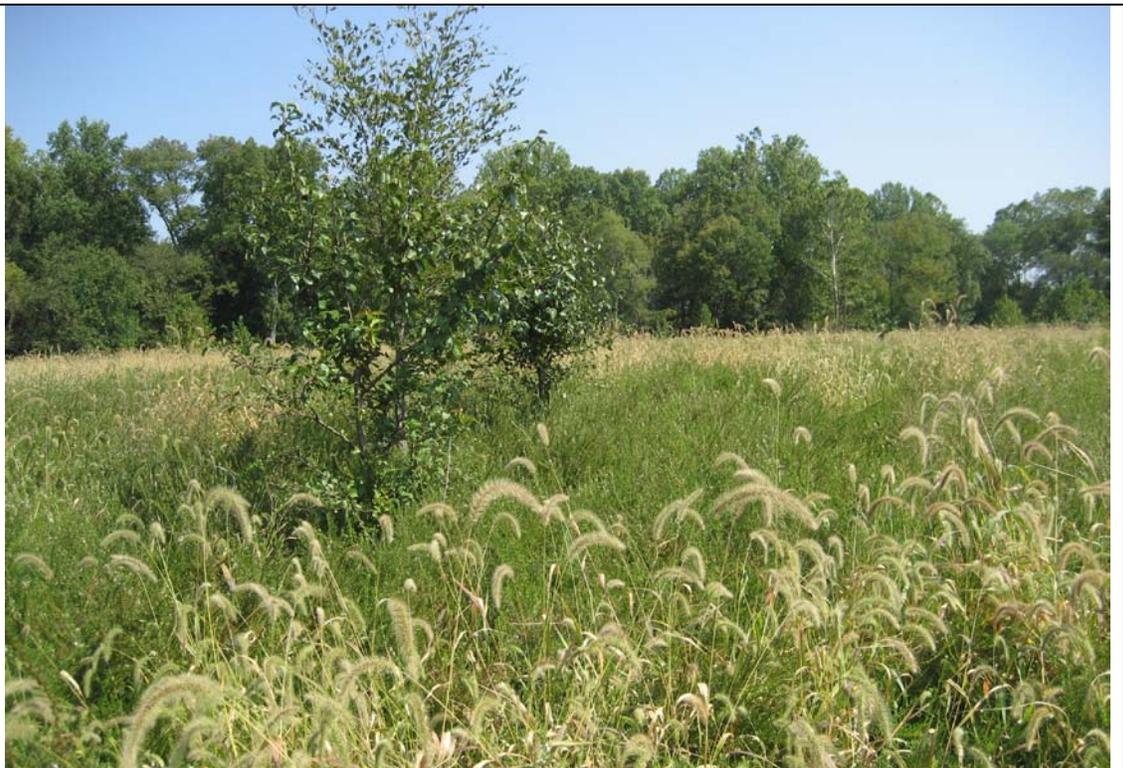
<b>Photo No.</b> P14	<b>Date:</b>
<b>Direction Photo Taken:</b> East/Northeast

**Description:**  
View towards Little Patuxent River from Southwest perimeter of IAL 1. Safety cover appears intact. Small trees present. Lespedeza and grasses are the dominant vegetation.

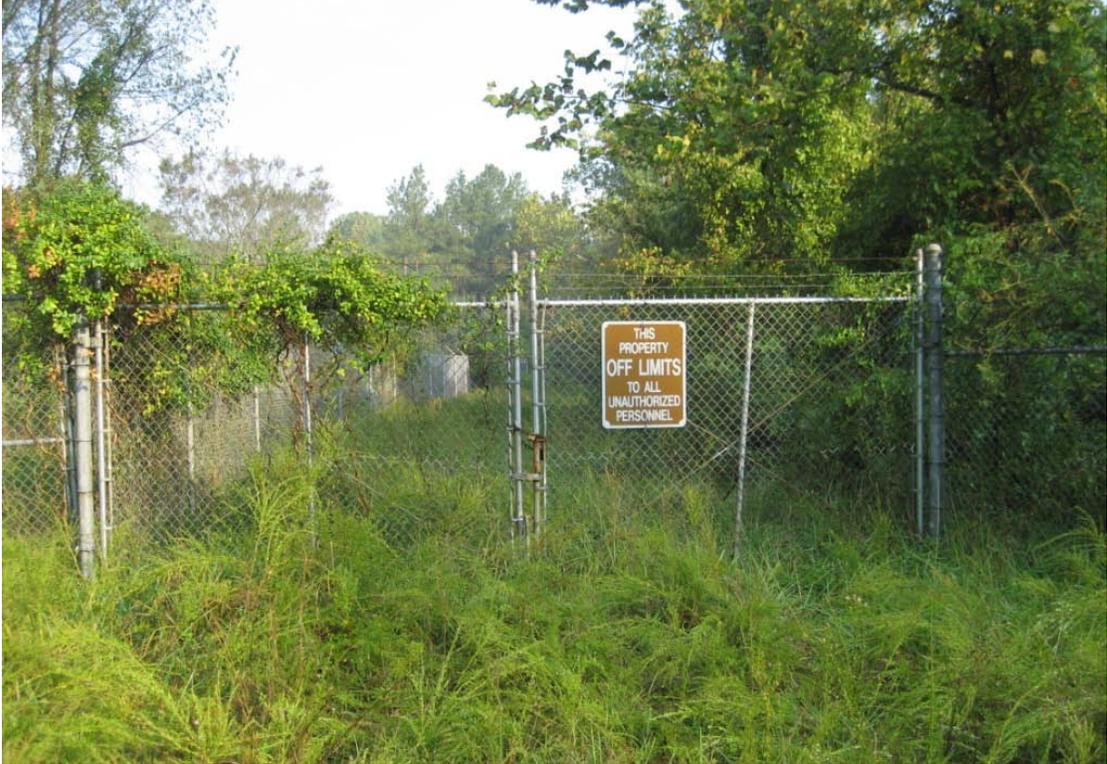
<b>Client Name:</b> USACE-Baltimore District		<b>Site Location:</b> FGGM Inactive Landfill No. 2	<b>Project No.</b> 15302389.40000
<b>Photo No.</b> P1	<b>Date:</b> 9-2010

<b>Direction Photo Taken:</b> Northwest			
<b>Description:</b> Main gate: locks, chain, signage in tact. Light overgrowth.  Photo by: URS

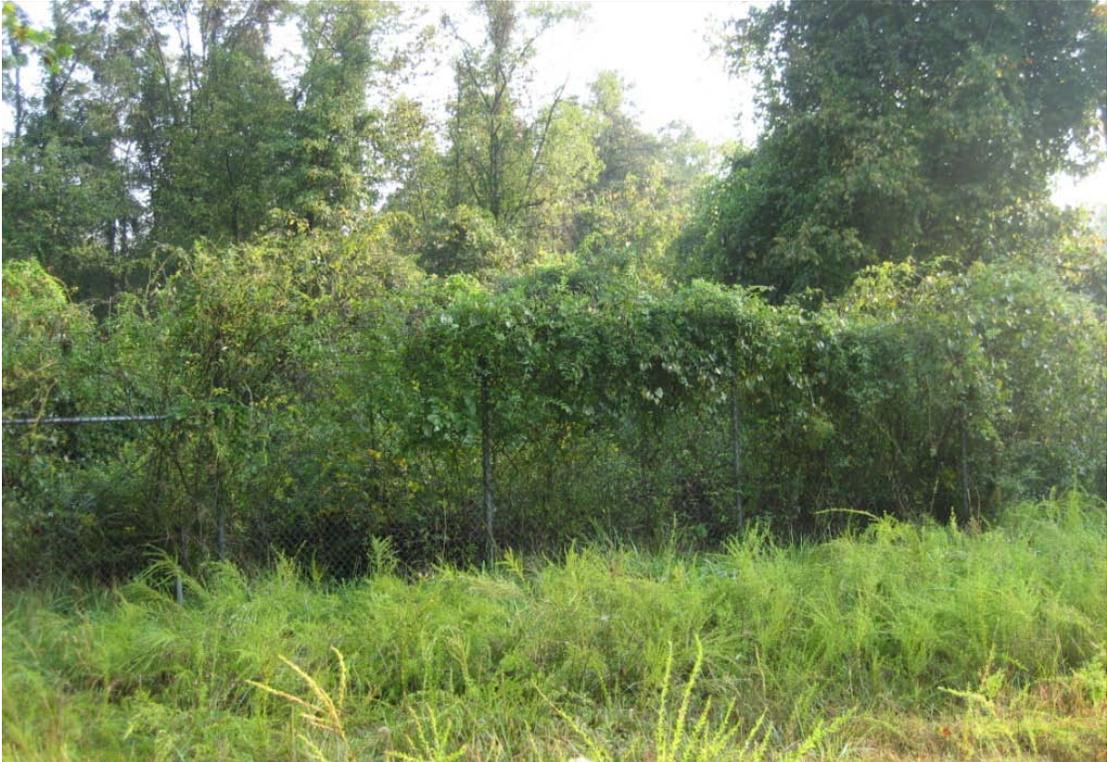
<b>Photo No.</b> P2	<b>Date:</b>

<b>Direction Photo Taken:</b> Northeast			
<b>Description:</b> Fence line adjacent to main gate. Moderate overgrowth.  Photo by: URS

- 2 Implement a contract in fiscal year 2011 to clear the IAL2 fence line. Once it is cleared, conduct the necessary fence line repair work.
- 3 Re-grade the swales and level the surface of IAL3's cover to remove settlement ridges.

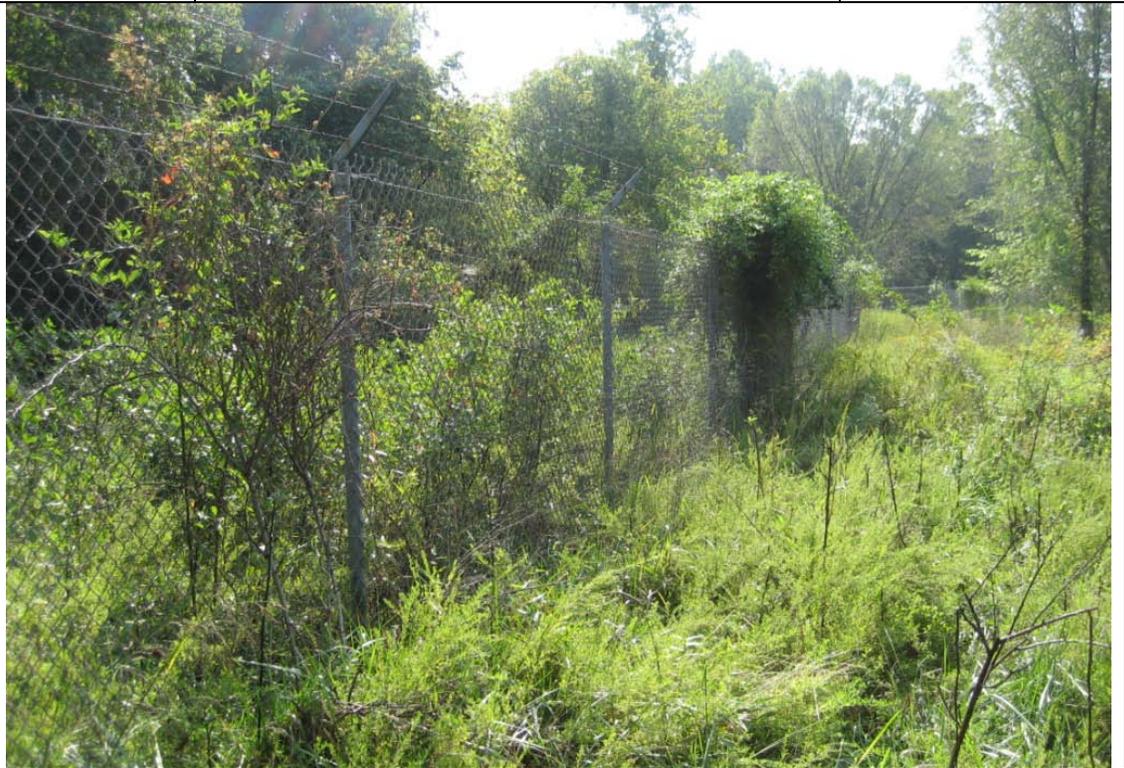
**Description:**  
Southwestern fence line.  
Light overgrowth.

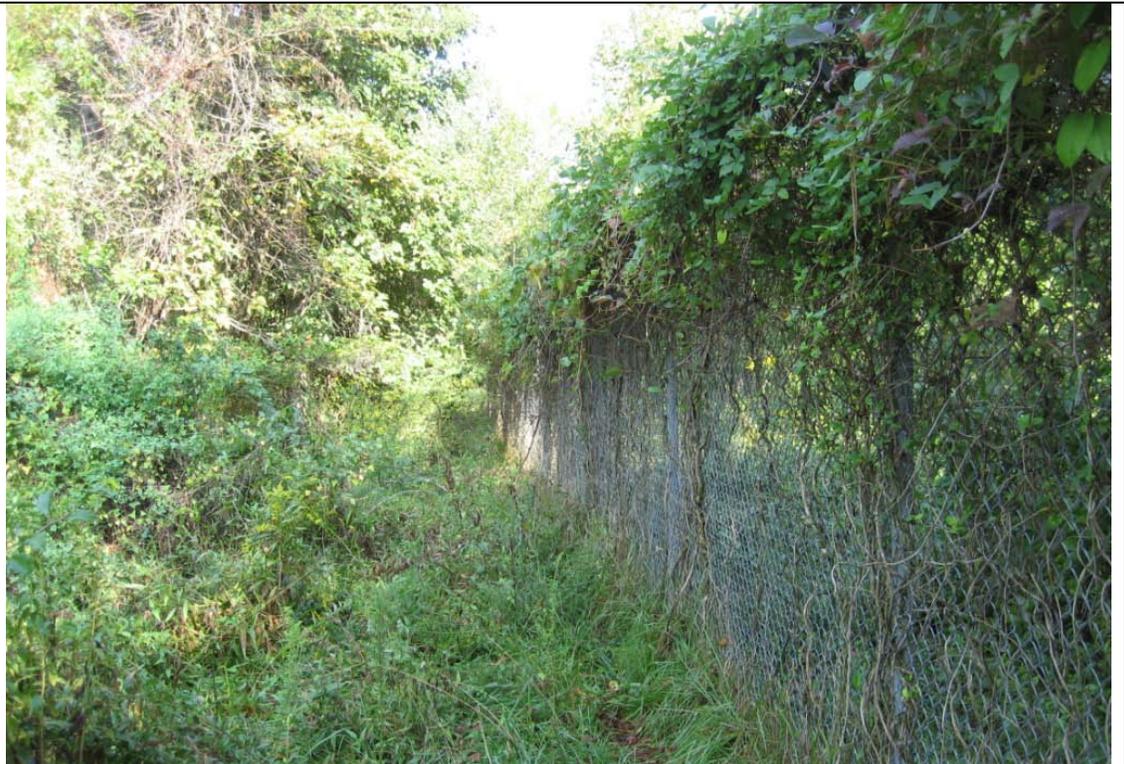
**Photo No.**  
P4

**Description:**  
Southwestern fence line. Moderate overgrowth.

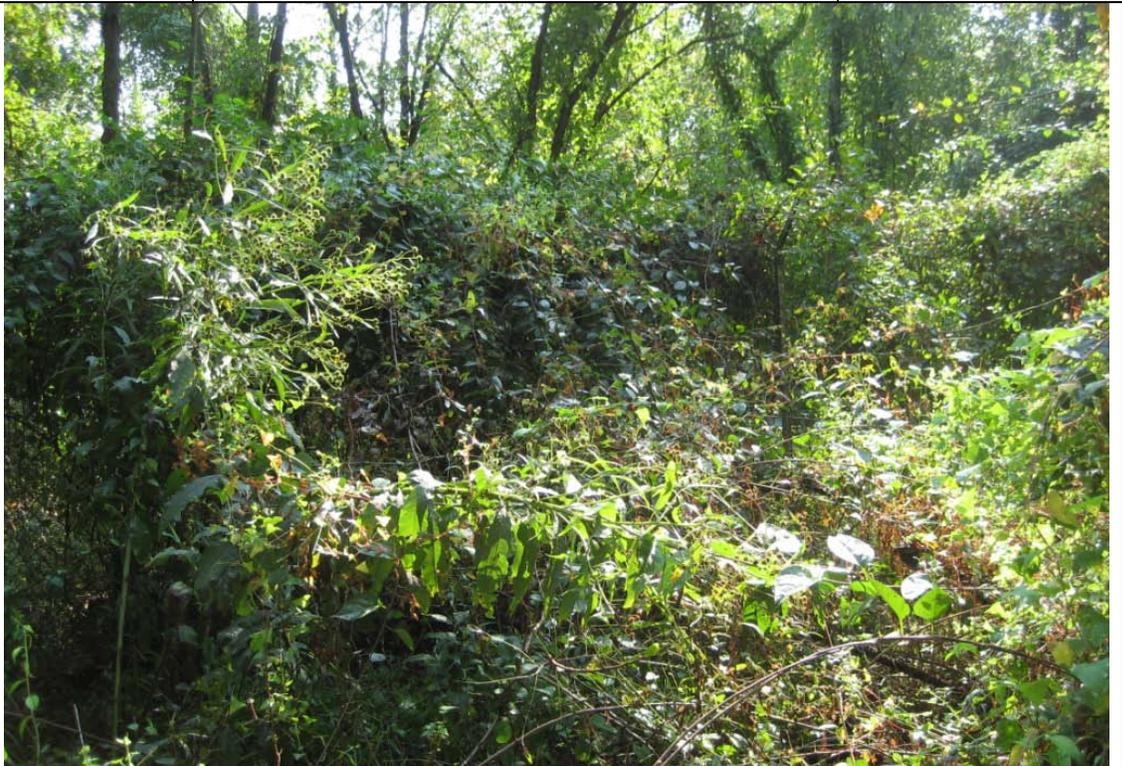
**Description:**  
Western fence line.  
Severe overgrowth.

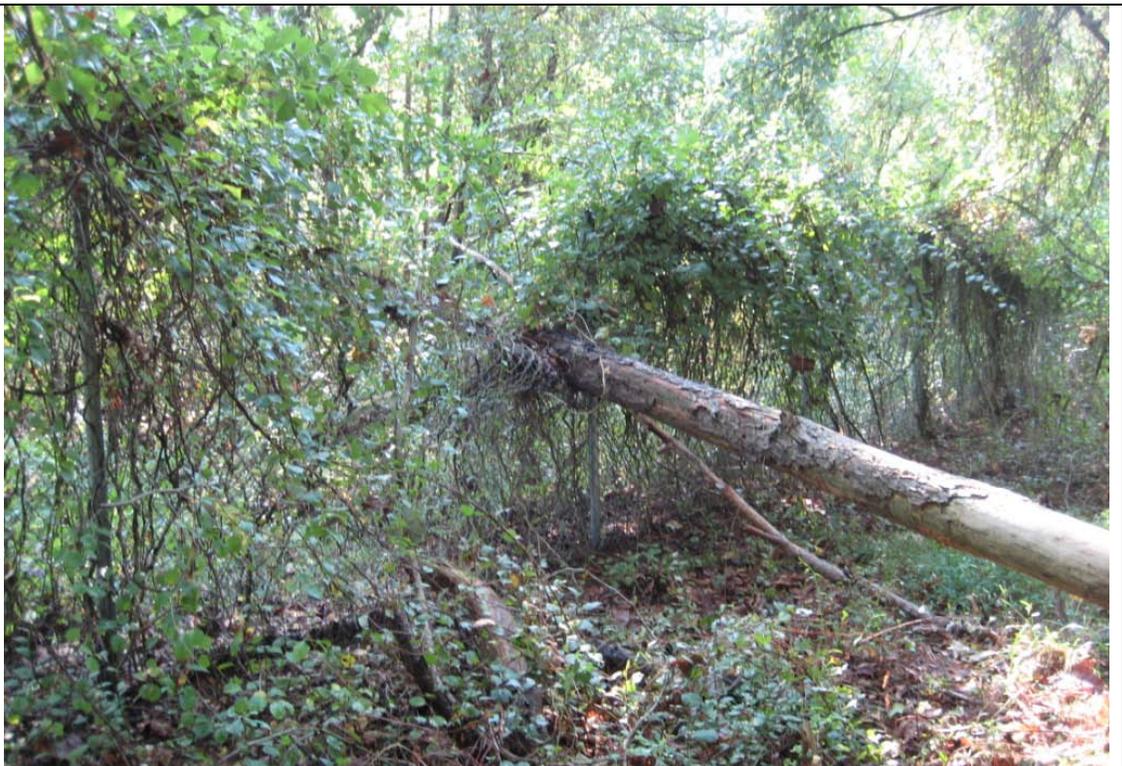
<b>Photo No.</b> P6	<b>Date:</b> 9-2010
------------------------	------------------------

**Description:**  
Western fence line.  
Downed tree on fence.  
Moderate damage.  
Moderate overgrowth.

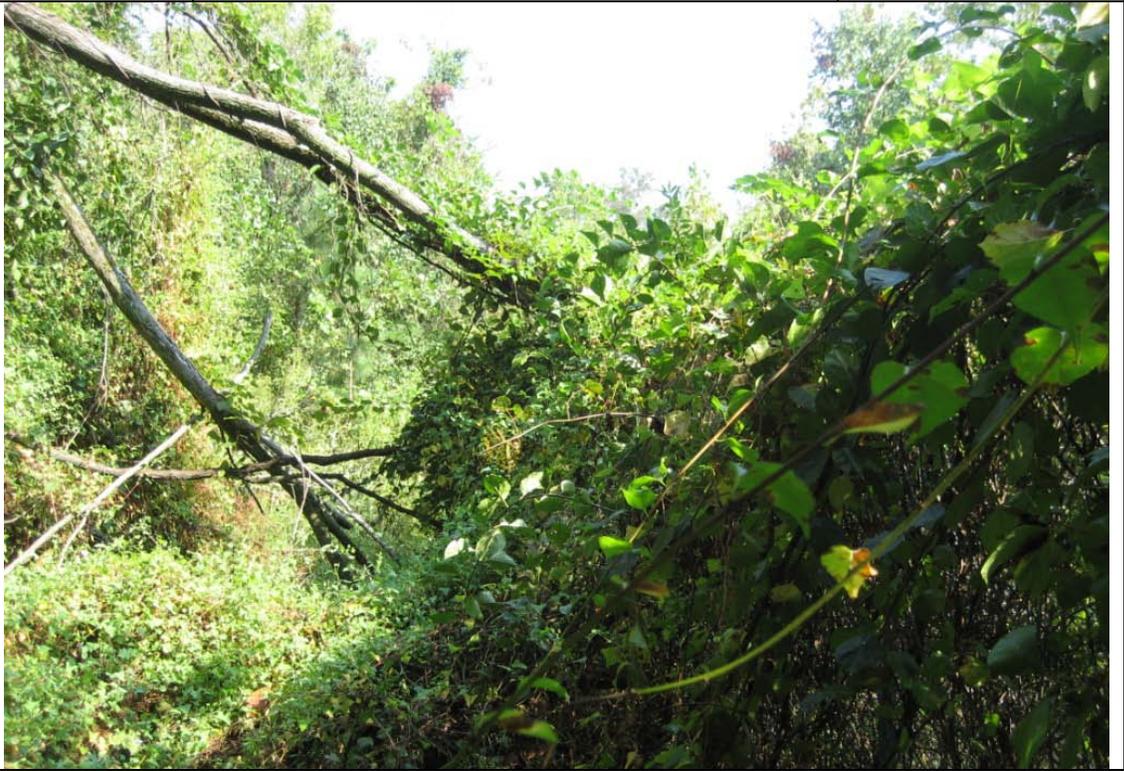
<b>Photo No.</b> P7	<b>Date:</b> 9-2010
------------------------	------------------------

**Description:**  
Western fence line.  
Downed branches on fence line.  
Moderate damage.  
Severe overgrowth.

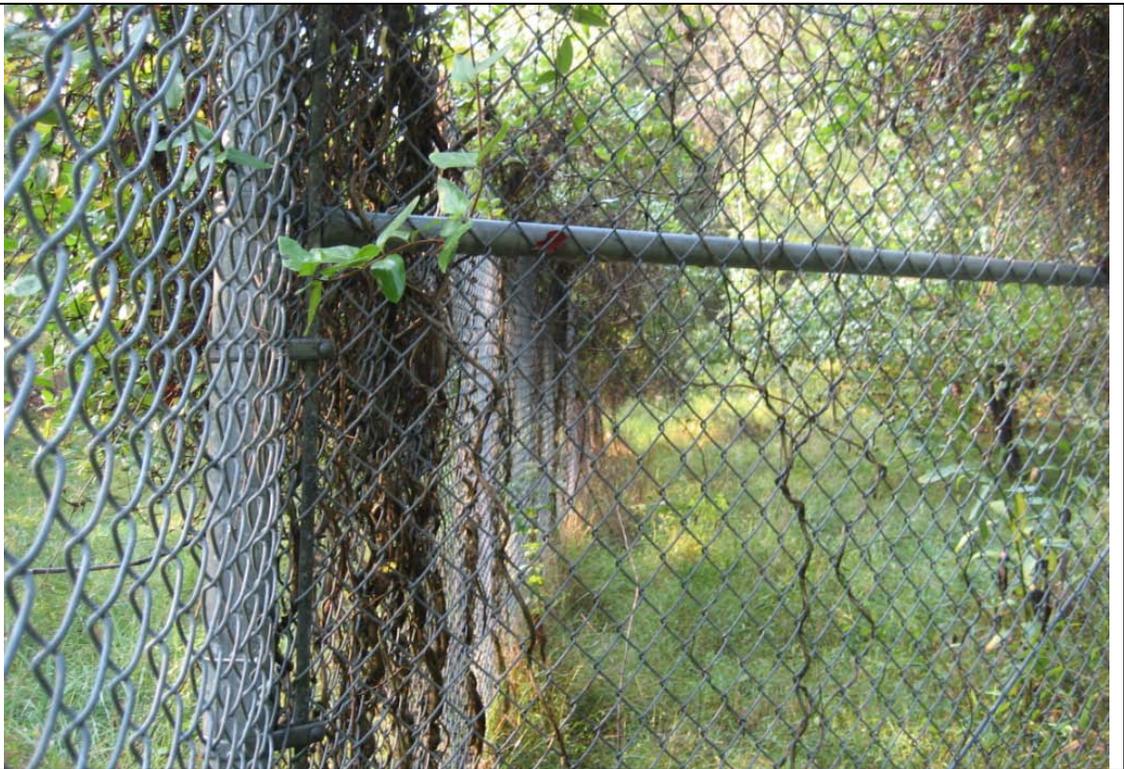
<b>Photo No.</b> P8	<b>Date:</b> 9-2010
------------------------	------------------------

**Description:**  
Western fence line.  
Light to moderate overgrowth.

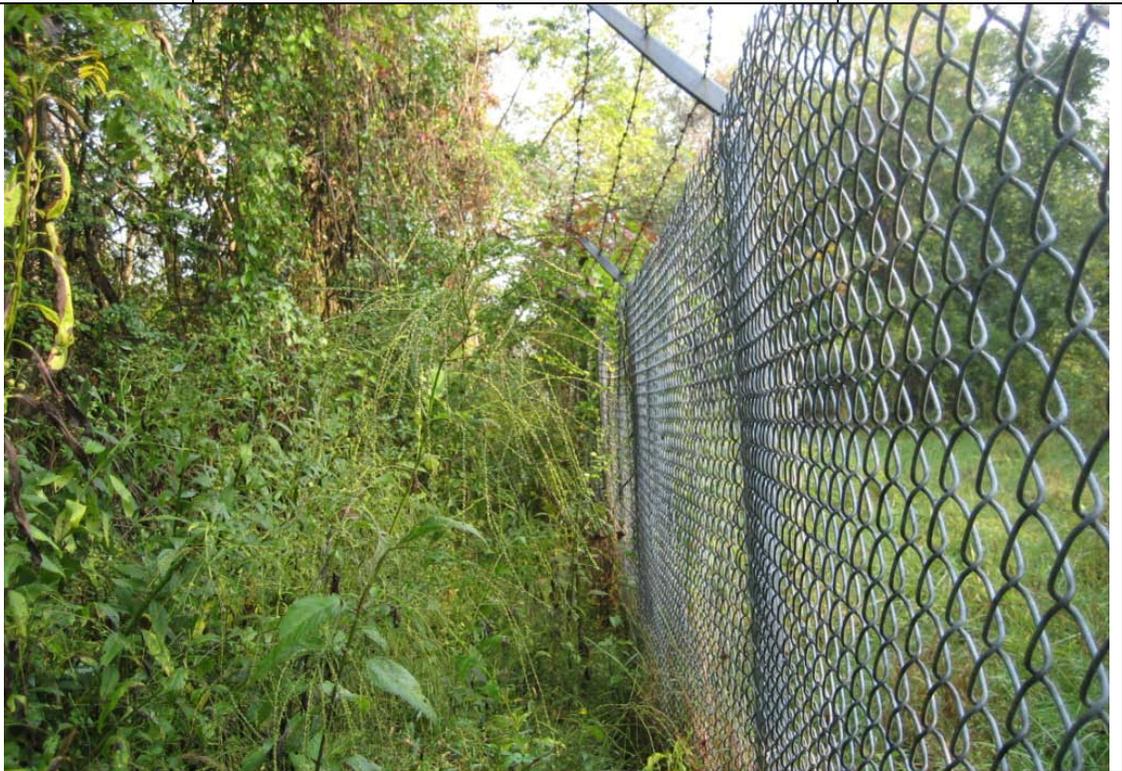
**Description:**  
Western fence line.  
Light to moderate overgrowth.

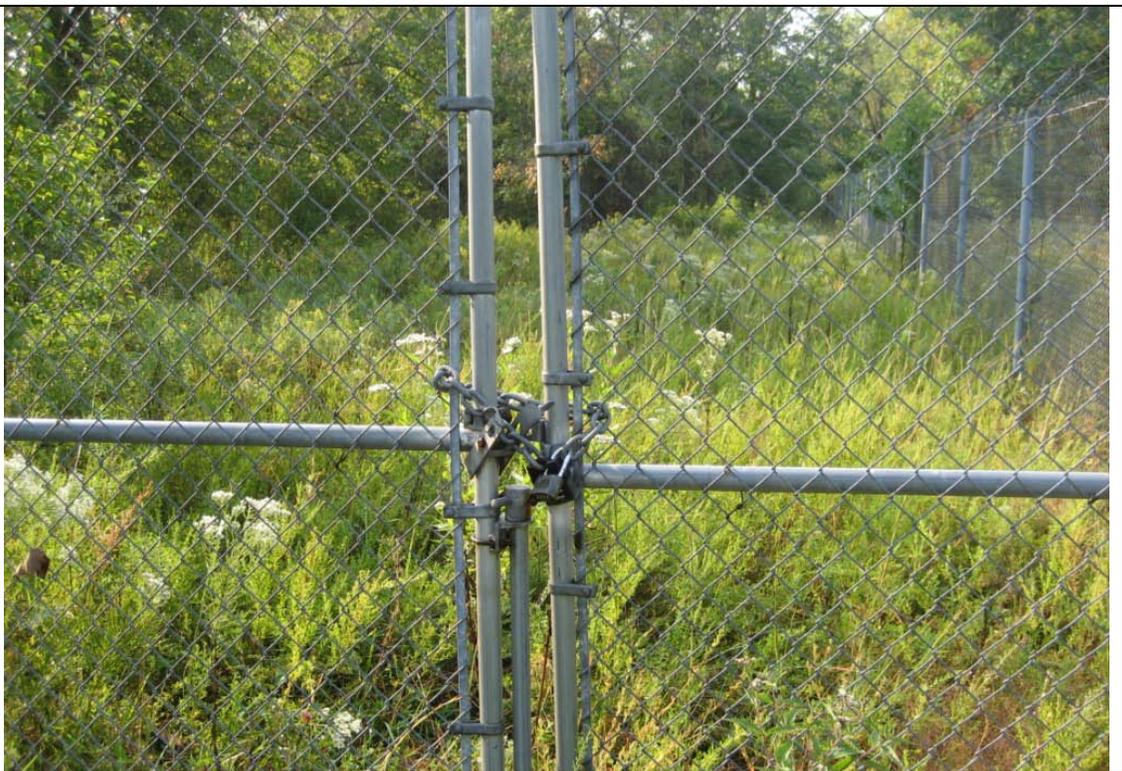
<b>Photo No.</b> P10	<b>Date:</b> 9-2010
-------------------------	------------------------

**Description:**  
Northwest gate, northwestern corner.  
Gate closed locks and chain in tact.

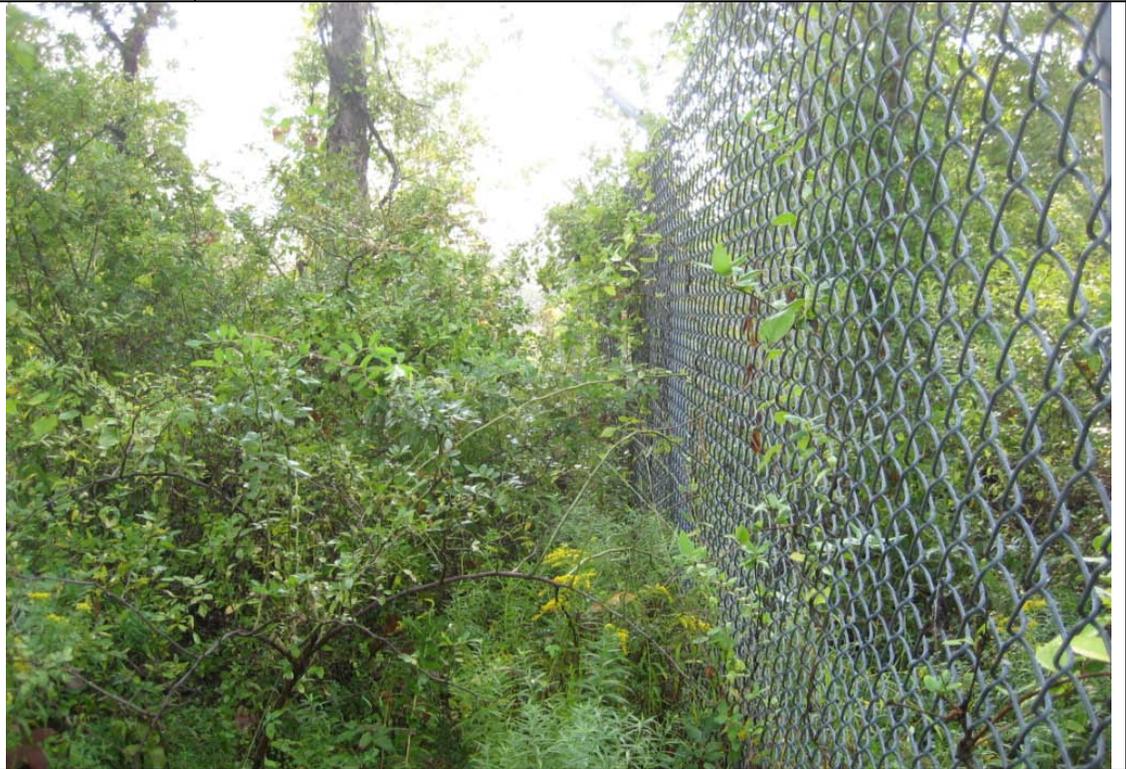
**Description:**  
Northern fence line.  
Light overgrowth.

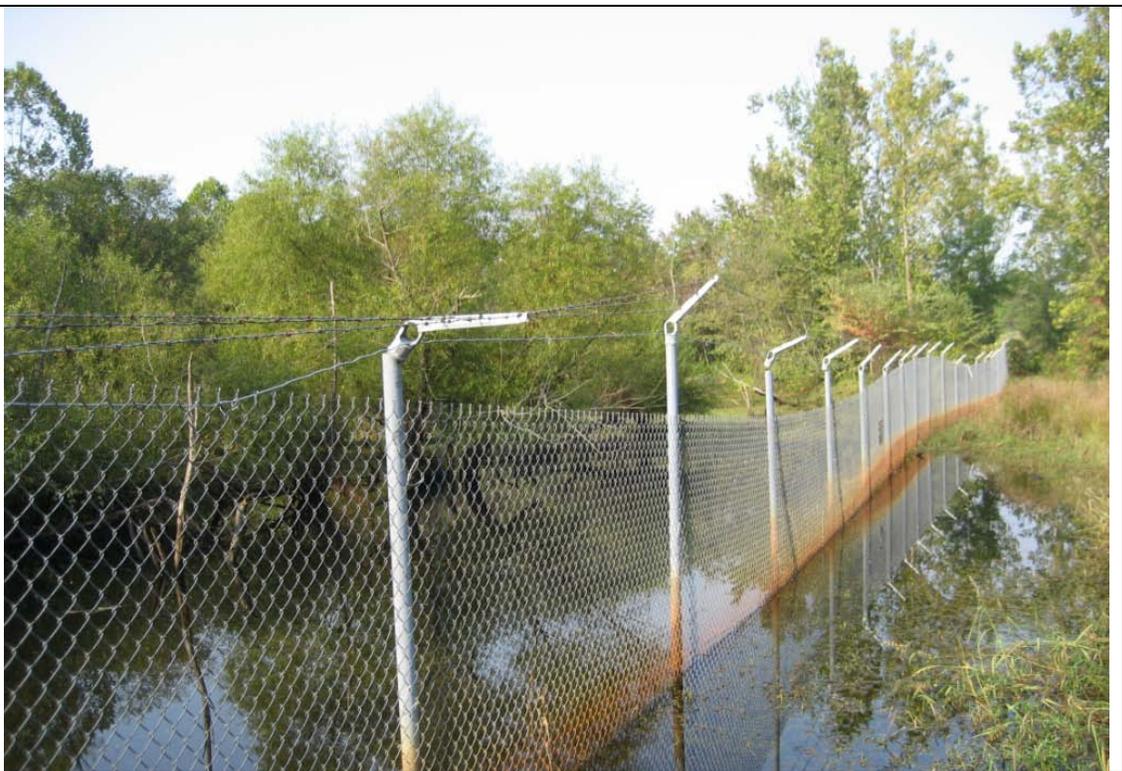
<b>Photo No.</b> P14	<b>Date:</b> 9-2010
<b>Direction Photo Taken:</b> West

**Description:**  
Northern fence line.  
Moderate to severe rust damage (bottom).  
Fence fabric detached from poles (top).

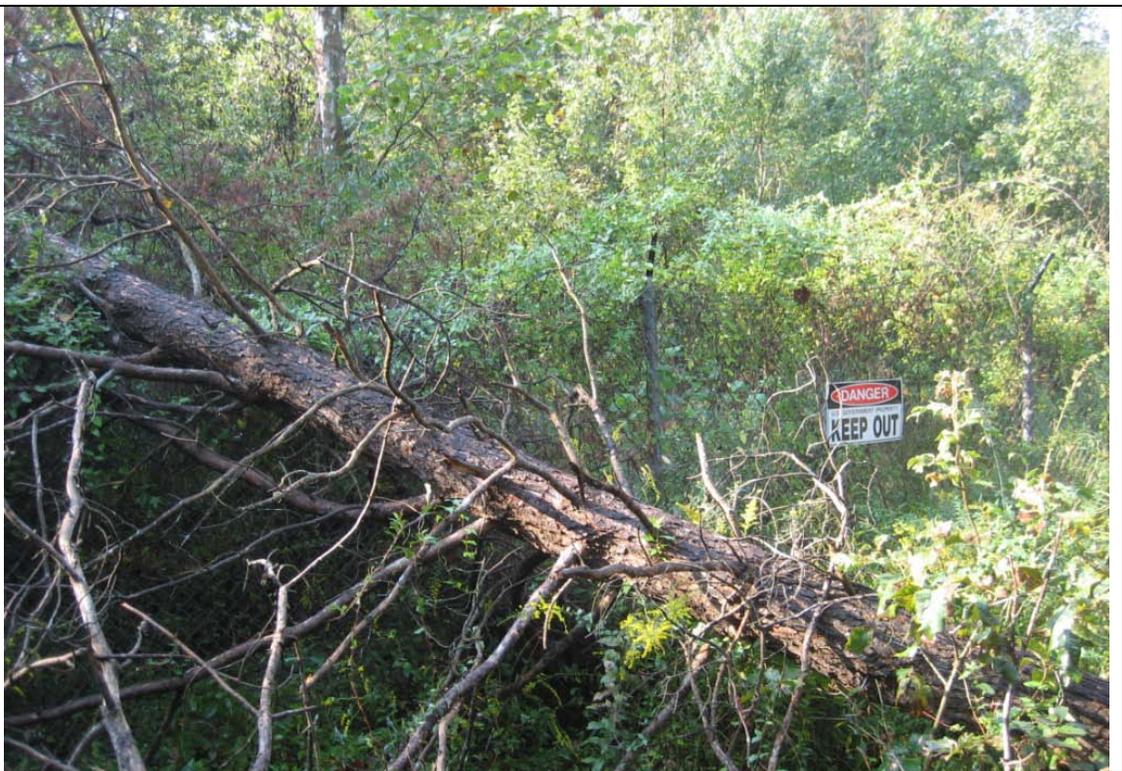
<b>Photo No.</b> P16	<b>Date:</b> 9-2010
<b>Direction Photo Taken:</b> South

**Description:**  
Northern fence line.  
Downed tree on fence.  
Moderate damage.  
Moderate overgrowth.
