**Re: April 2011 Final Tipton Airfield Parcel Five-Year Review;  
Fort George G. Meade, Maryland**

**SECOND FIVE-YEAR REVIEW REPORT  
FOR  
FORT GEORGE G. MEADE  
LEGACY BASE REALIGNMENT AND CLOSURE  
PROGRAM**

**Tipton Airfield Parcel**

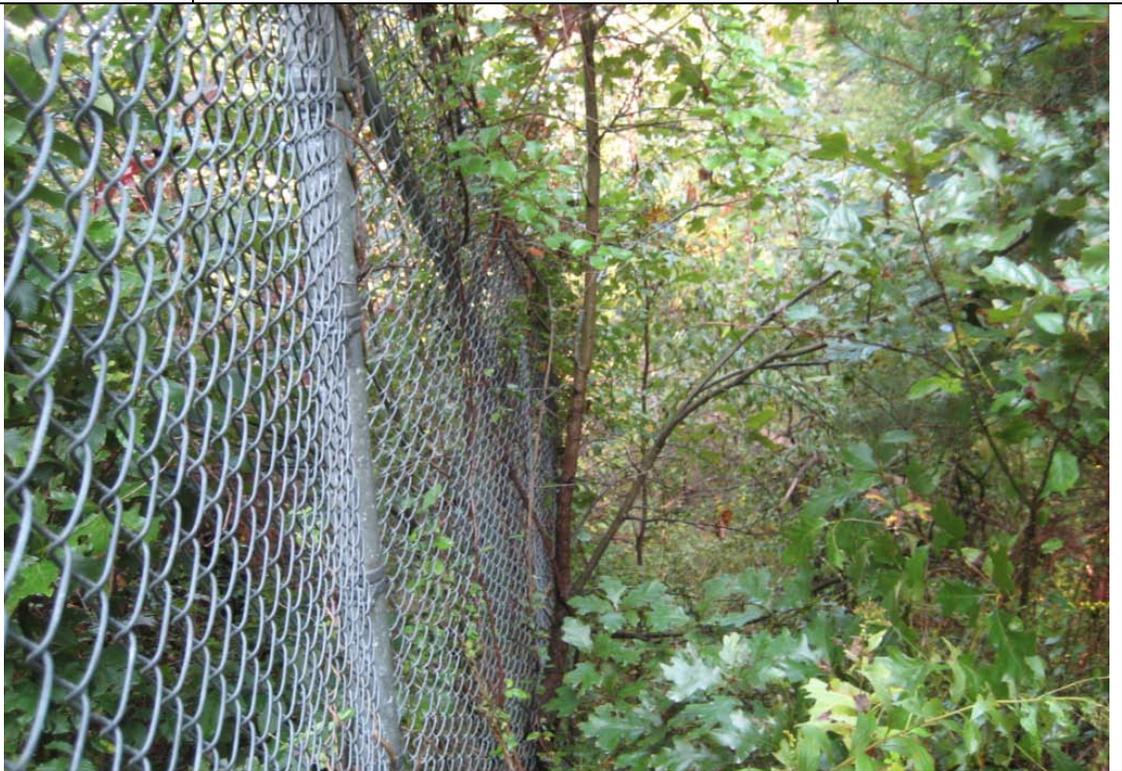
**Description:**  
Northeast corner.  
Light overgrowth.

- 2 Implement a contract in fiscal year 2011 to clear the IAL2 fence line. Once it is cleared, conduct the necessary fence line repair work.
- 3 Re-grade the swales and level the surface of IAL3's cover to remove settlement ridges.

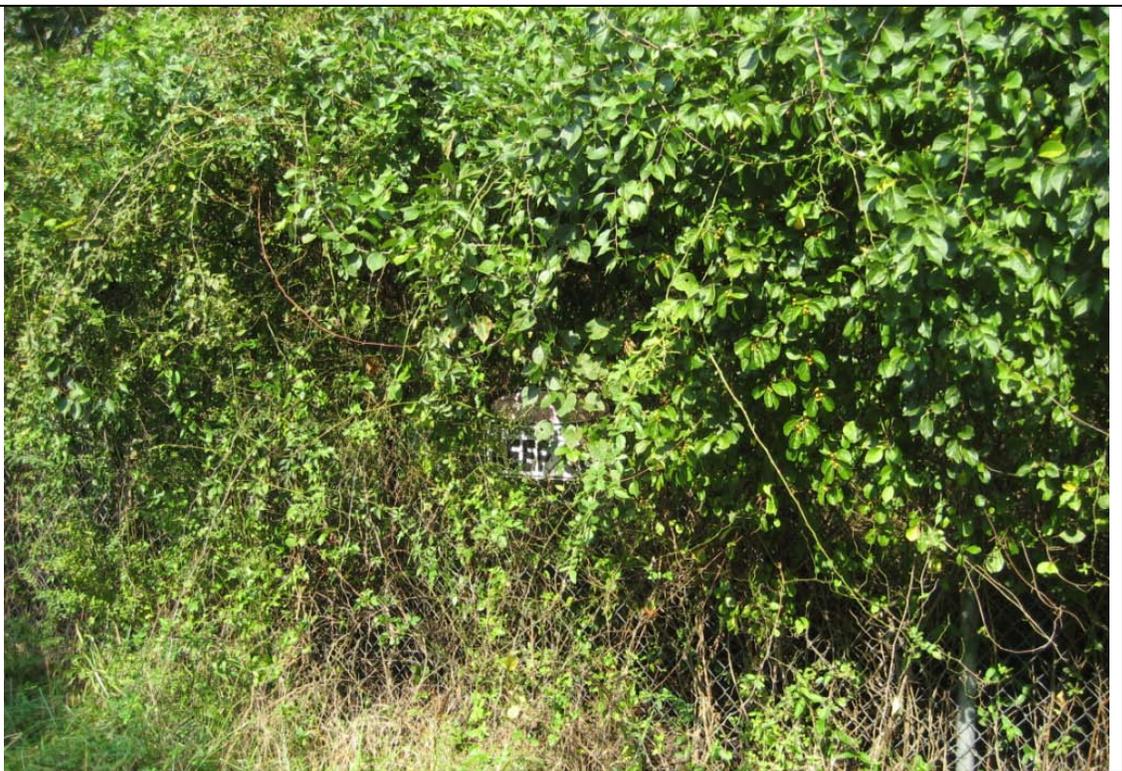
<b>Photo No.</b> P26	<b>Date:</b> 9-2010
<b>Direction Photo Taken:</b> North/Northwest

**Description:**  
Southern fence line.  
Severe overgrowth.  
Signage intact, barely visible.

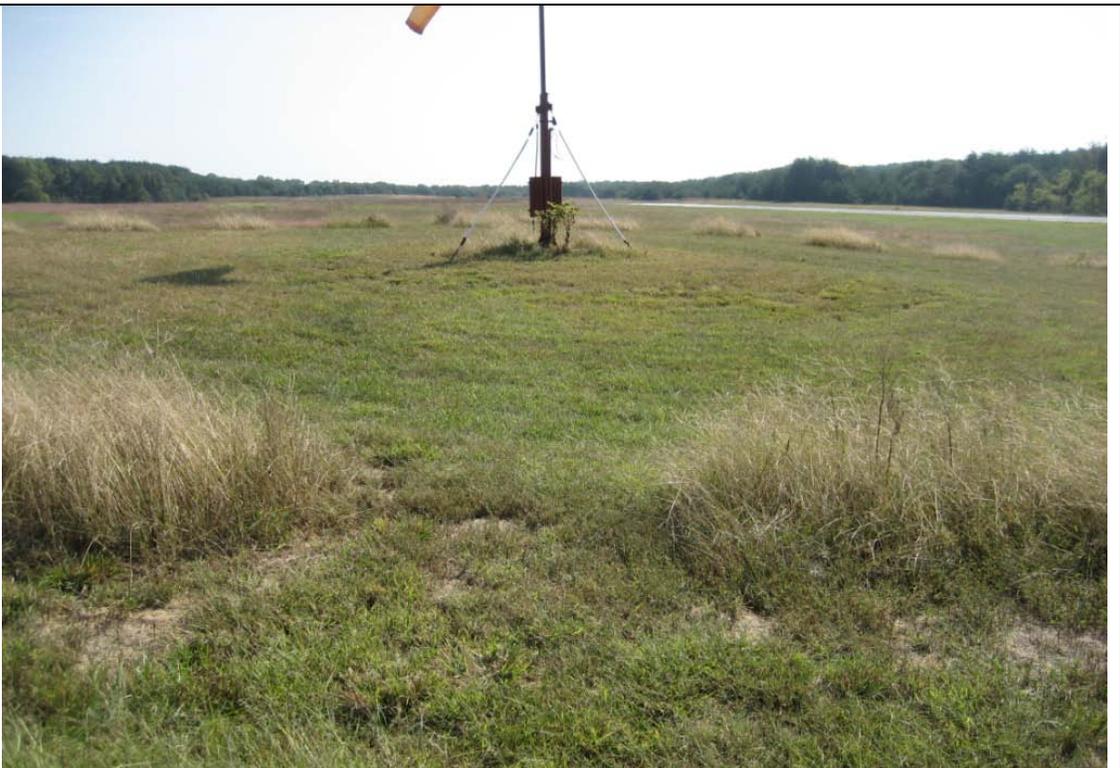
<b>Photo No.</b> P4	<b>Date:</b>
<b>Direction Photo Taken:</b> East

**Description:**  
Settlement occurring around aviation windsock.

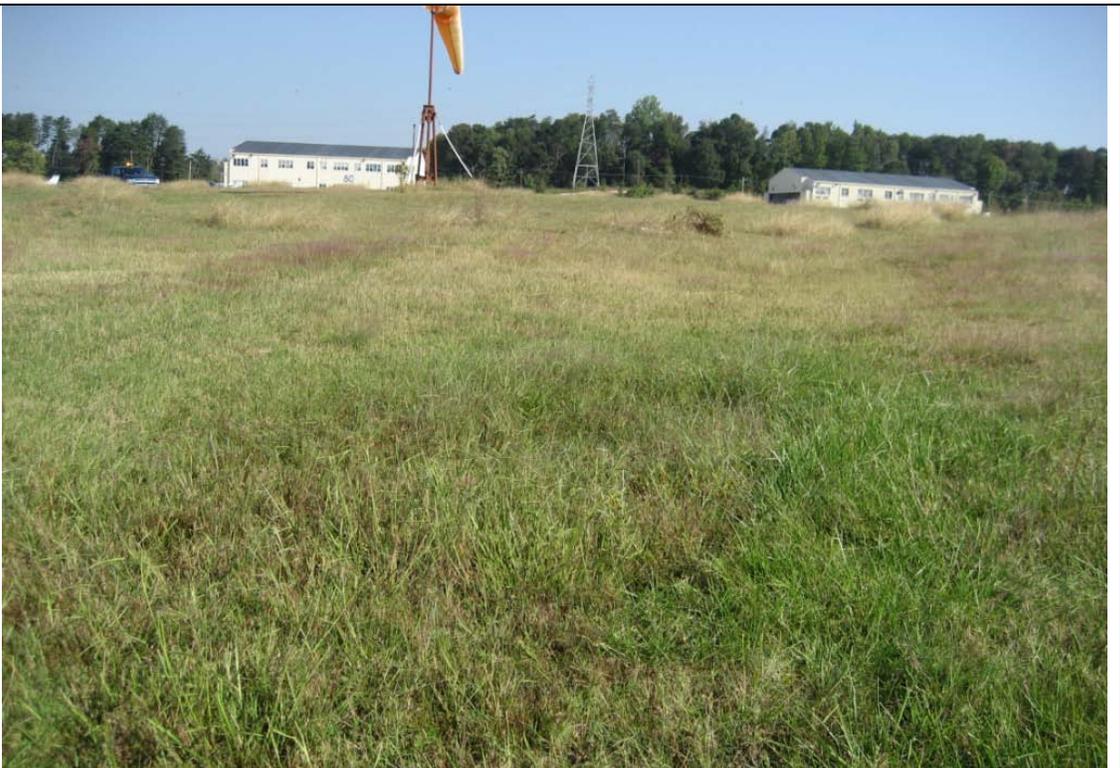
<b>Photo No.</b> P6	<b>Date:</b>
<b>Direction Photo Taken:</b> North

**Description:**  
Settlement ridges

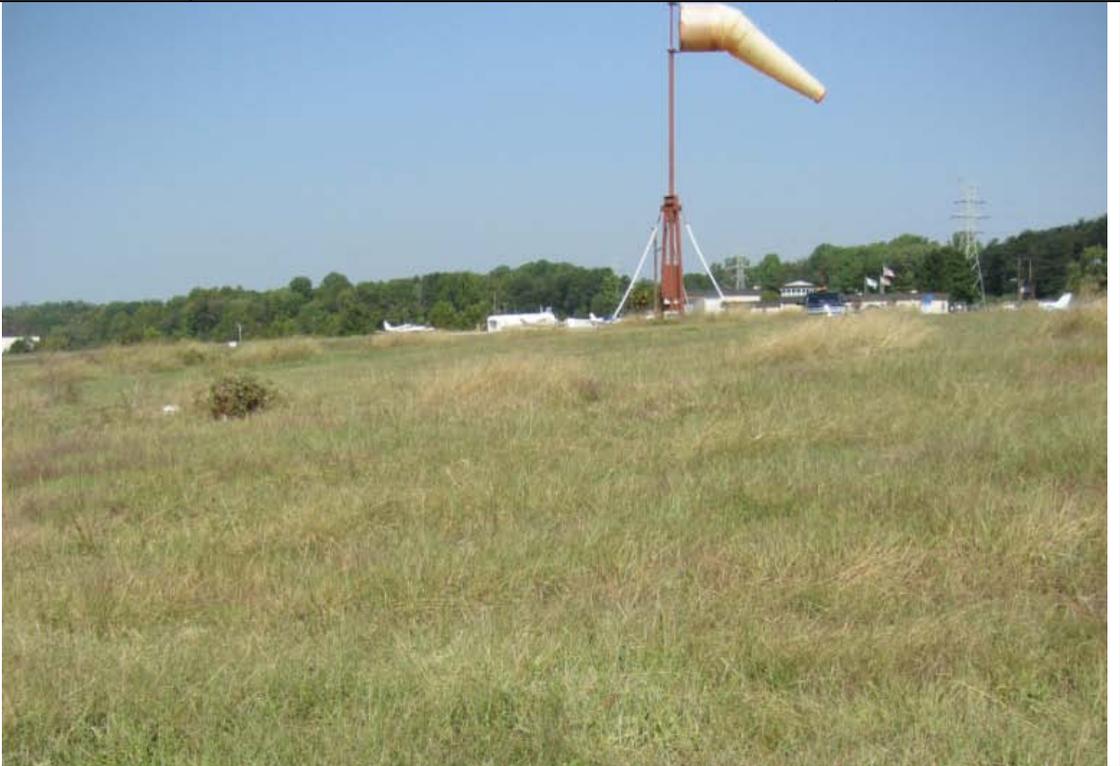
<b>Client Name:</b> USACE-Baltimore District		<b>Site Location:</b> FGGM Inactive Landfill No. 3	<b>Project No.</b> 15302389.40000
<b>Photo No.</b> P7	<b>Date:</b> 9-2010

<b>Direction Photo Taken:</b> Northwest			
<b>Description:</b> Settlement ridges are visible.  Photo by: URS

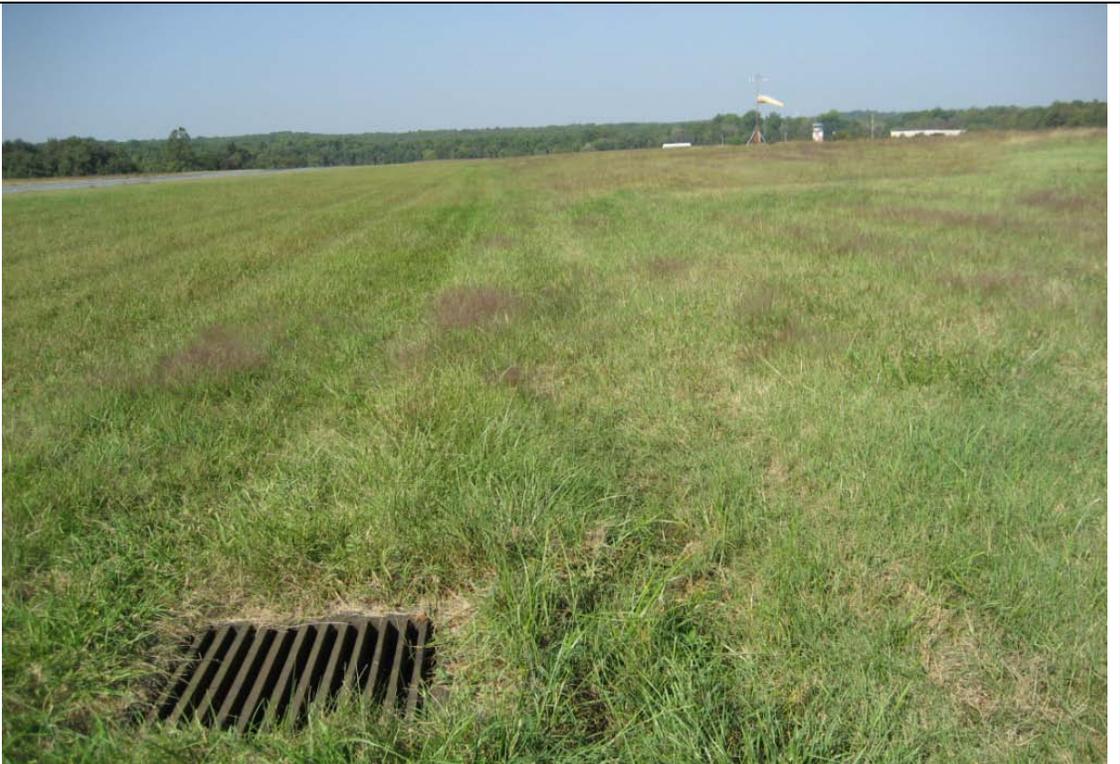
<b>Photo No.</b> P8	<b>Date:</b>

<b>Direction Photo Taken:</b> West			
<b>Description:</b> Settling occurring around storm water drainage structure.  Photo by: URS

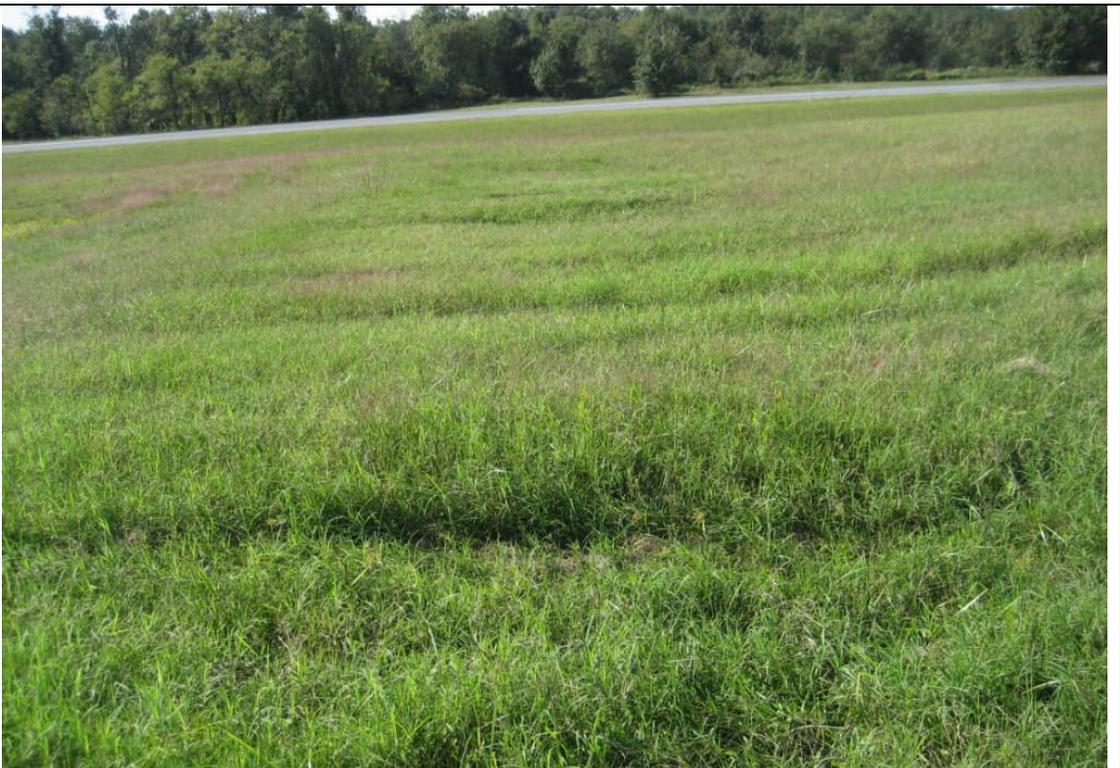
<b>Photo No.</b> P10	<b>Date:</b>
<b>Direction Photo Taken:</b> South

**Description:**  
Settlement ridges are visible.
