Re: Final Amended 2012 Site Management Plan, Fort George G. Meade
Docket Number: CERC-03-2009-0207FF

**SITE MANAGEMENT PLAN
2012 ANNUAL UPDATE
FORT GEORGE G. MEADE, MD**

URS Group, Inc.
12420 Milestone Center Drive, Suite 150
Germantown, MD 20876
Project no. 15302269

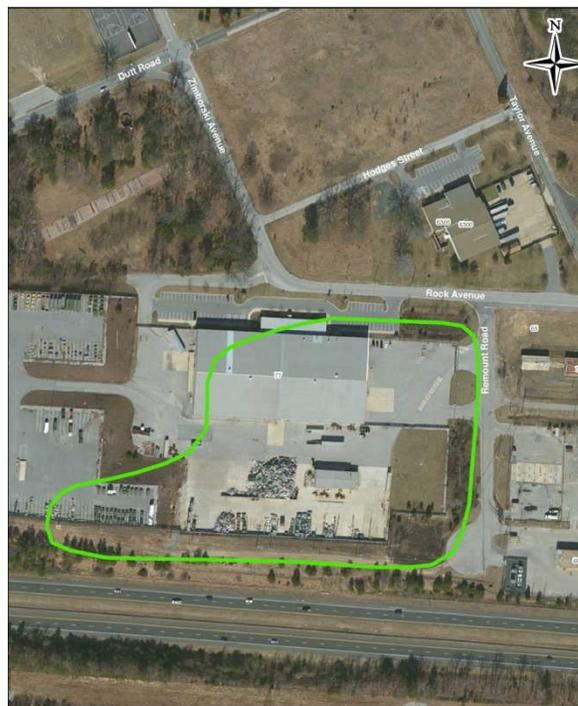
FGGM 07 - DRMO Drum Site
0 100 200 400 Feet

Previous Studies: A total of 267 drums, 2 transformers, 1 high voltage box, and 3,500 tons of contaminated soil were removed in 1995 after the discovery of a few buried drums on June 15, 1995.

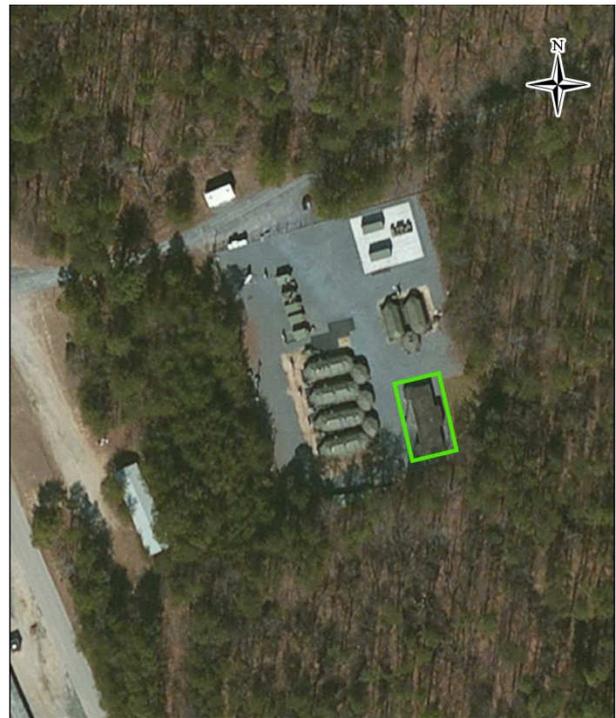
FGGM 11 - Gas Training Building 73
0 40 80 160 Feet

Building 73 has concrete floors and walls and the tear gas agent was only released inside the building. There is very low potential for the tear gas agent or its decomposition products to have entered the soil or groundwater surrounding Building 73.

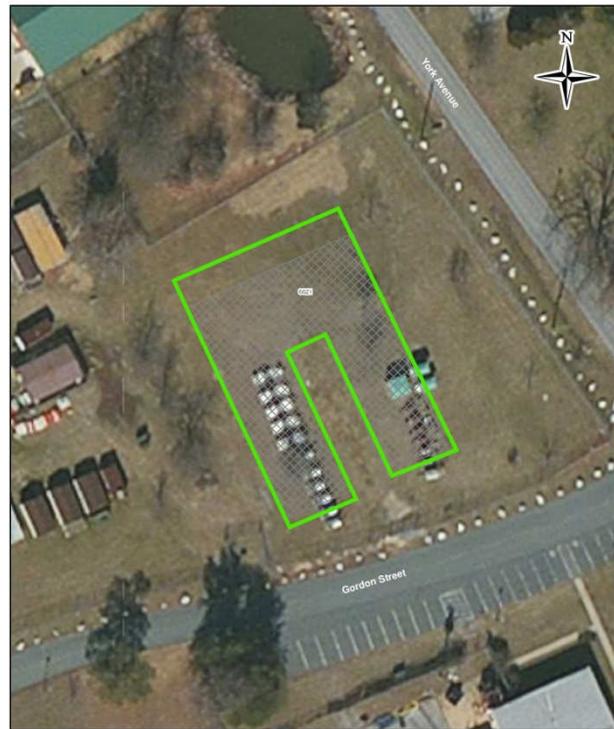
FGGM 13 - Pesticide Shop Building 6621
0 25 50 100 Feet

Additional RI work conducted in 2010 indicated that groundwater is contaminated with pesticides at low levels (primarily chlordane). Groundwater pesticide

concentrations decrease substantially away from the pesticide handling area. Tetrachloroethene (PCE) was also detected in 2 wells in the vicinity of the former pesticide shop and also decreases in concentration away from the pesticide handling area to non-detect. The human health risk assessment (HHRA) prepared as part of the RI concluded:

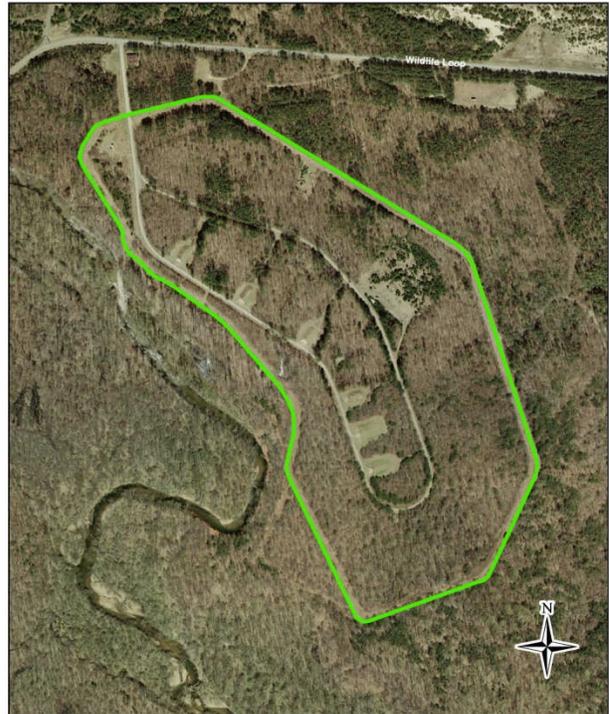
FGGM 18 - Comp Ammunition Supply Point No. 2 (OU-13)
 0 250 500 1,000
 Feet

Current Use: Grass, trees, roadways, and igloos cover this AOI.

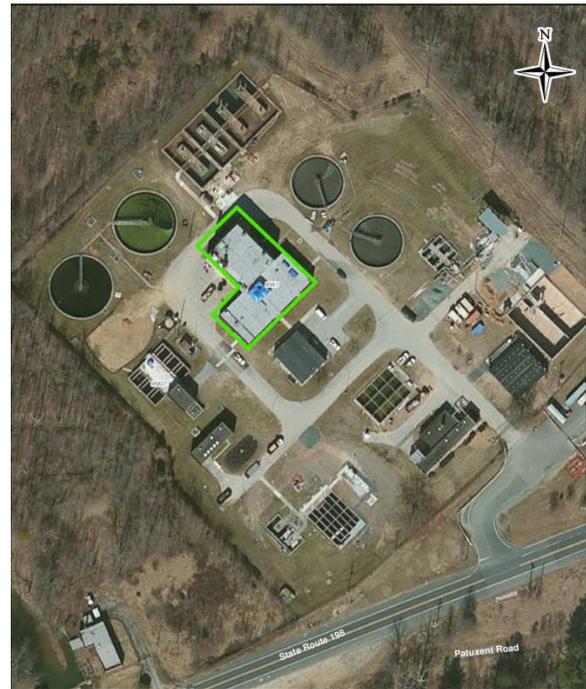
Building 9581 - Wastewater Treatment Plant
 0 60 120 240 Feet

Previous Studies: Over the course of previous investigations at this site, 1 surface soil samples, 18 subsurface soil samples, and nine groundwater samples were collected and submitted for laboratory analysis. Based on a risk analysis of the analytical results, arsenic and chromium elevate the risk numbers above the site-specific action levels.

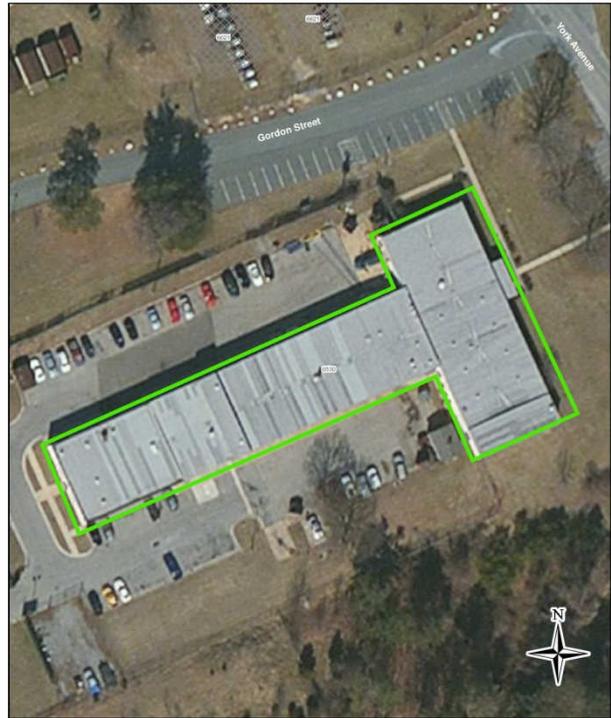
FGGM 36 (OU20) – Building 6530 - Auto Repair and Craft Center
0 30 60 120
Feet

Site Description: Building 6530 is a vehicle maintenance facility (SWMU 105) with nearby oil/water separator (SWMU 106) and wash racks (SWMUs 107 and 108). Approximately 1/3 of the building used as a craft center for installation residents involved in woodworking, ceramics, framing, and similar recreational activities. No chemicals except typical cleaners are kept in the crafts portion of the building. The auto repair facility stores oil, anti-freeze, and Freon. Used oil cans, oil filters, and rags are stored in 55-gallon drums for eventual removal. All floor drains in the auto repair area flow to an oil/water separator (SWMU 106), which also receives Wastewater from two wash racks (SWMUs 107 and 108) at the site. An 800-gallon waste oil above-ground storage tank (AST) is located at the northern exterior wall of the building.

Previous Studies: As part of the RCRA Facility Assessment (RFA) 3rd Phase, 16 direct-push borings were advanced around the building. 3 surface soil samples, 12 subsurface soil samples, and 1 groundwater sample were collected using a direct-push sampling rig. Based on a risk analysis of the analytical results, mercury, arsenic, and chromium elevate the risk numbers above the site-specific action levels.

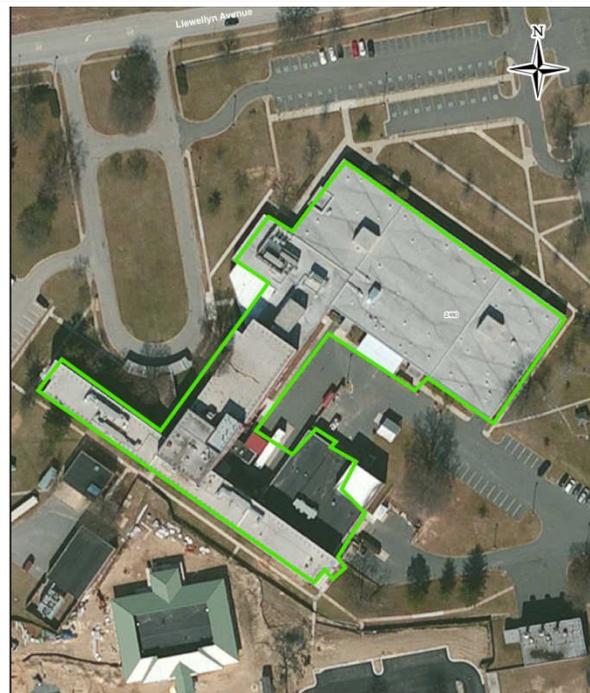
FGGM 37 (OU-21) – Kimbrough Army Hospital
0 50 100 200 Feet

Previous Studies: Over the course of previous investigations at this AOI, 8 subsurface soil samples, and 1 groundwater sample were collected and submitted for laboratory analysis. Based on a risk analysis of the analytical results, arsenic and chromium elevate the risk numbers above the site-specific action levels.

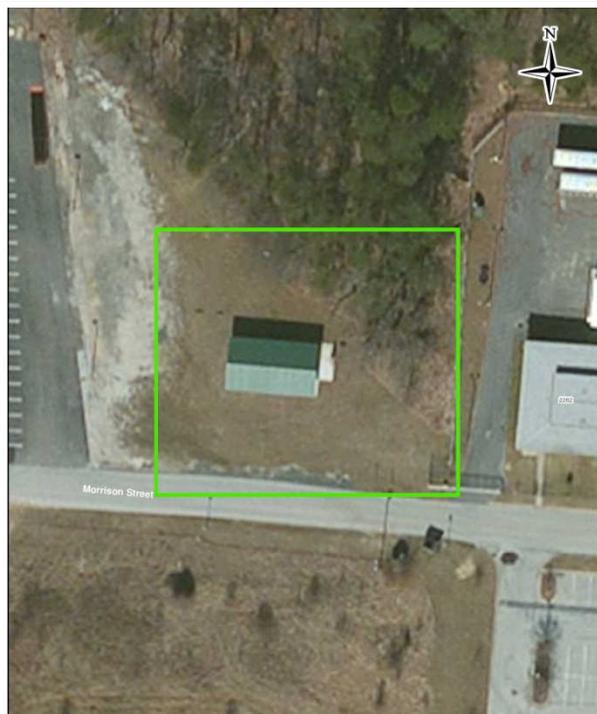
FGGM 33 - Battery Shop Building 2283
 0 25 50 100 Feet

Previous Studies: An interim removal action was completed in 1994 (EA, 1994). Over the course of previous investigations at this AOI, 59 surface soil samples, 67 subsurface soil samples, and 14 groundwater samples (plus 1 duplicate sample) were collected and submitted for laboratory analysis. A risk analysis was not performed on the chemical data because the data was pre-removal action.

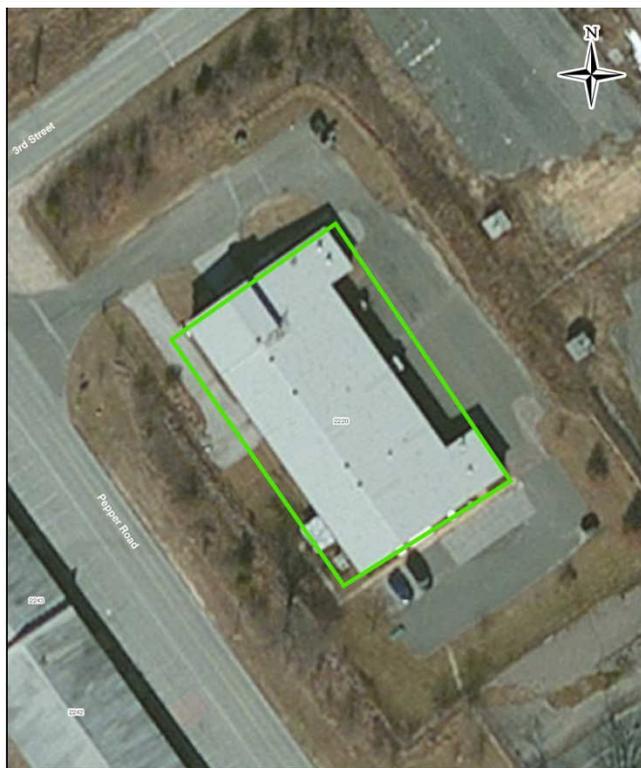
FGGM 45 - Building 2220 - Calibration Laboratory

Previous Studies: Over the course of previous investigations at this AOI, 4 surface soil samples, 6 subsurface soil samples, and 13 groundwater samples were collected and submitted for laboratory analysis. Based on a risk analysis of the analytical results, the risk numbers are below site-specific action levels.

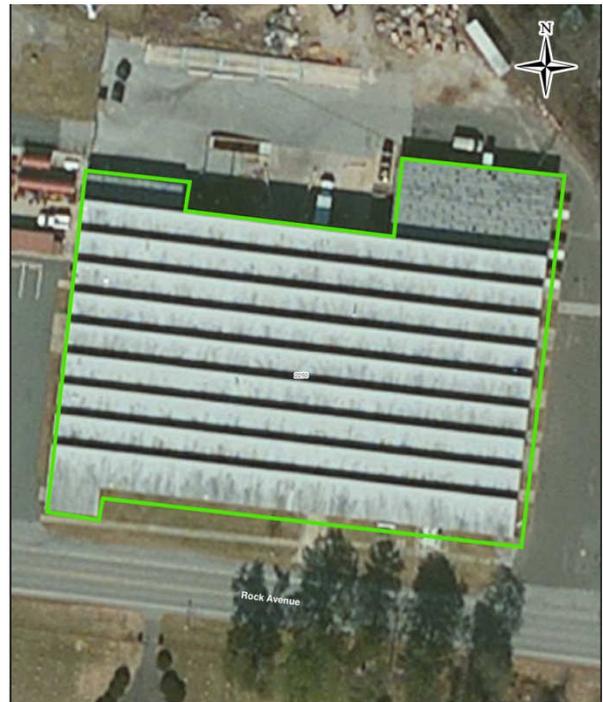
FGGM 47 - Post Laundry
0 25 50 100 Feet

Previous Studies: In 1989, a preliminary soil investigation identified PCE in soil in an area believed to be a former drum storage area north of the building. Surface water samples and sediment samples were collected from the retention pond near State Route 32 in 1998.

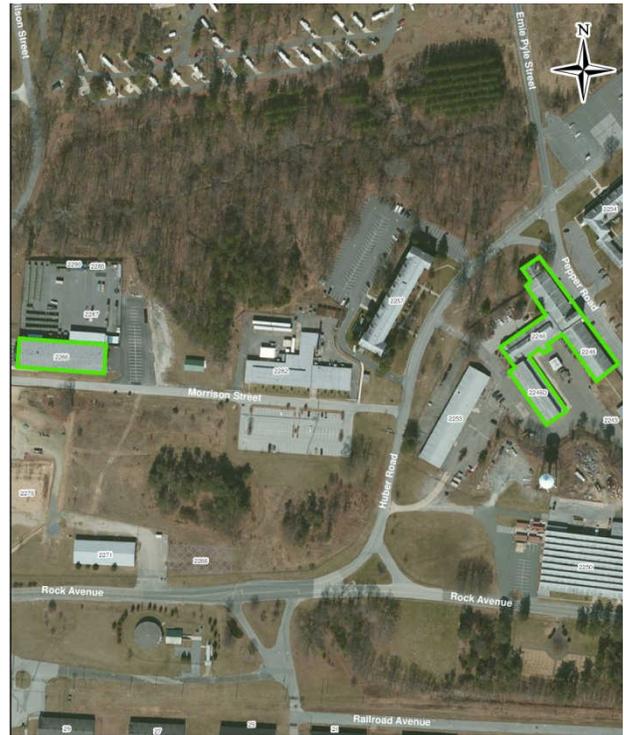
FGGM 49 - DOL Buildings 2286 and 2246
0 125 250 500 Feet

Site Description: FGGM 49 includes Buildings 2286 and 2246. The soil and groundwater investigations and actions around Building 2286 are covered under FGGM 86. The soil and groundwater investigations and actions around Building 2246 are covered under FGGM 92. Both FGGM 86 and FGGM 92 are part of OU-4. The initial delineations of these two buildings were completed (Versar, Inc., 2000c and 2000b). Further actions are required for soil and groundwater and will be conducted under FGGM 86 (for Building 2286) and FGGM 92 (for Building 2246). FGGM 49 is part of OU-4.

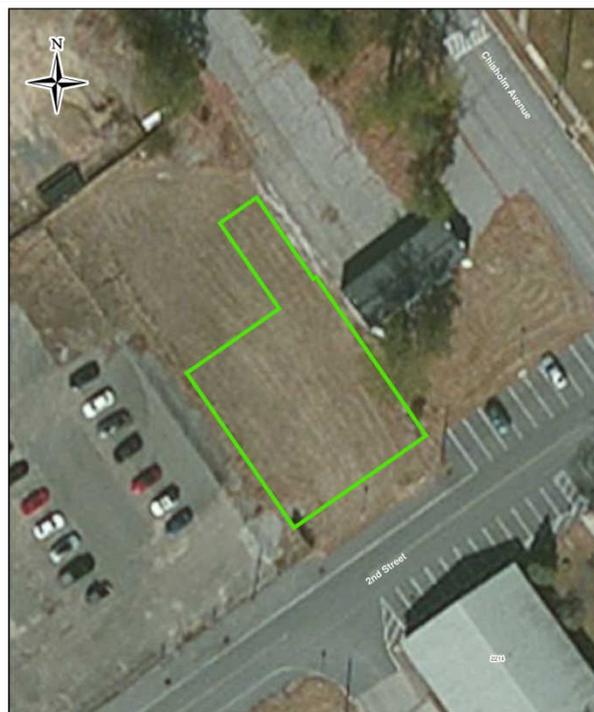
FGGM 51 (OU-24) – Building 2217 (Spill Site)
0 25 50 100 Feet

The soil chemicals of potential concern (COPCs) driving the risk are chromium, thallium, and 2-methylnaphthalene. Chromium and thallium appear to be consistent with background. The 2-methylnaphthalene risk is driven by a hot spot in Boring 3.

PCE was also noted in 2 toxicity characteristic leaching procedure (TCLP) samples, this indicates that some amount of PCE (a non-petroleum solvent) was also present in the soil.

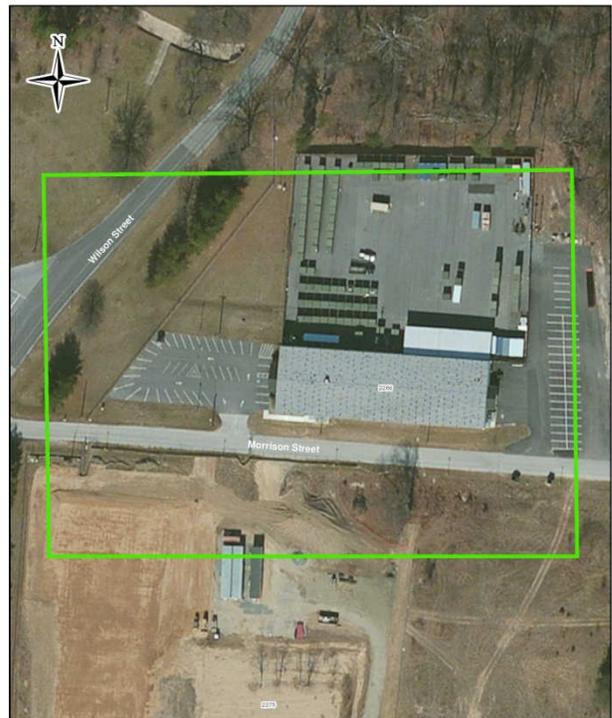
FGGM 86 - Former Motor Pool
0 50 100 200 Feet

In an investigation of soils and groundwater at Building 2286 in 2004 (Versar, 2005b), lead was detected in soil at up to 892 milligram/ kilogram (mg/kg), and PCE and TCE were detected in groundwater at up to 2,960 microgram/liter (µg/L) and up to 342 µg/L, respectively.

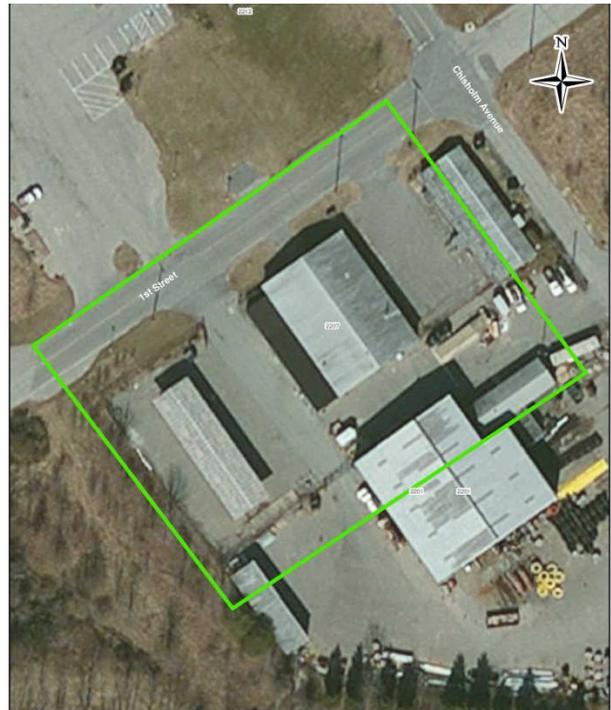
FGGM 88 - Former Tank Maintenance Facility Shop-1
 0 30 60 120 Feet

Soil: Arsenic exceeded the residential RBC, the industrial RBC, and the background mean in 2 of 17 samples tested. TPH-DRO was detected at up to 650,000 µg/kg.

Groundwater: Dissolved arsenic exceeded its tap water RBC. TPH-DRO was detected at up to 120,000 µg/L. TPH-gasoline-range organics (GRO) was detected at up to 56,000 µg/L.

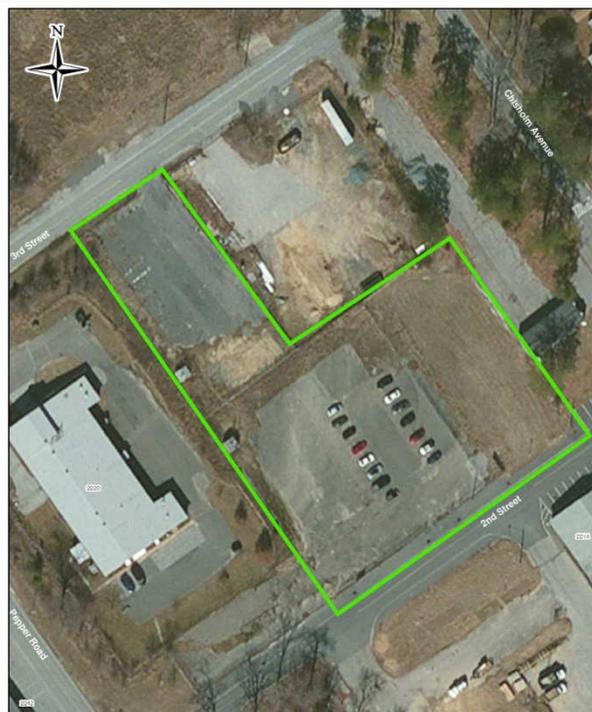
FGGM 89 - Former Tank Maintenance Facility Shop-2
 0 40 80 160 Feet

Soil: Arsenic exceeded the residential RBC and the industrial RBC at 2 of 32 locations tested.
 Groundwater: Six metals (arsenic, beryllium, chromium, lead, mercury, and thallium) had concentrations that exceeded their maximum contaminate level (MCL) or tap water RBC value (or at-tap action level in the case of lead). Seven VOCs (benzene; naphthalene; n-propylbenzene; chlorobenzene; dichlorobenzene (DCB); 1,2,4-trimethylbenzene; and 1,3,5-trimethylbenzene) exceeded RBCs at 5 of 30 locations tested.

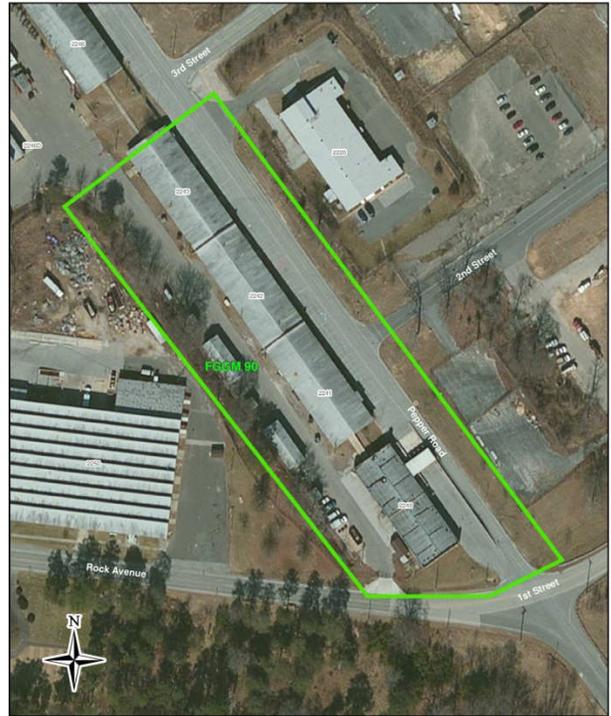
FGGM 90 - Former Tank Cleaning Supply Warehouse
 0 60 120 240 Feet

Site Description: The complex is in OU-4 and includes Buildings 2240 (SWMUs 45 and 46), 2241 (SWMUs 47 and 48), 2242 (SWMUs 49 and 50), 2243, 2247, 2248 (SWMUs 51 and 52), and 2249 (SWMUs 53 and 54). Building 2240 is a separate single-story brick structure. Buildings 2241, 2242, and 2243 are connected in sequence and are elevated on wooden piers. Buildings 2247, 2248, and 2249 are smaller, wooden garage-type structures located behind the larger buildings. Other features on the site include a propane storage pen (Building 2247A), a flammable gas storage pen (Building 2248A), an empty compressed gas storage pen north of Building 2249, and a former 1,000-gallon AST storing No. 2 fuel oil located behind Building 2242, was removed in 1995.

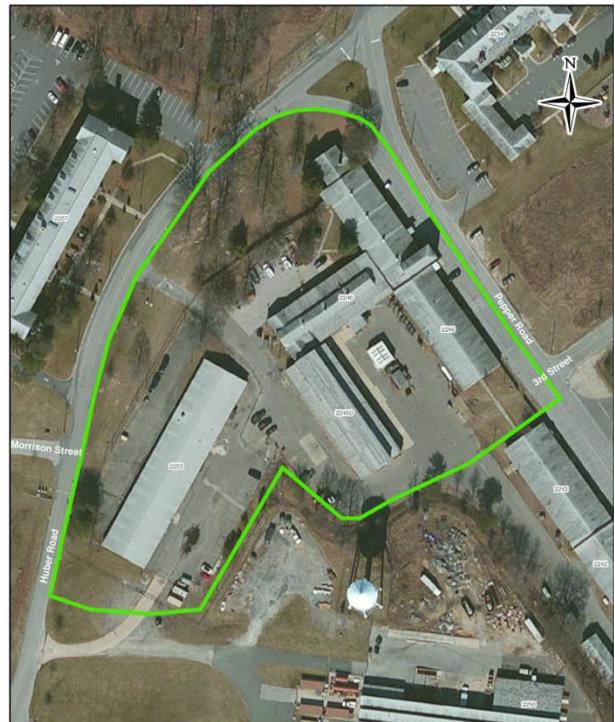
FGGM 92 - Former Heavy Gun Cleaning and Repair Shop

Site Description: FGGM 92 is part of OU-4 and is currently the DOL Tactical and Support Vehicle/Heavy Equipment Maintenance Facility and includes Building 2246/2246D (SWMUs 55–58), Building 2253 (SWMUs 61–62), and two storage sheds (Buildings 2244 and 2245). Building 2246 has been used as a heavy gun repair shop from 1934 until the mid-1980s, and a military tank repair shop in the past. Since 1992, the Director of Community Activities has used the facility for storage and maintenance of grounds-keeping equipment and supplies. Building 2253 was constructed in 1934, and has been used for vehicle maintenance in the past. Prior to 1992, it was used by the DOL as a warehouse.

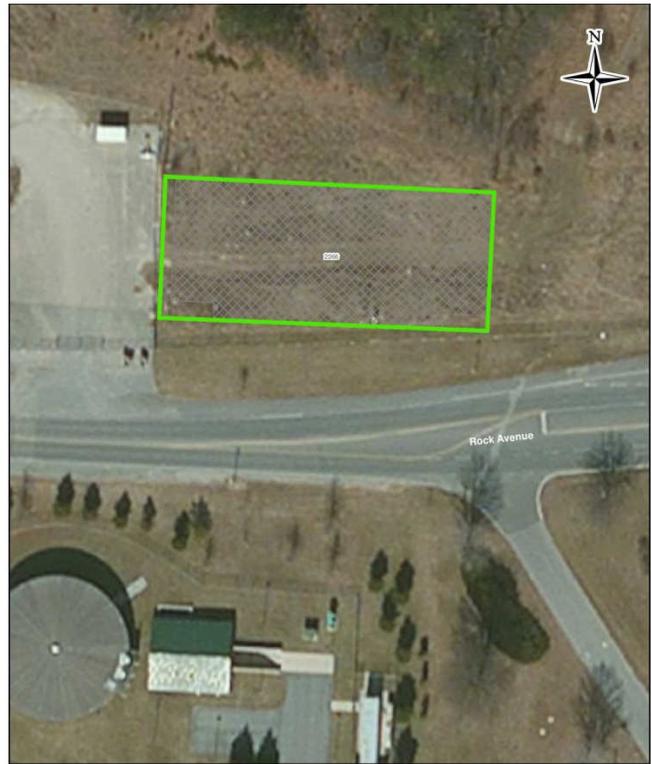
Former Building 2266
0 25 50 100 Feet

Previous Studies: This AOI was not identified in the Solid Waste Management Unit study (BCM, 1996) or the EPA (1996) historic aerial photograph study of the installation. Past use of the building is unknown. No stains, stressed vegetation, debris, or solid waste were identified in this area. The 2006 FGGM IAP lists a 6 September 2002 SI Report for Building 2266. That report is not available for review. The 1952 land use map shows a spur of the railroad near Building 2266 and between Buildings 2271 and 2272. These buildings were probably used as warehouses.

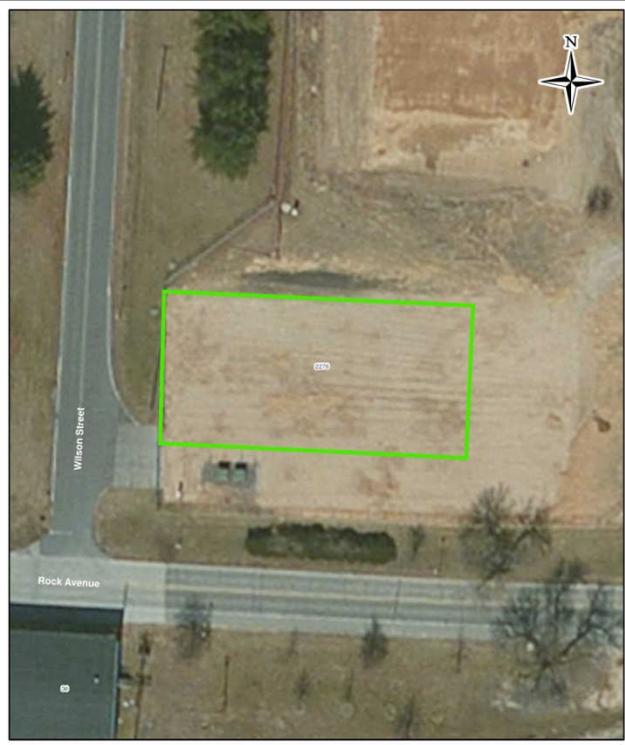
Building 2276 - Furniture Repair Shop
 0 25 50 100 Feet

Site Description: Building 2276 was constructed between 1910 and 1920 and used as a warehouse. Hazardous chemicals (paint thinners, adhesives, stains, and aerosols) were used and stored in small quantities at the facility. The building also contained a paint booth. The building was demolished in early 2012. Building 2276 is part of OU-4.

Previous Studies: Over the course of previous investigations at this site, 4 surface soil samples, 6 subsurface soil samples and 10 groundwater samples were collected and submitted for laboratory analysis. Based on a risk analysis of the analytical results, tetrachloroethene and some metals elevate the risk numbers above the site-specific action levels.

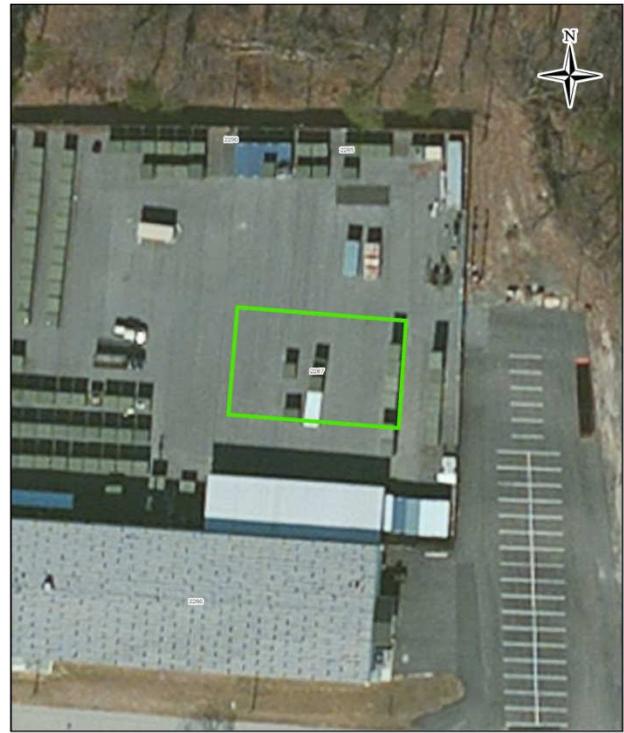
Building 2287 - NSA Motor Pool Storing Equipment and Chemicals

Site Description: Former Building 2287, NSA MP Equipment and Chemicals Storage Shed (SWMU 68), was constructed in 1941 and used as a vehicle maintenance shed and later as a carpentry shop and storage facility for airplane platforms associated with the DOL Allied Trades. In 1996, the NSA MP started storing equipment and small quantities of chemicals (lube oil, adhesives, and brake fluid) in the building. The building was demolished around 2000. Building 2287 is part of OU-4

Previous Studies: Over the course of previous investigations at this site, 6 subsurface soil samples and 2 groundwater samples were collected and submitted for laboratory analysis. Based on a risk analysis of the analytical results, no compounds elevate the groundwater or soil risk numbers above the site-specific action levels.

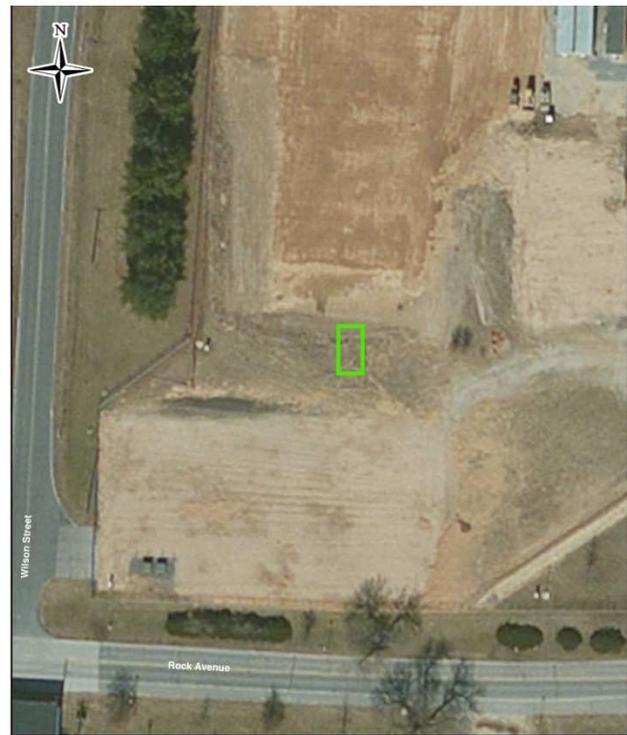
Building 2288 -- Paint Storage Shed
0 30 60 120 Feet

Site Description: Former Building 2288 was a small, concrete block storage building for Building 2276. The building was reportedly used in the past for storage of paints, thinners, and gasoline. Disposal practices in the building were unknown.

Previous Studies: Over the course of previous investigations at this site, 3 surface soil samples, 4 subsurface soil samples, and 2 groundwater samples were collected and submitted for laboratory analysis. Based on a risk analysis of the analytical results, arsenic, mercury, lead and chromium elevate the risk numbers above the site-specific action levels.

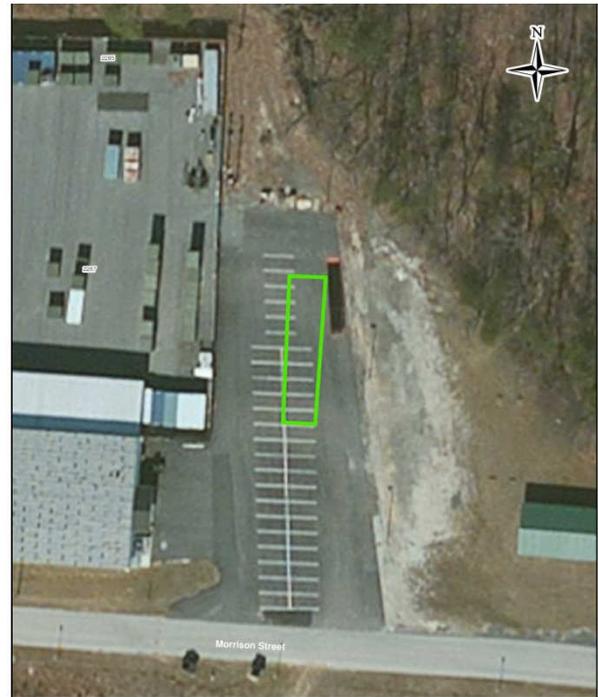
Wash Rack 5
0 25 50 100 Feet

Site Description: WR-5 was identified as an AOI because the circa 1952 land use map (Anon., 1952) listed WR-5 in the southeastern portion of the installation. The 1996 SWMU study identifies a WR-5 associated with Building 940 located in the north-eastern portion of the installation. The circa 1952 land use map (Anon., 1952) did not identify a WR in the vicinity of Building 940. The naming of WRs in 1952 and 1996 may have been different. The WR associated with Building 940 will be addressed under separate cover in the report of Building 940. AOI WR-5 falls within the geographical boundary of OU-4 and is part of OU-4.

Previous Studies: Over the course of previous investigations, 3 subsurface soil samples and 1 groundwater sample were collected. Based on a risk analysis of the analytical results, arsenic, iron, cobalt, vanadium, aluminum, chloroform, and chromium elevate the risk numbers above the site-specific action levels (URS Group, Inc., 2011n).

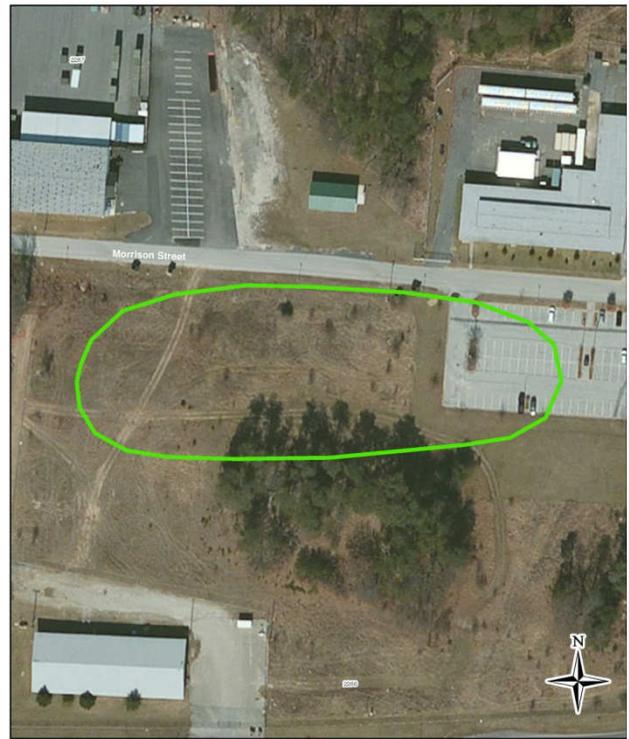
Debris and Stain -- 1975
0 50 100 200 Feet

Site Description: The EPA (1996) study described this AOI in the 1975 aerial photograph as: “debris has been deposited in this area and a dark stain is visible adjacent to a small building. The stain is aligned along a drainage pathway that leads from the building northeast into the nearby woods.” The 1975 aerial photograph (EPA, 1996) does not have the stain labeled. The write-up for the 1988 aerial photograph (EPA, 1996) says that staining is still present along the drainage way and solid waste is present in an accumulation of debris, although these feature are not labeled on the photograph itself. The AOI is not labeled in the 1995 aerial photograph (EPA, 1996) and no debris or stains are visible.

Previous Studies: Over the course of previous investigations near this AOI, 15 subsurface soil samples (plus 1 duplicate sample) and 2 groundwater samples were collected and submitted for laboratory analysis. Based on a risk analysis of the analytical results, arsenic, cobalt, iron, manganese, and chromium elevate the risk numbers above the site-specific action levels (URS Group, Inc., 2011n).

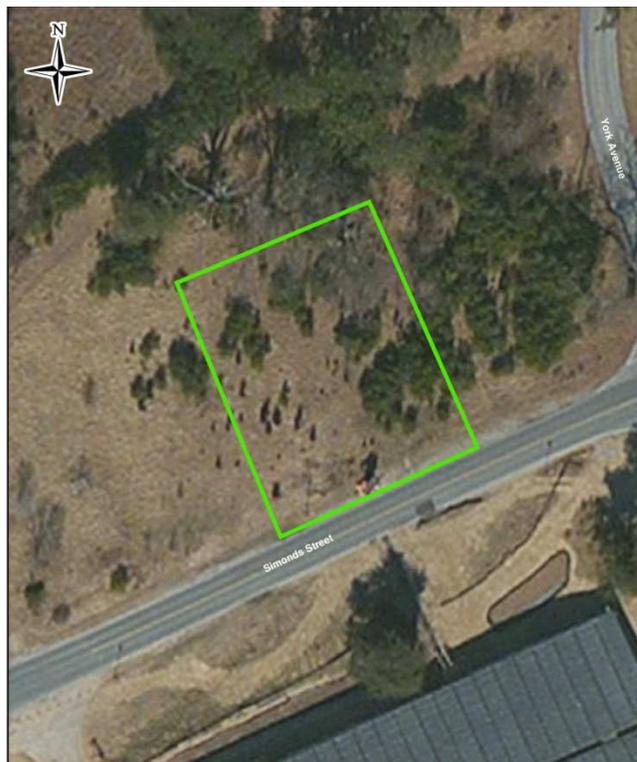
FGGM 70 (OU-25) -- Indoor Range, Building 6513
 0 25 50 100 Feet

Over the course of previous investigations at this AOI, 4 surface soil samples (plus 1 duplicate sample), 5 subsurface soil samples, and 5 groundwater samples (plus 1 duplicate sample) were collected and analyzed. Based on a risk analysis of the analytical results, 1,2,4-trimethylbenzene and naphthalene elevate the risk numbers above the site-specific action levels.

Current Use: Grass field

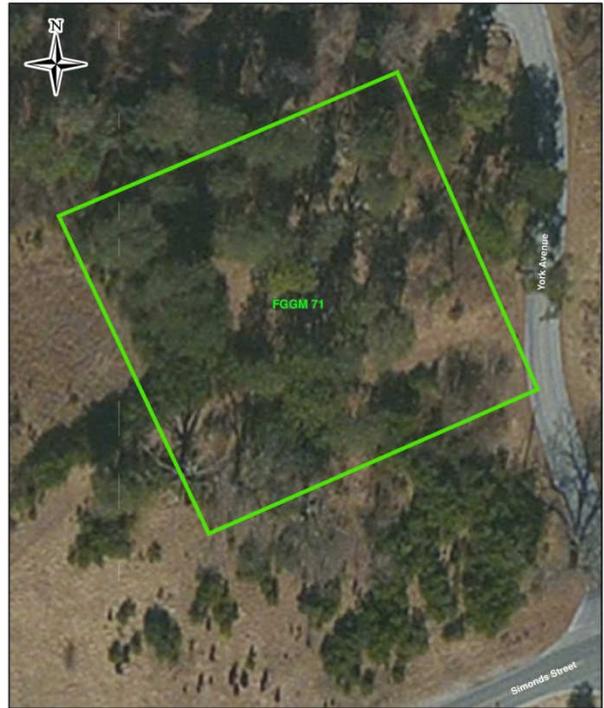
FGGM 71 (OU-26) -- EX Indoor Range, Building 6522
 0 25 50 100 Feet

Over the course of previous investigations at this site; 4 subsurface soil samples and 3 groundwater samples were collected and analyzed. Based on a risk analysis of the analytical results, mercury, arsenic, and chromium elevate the risk numbers above the site-specific action levels.

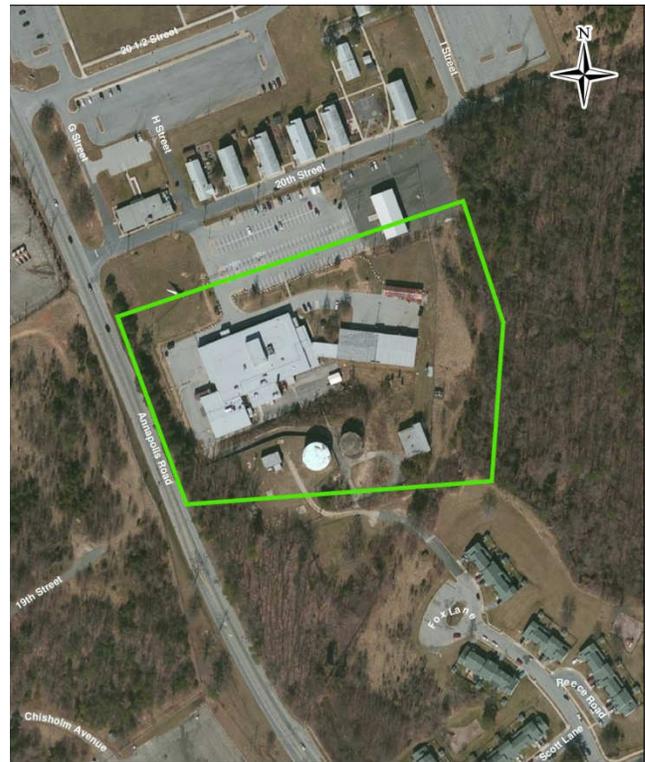
FGGM 87 - Former Nike Control Site
0 100 200 400 Feet

Previous Studies: Over the course of previous investigations at this site, soil and groundwater samples were collected and analyzed. An RI/FS was submitted in January 2008. Regulatory comments were received in November 2008 and April 2009. Additional soil and groundwater samples were collected in a supplemental RI field effort in 2009. Based on additional EPA comments, sediment sampling and analysis was conducted adjacent to the site in 2010.

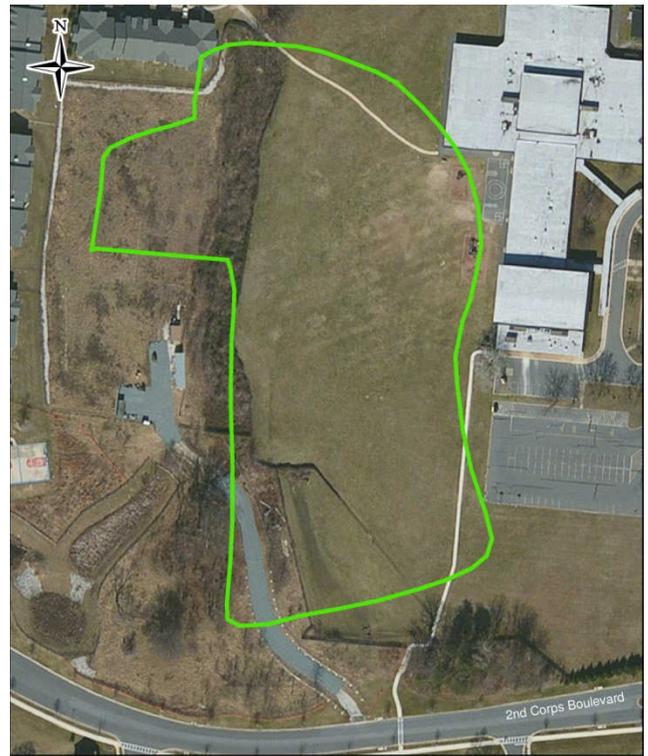
FGGM 93 - Manor View Dump
 0 60 120 240 Feet

The area of buried waste was temporarily fenced with barricade safety fencing and then replaced with chain link fence when the landfill gas migration control system was installed in August 2005 (Plexus, 2008b). A passive vent trench was installed and later upgraded to a soil vapor extraction system with a blower to enhance vapor capture (Plexus, 2006).

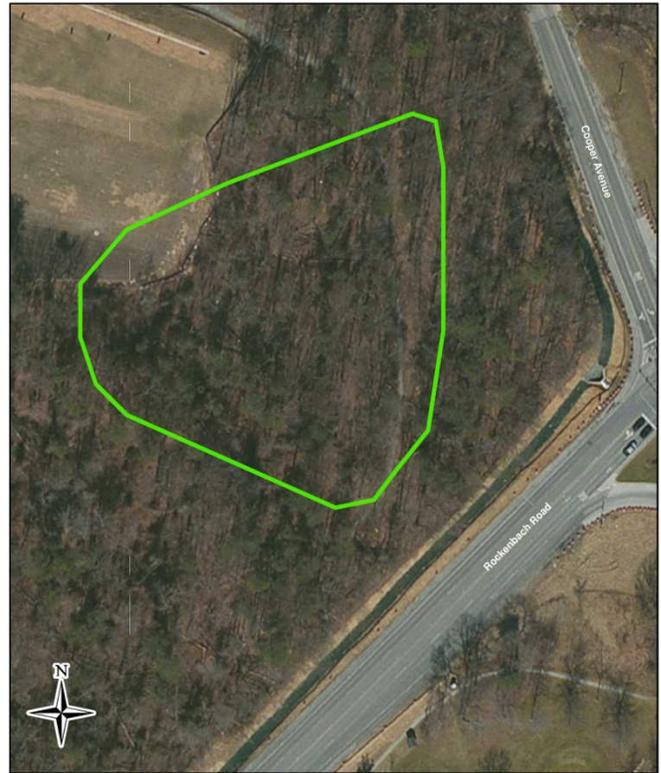
Possible Dump Site E - 1957
0 50 100 200 Feet

Over the course of previous investigations at this AOI, 5 subsurface soil samples, 4 groundwater samples, 3 sediment samples, and 3 surface water samples were collected and submitted for laboratory analysis. Based on a risk analysis of the analytical results, cobalt, manganese, iron, arsenic, and chromium elevate the risk numbers above the site-specific action levels.

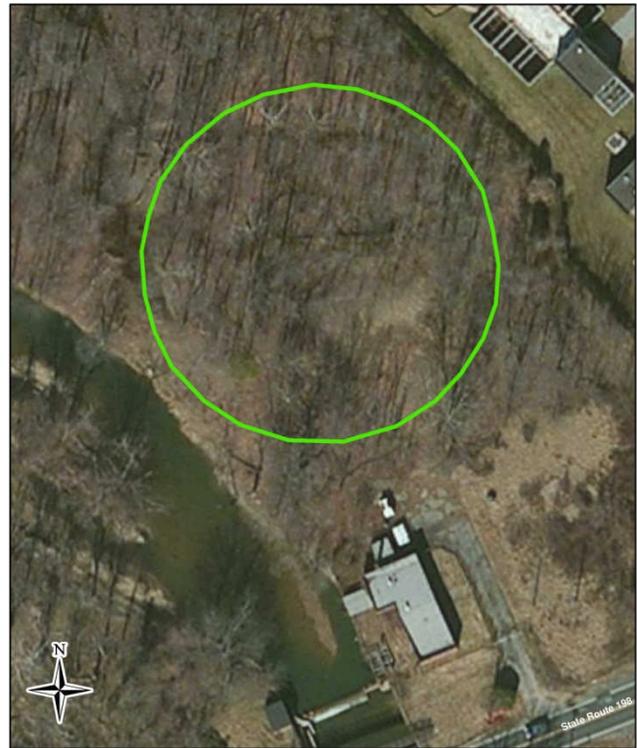
Possible Dump Site G - 1957
0 30 60 120 Feet

Site Description: Possible Dump Site G-1957 was identified as an AOI because the EPA (1996) study of the installation listed “possible dump” at this AOI during an analysis of a 1957 aerial photograph. In an analysis of a 1963 aerial photograph, the EPA labeled the AOI as a “re-vegetated dump site.”

Previous Studies: A geophysical investigation of Possible Dump Site G - 1957 provided little evidence that the AOI contains metallic or conductive buried waste. There is little geophysical evidence to suggest that this AOI is a former dump or landfill (Versar, 2004).

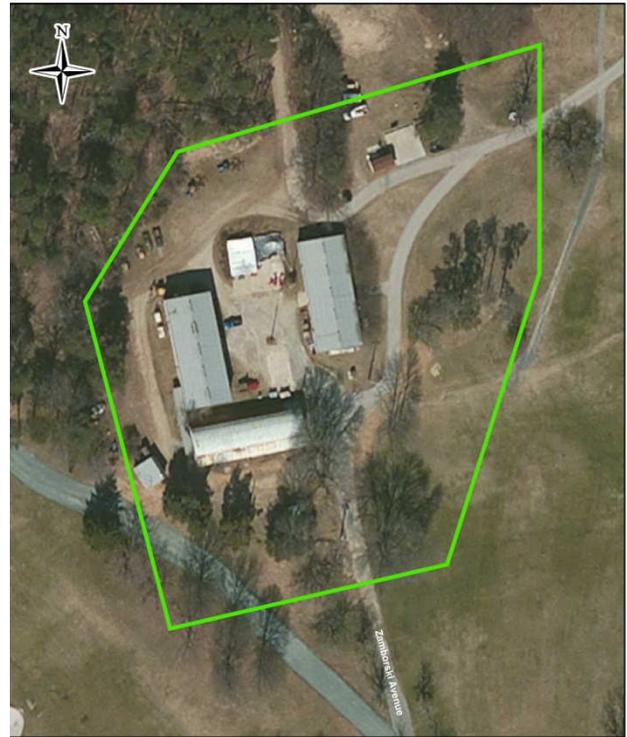
Site M - Parcel 3
0 40 80 160 Feet

Buildings 8870 (SWMU 134) and 8890A (SWMU 136) are used for storage. Building 8890 (SWMU 135) is a mechanic shop and storage area. Building 8891 (SWMU 137) is a storage building/maintenance area. Building 8881 is a storage/maintenance building. Building 21 is a metal storage locker that is used to store hazardous waste awaiting disposal. There is also a storage shed/rollaway (no building number) located north of Building 8890 that is used to store old tires and a lawnmower. Four ASTs and 1 UST were associated with the maintenance buildings.

Previous Studies: Over the course of previous investigations at this site, 8 surface soil samples, 35 subsurface soil samples, and 10 groundwater samples were collected and analyzed. Based on a risk analysis of the analytical results, arsenic, benzo(a)pyrene, mercury, heptachlor epoxide, and 1,1,2,2, tetrachloroethane elevate the risk numbers above the site-specific action levels.

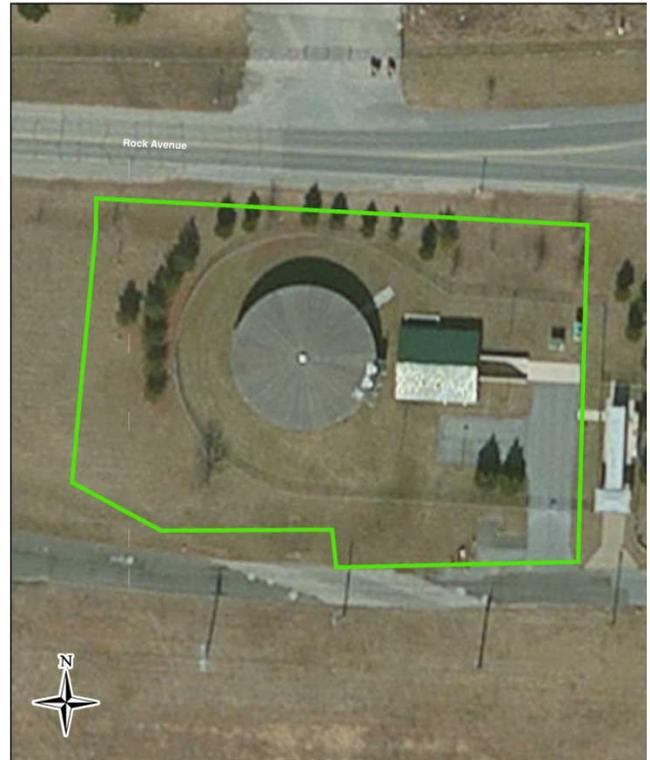
Pre-WWII Laundry - USAOC
0 25 50 100 Feet

Previous Studies: Two Geoprobe™ borings (DPT/GW9 and DPT/GW10) were advanced near this site in 2007. Soil and groundwater grab samples were collected. Arsenic was detected in surface and subsurface samples at concentrations above industrial and residential RSLs, but below background concentrations for Fort Meade. Iron, lead, vanadium, and zinc were detected in water samples collected from DPT/GW9 at concentrations above RSLs for tap water. In 2010, 2 closely spaced wells (MW-102s and MW-101d) were installed just east of the site. Monitoring wells MW-102s and MW-101d were sampled in 2010 and volatile organics, most notably tetrachloroethene, were detected at 3.82 µg/L and 139 µg/L, respectively.

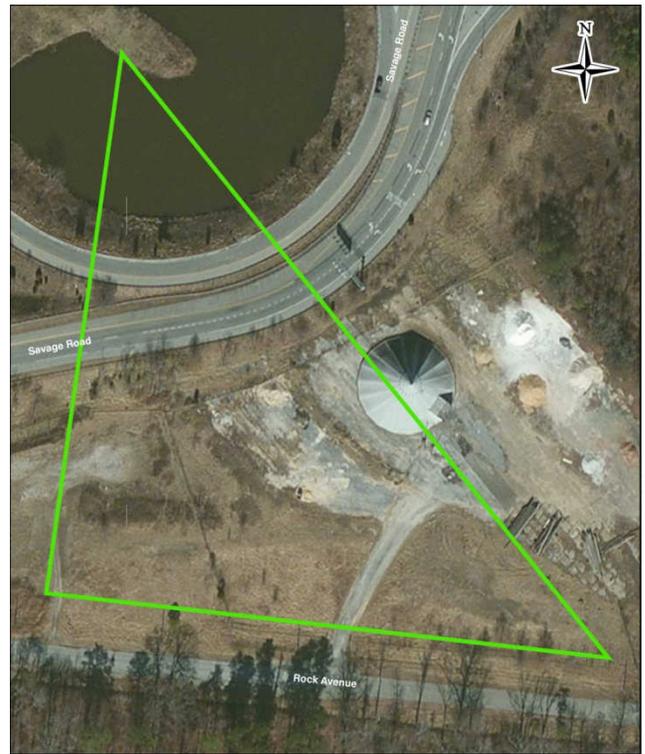
WASTE STORAGE / DISPOSAL AREA- 1938
0 50 100 200 Feet

Previous Studies: The EPA (1996) aerial photographic study of the installation identified a “Possible Dump or Waste Storage” area approximately 1,000 feet west of this AOI in the 1938 aerial. That site is being further studied under OU-4 as FGGM 88. In 1943, a building and vehicles are observed at the AOI. The building number or past use is not known. The description for the 1952 aerial photograph states “*This possible waste storage/disposal site has changed since 1943. It is now being used to store stockpiled raw materials. No evidence of waste material exists.*” The outline of the eastern area appears on the 1963 aerial but there is no discussion of this area in the text of the EPA (1996) report. A possible ground scar can be seen in the 1970 aerial; however the EPA (1996) study does not address it. The description for the 1975 aerial photograph states “*almost all of the raw materials previously stored at this site are removed.*”

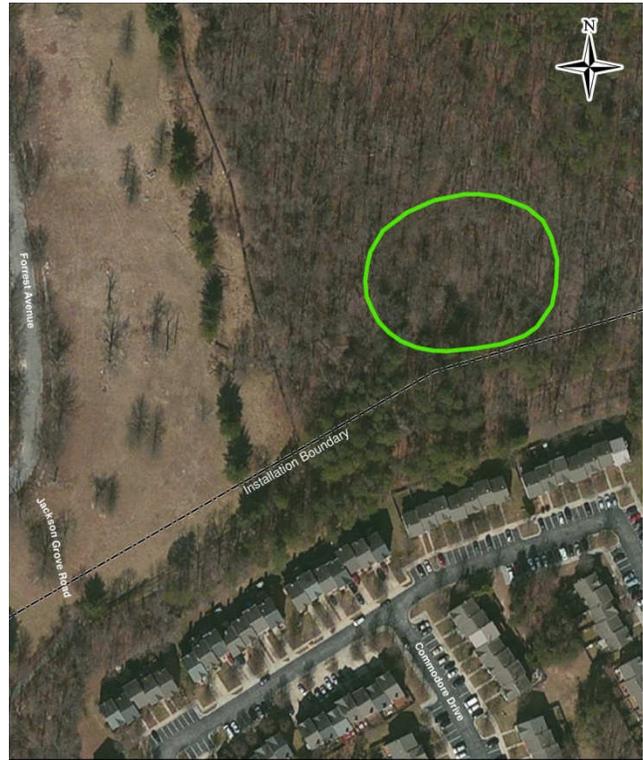
FGGM 95 - Small Pit - 1952
 0 60 120 240 Feet

Previous Studies: No previous sampling was undertaken. This area was extensively walked as part of a PA/SI (URS Group, Inc., 2007d), and no signs of pits or stressed vegetation were identified. The EPA (1996) study did not identify stained soils or stressed vegetation in this area.

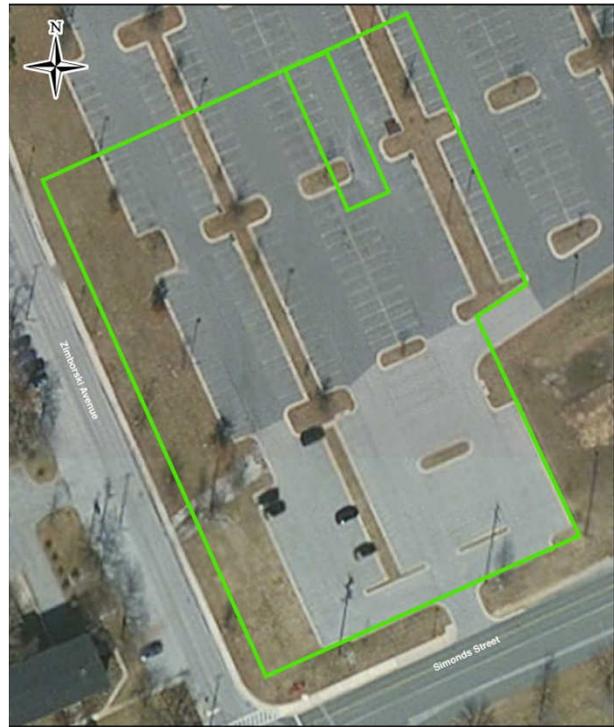
MP-3 and WR-2
0 30 60 120 Feet

Site Description: MP-3/WR-2 was identified as an AOI because the circa 1952 land use map (Anon., 1952) listed them in the southern portion of the Installation. The EPA (1996) report shows a vehicle service and storage area at this location on the 1963, 1970, 1975, and 1988 aerial photographs. The write-up for the 1995 aerial photograph specifically states “Former Vehicle Service and Storage Area” for this location. The EPA study did not report any environmental conditions for this location. There are no recent or historical indications of releases or contamination at this AOI. Also, there is no evidence of scarring, staining, or disturbance in any of the historic aerial photographs. This site may have been used as a parking lot (motor pool) and for washing cars (wash rack) for a limited time period. The potential for contamination in this area is minimal. It is unknown if vehicles were serviced at any of the former buildings at this AOI. All buildings have been removed and the soils have been excavated and graded.

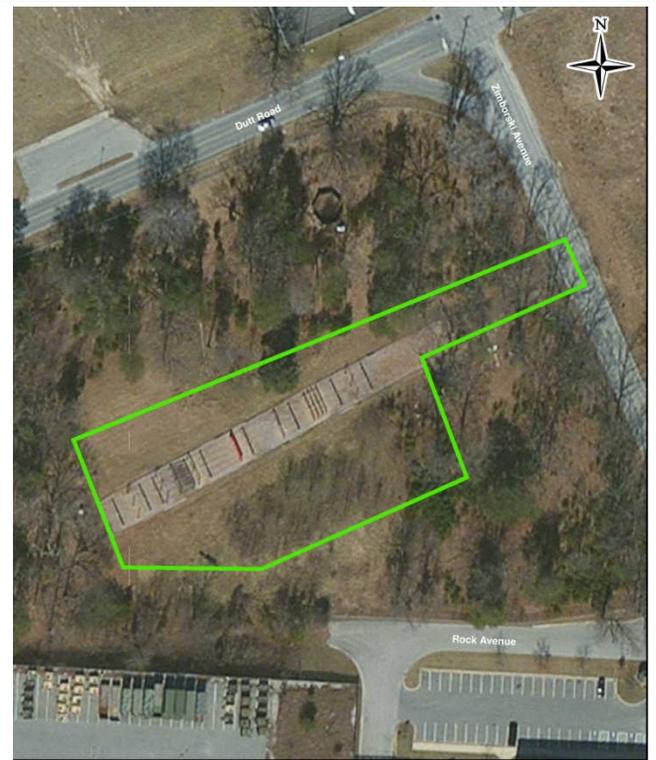
MP-4
0 40 80 160
Feet

Site Description: MP-4 was identified as an AOI because the circa 1952 land use map (Anon., 1952) listed it in the southern portion of the installation. The EPA (1996) study shows a vehicle service and storage area at this location on the 1943 and 1947 aerial photographs. Potential environmental concerns (i.e., stained soil or stressed vegetation) were not cited for this location in the EPA (1996) report.

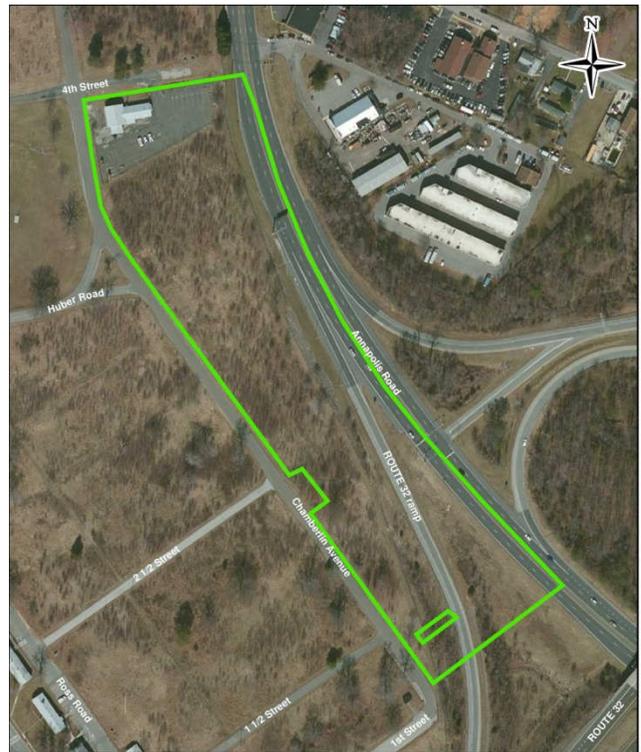
MP-7 and WR-6
 0 100 200 400 Feet

Previous Studies: Over the course of previous investigations at this AOI, 5 subsurface soil and 3 groundwater samples were collected and submitted for laboratory analysis. Based on a risk analysis of the analytical results, arsenic, iron, vanadium, and chromium elevate the risk numbers above the site-specific action levels.
