Re: Final Amended 2012 Site Management Plan, Fort George G. Meade
Docket Number: CERC-03-2009-0207FF

**SITE MANAGEMENT PLAN
2012 ANNUAL UPDATE
FORT GEORGE G. MEADE, MD**

URS Group, Inc.
12420 Milestone Center Drive, Suite 150
Germantown, MD 20876
Project no. 15302269

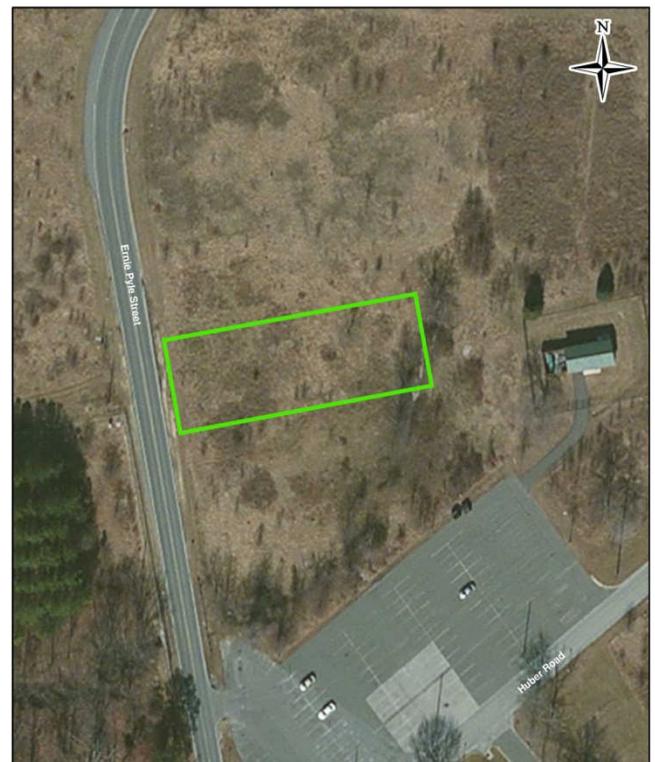
MP-8
0 40 80 160 Feet

Site Description: MP-8 was identified as an AOI because the circa 1952 land use map (Anon., 1952) listed it in the southeastern portion of the Installation. The EPA (1996) study shows a vehicle service and storage area at this location on aerial photographs from 1943, 1952, and 1957. This area is not covered in the 1947 aerial photograph. The 1952 land use map (Anon., 1952) identifies MP-8 in the southwestern portion of the AOI outlined in the EPA study (1996).

Previous Studies: No previous sampling was undertaken. The EPA (1996) study did not identify stained soils or stressed vegetation at this location.

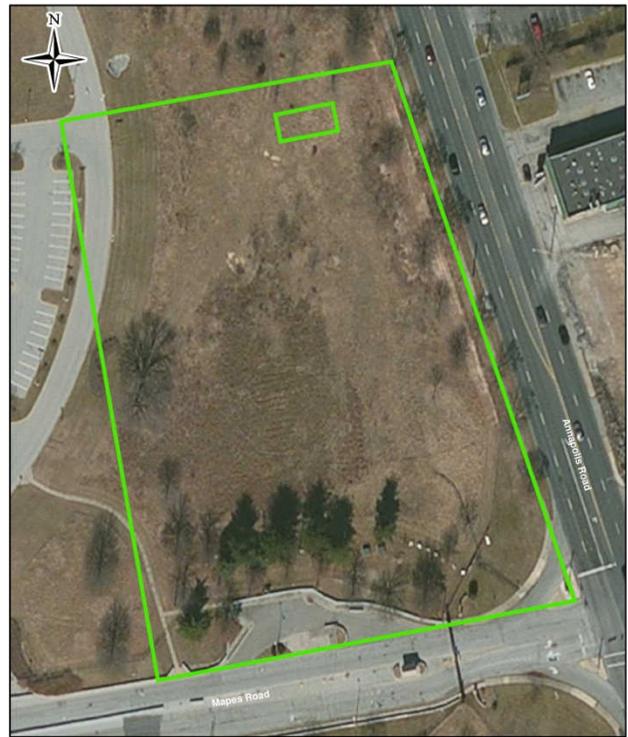
MP-11 and WR-7
0 40 80 160 Feet

Site Description: MP-11/WR-7 was identified as an AOI because the circa 1952 land use map (Anon., 1952) listed them in the eastern portion of the Installation. This AOI is also identified in the EPA (1996) study, which shows a vehicle service and storage area at this location in the 1947 and 1952 aerial photographs. Ground staining is visible at three locations and standing liquid is noted at one location on the 1947 aerial photograph (EPA, 1996). The standing liquid was not discolored or stained. No staining is visible in the 1952 aerial photograph. A smaller area at this location is shown as a vehicle service and storage area in the 1963, 1970, and 1975 aerial photographs.

Current Status: A PA/SI is underway with a recommendation to sample soil and groundwater in the areas of past staining. Four soil and 4 groundwater samples (from 4 new groundwater monitoring wells) should be collected and analyzed for VOCs, SVOCs, metals, TPH-DRO and TPH-GRO.

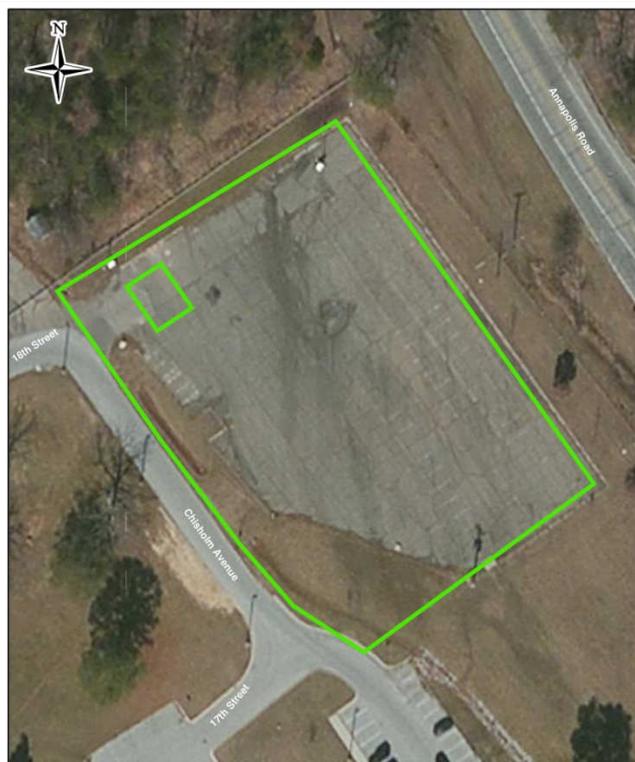
MP-13 and WR-9
0 30 60 120 Feet

Site Description: MP-13/WR-9 was identified as an AOI because the circa 1952 land use map (Anon., 1952) listed them in the north-eastern portion of the installation. This AOI is also identified in the EPA 1996 historic aerial photograph study of the installation which shows a vehicle service and storage area at this location on the 1943, 1947, 1957, 1963, 1970, and 1988 aerial photographs. Staining is visible in the northwest portion of this AOI in the 1963 and 1970 aerial photographs (EPA, 1996).

Current Status: A PA/SI is underway with a recommendation to sample soil and groundwater in the area of past staining. One soil and 1 groundwater sample (from 1 new groundwater monitoring well) should be collected and analyzed for VOCs, SVOCs, metals, TPH-DRO and TPH-GRO.

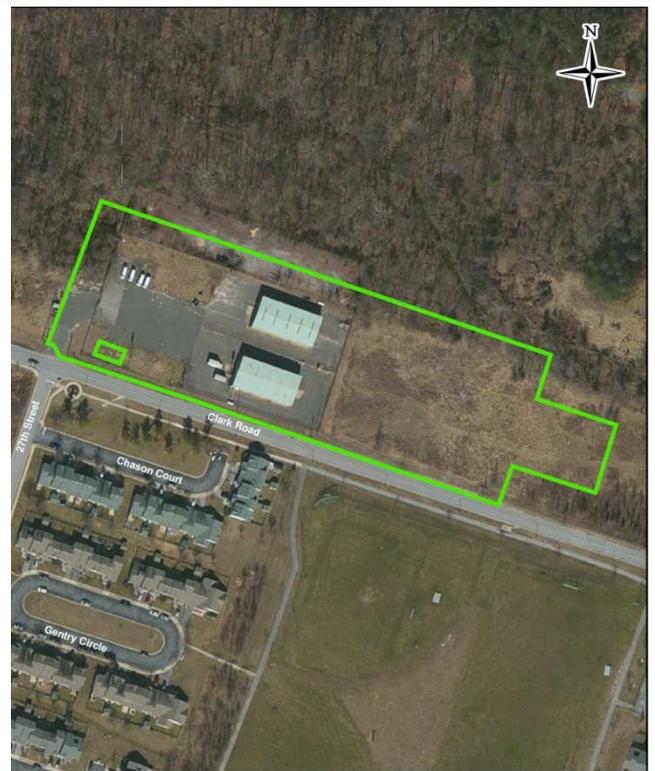
MP-19 and WR-13
0 75 150 300 Feet

Previous Studies: The EPA (1996) study identified a stain in the southwest portion of the AOI, stressed vegetation directly to the north, and a runoff pattern off the northwest corner of the vehicle service and storage area on the 1957 aerial photograph. Over the course of previous investigations at this AOI, 6 surface soil samples (plus 1 duplicate sample), 6 subsurface soil samples, and 3 groundwater samples were collected and submitted for laboratory analysis. Based on a risk analysis of the analytical results, arsenic and chromium elevate the risk numbers above the site-specific action levels.

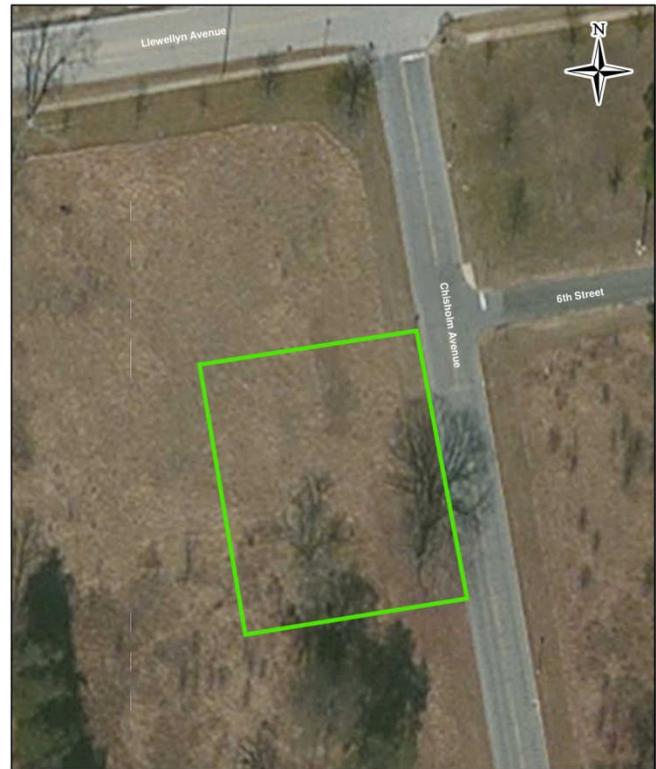
Chisholm Avenue and 6th Street
0 25 50 100 Feet

The U.S. Army Public Health Command (2010) report recommends the installation of 2 additional temporary monitoring wells. One temporary monitoring well should be installed to the east of former temporary monitoring well 6TH-TWP-1. The second monitoring well should be installed to the northwest of former temporary monitoring well 6TH-TWP-1. The additional monitoring wells will be used to determine the horizontal extent of petroleum affected groundwater.

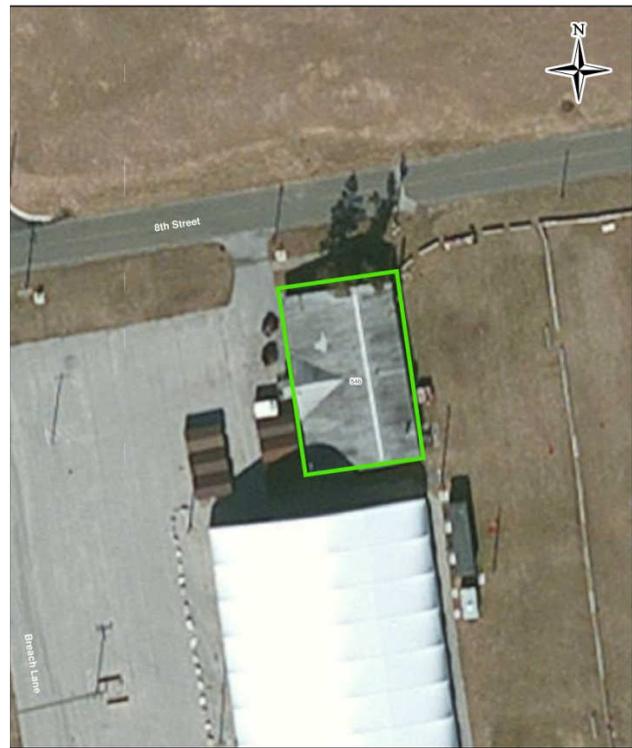
Building 546 - Photography Laboratory
 0 25 50 100 Feet

Site Description: Building 546 was identified as a SWMU because of routine discharge of water from a silver recovery unit (BCM, 1996). The discharge point was the Fort Meade sanitary sewer system. There were no spills or reported releases identified during the SWMU study (BCM, 1996). Prior to 1985, the building was used as a visual information training center, and since 1985 it has been used as a full service photographic laboratory, offices, and graphic arts department.

Previous Studies: Over the course of previous investigations at this AOI, 12 subsurface soil samples (plus 1 duplicate subsurface soil sample) and 12 groundwater samples (plus 1 duplicate groundwater sample) were collected and submitted for laboratory analysis. Based on a risk analysis of the analytical results, arsenic, copper, mercury, and chromium elevate the risk numbers above the site-specific action levels.

Current Status: A PA/SI is underway with a recommendation to install 3 groundwater monitoring wells and analyze groundwater samples for SVOCs and metals.

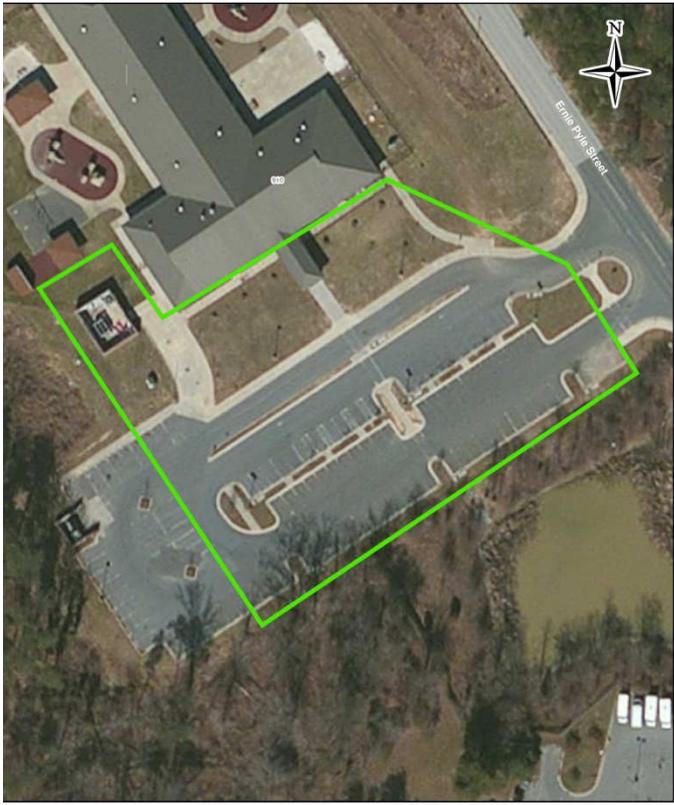
Building 940 - Motor Pool, Wash Rack and Oil/Water Separator

Site Description: Former Building 940 (SWMU 146) was identified as a potential past SWMU in the 1996 SWMU study (BCM, 1996) because it was formerly used as a MP and the exact management of waste from the MP is unknown. The associated former WR (SWMU 13) and OWS (SWMU 12) were identified as potential SWMUs because there was systematic discharge of wash water to the OWS from the WR (BCM, 1996). There were no spills or reported releases identified during the SWMU study (BCM, 1996). Building 940 was vacant for a period of time and was demolished in 1999. The OWS and WR were also removed in 1999.

Previous Studies: Over the course of previous investigations at this AOI, 4 surface soil samples (plus 1 duplicate surface soil sample), 14 subsurface soil samples (plus 1 duplicate subsurface soil sample), and 6 groundwater samples (plus 2 duplicate groundwater samples) were collected and submitted for laboratory analysis. Based on a risk analysis of the analytical results, arsenic, cobalt, iron, aluminum, manganese, and chromium elevate the risk numbers above the site-specific action levels.

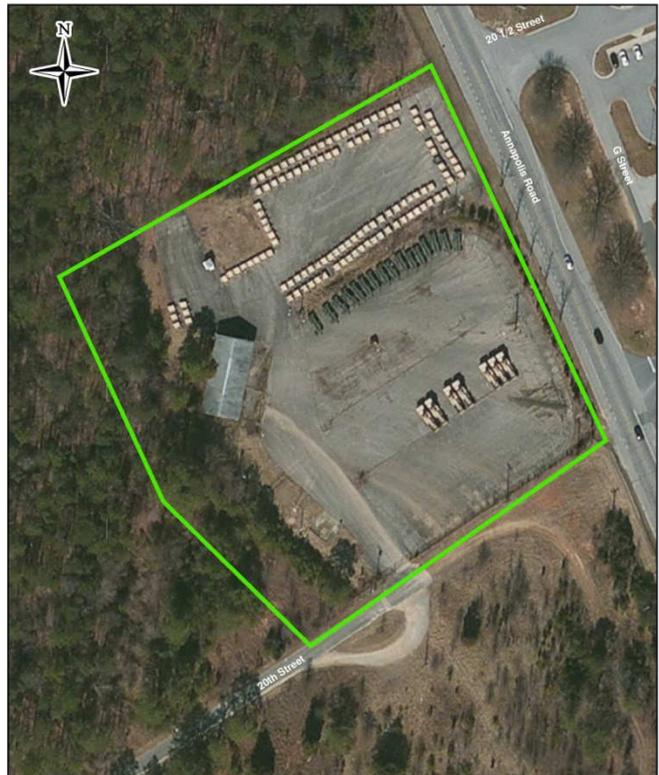
Building 1007 - Army Reserves Motor Pool
0 50 100 200 Feet

Site Description: This AOI is comprised of Building 1007 (SWMUs 14 and 15), OWS (SWMU 16), Vehicle WR (SWMU 17), and Pump station (SWMU 18). Since its construction in 1941, Building 1007 has had a variety of uses including equipment and vehicle storage, motor repair, and shipping of equipment. The shop used petroleum products, solvents, paints, and cleaning materials. Military vehicles were stored at the AOI by the U.S. Army Reserves.

The vehicle WR, OWS, and pump station were used to wash vehicles, collect the discharge water into the OWS and then pump it into the sanitary sewer until it was demolished and removed from service in 1999/2000.

Previous Studies: During previous sampling at this AOI, 1 surface soil sample (plus 1 duplicate surface soil sample), 17 subsurface soil samples (plus 1 duplicate subsurface soil sample), and 5 groundwater samples were collected and analyzed. Based on a risk analysis of the analytical results, arsenic, naphthalene, 1,2,4-trimethylbenzene, 1,1,2,2-tetrachloroethane, and chromium elevate the risk numbers above the site-specific action levels. Benzene and lead were detected above their MCLs.

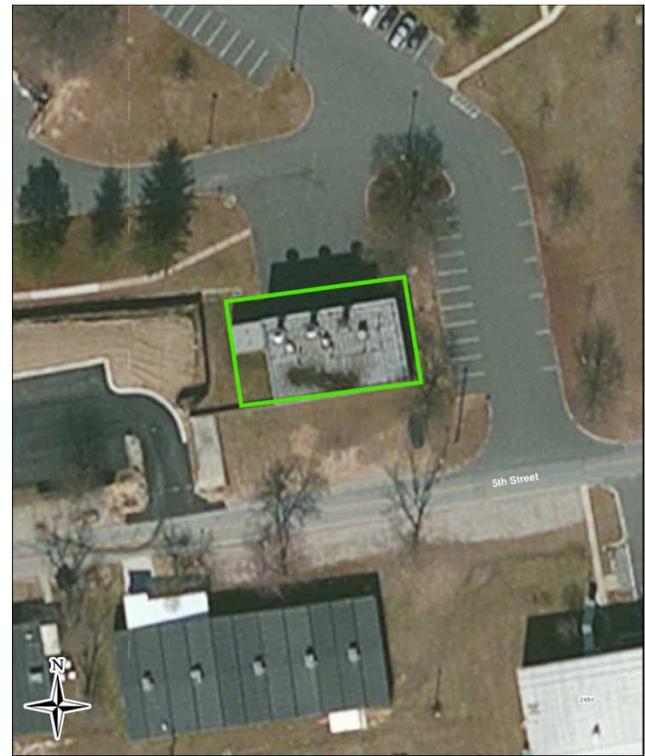
Building 2482 - Used Oil Recycling Tank at Hospital Boiler Plant
0 30 60 120 Feet

Site Description: Building 2482 was formerly used as a boiler plant to provide steam to Kimbrough Army Community Hospital. The plant contains three oil-fired boilers. A 400-gallon AST located in the parking lot on the north side of the building stored used oil collected throughout the installation for recycling. Chemicals for boiler water treatment, including neutralizing solutions, phenolphthalein, hardness solution, iodine, sodium sulfate, phosphates, and caustic soda, were stored in the boiler room. Two 20,000-gallon fuel oil steel USTs were removed from the south side of the building in January 2001. An 8,000-gallon fuel oil fiberglass-reinforced plastic UST was abandoned in place on the northeast corner of the building.

Previous Studies: Over the course of previous investigations at this site, 10 surface soil samples, 14 subsurface soil samples, and 13 groundwater samples were collected and submitted for laboratory analysis. Based on a risk analysis of the analytical results, arsenic, benzo(a)pyrene, benzo(a)anthracene, iron, naphthalene, cobalt, aluminum and manganese elevate the risk numbers above the site-specific action levels.

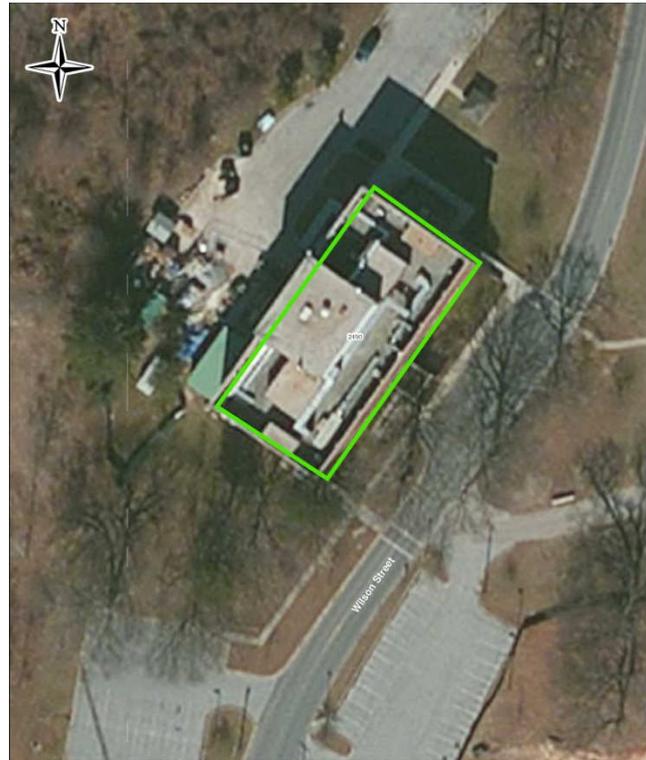
Building 2490 - Forensic Toxicology and Drug Testing Lab
0 25 50 100 Feet

Site Description: Building 2490 has been used as a medical laboratory since its construction in the late 1950s. The basement was used as a radioactive section of a clinical laboratory from 1960 to 1994. Chemicals used in the radioactive section include buffer solutions, alcohol, and WD-40. The radioactive materials are stored in a refrigerated room. Chemicals used in the lab include methanol, acid dichromate, 2-proponal, hexanes, and 2,2,4-trimethyl pentane. Chemicals which are being used are kept in the refrigerated room; otherwise, new chemicals are stored in flammable cabinets.

Previous Studies: Over the course of previous investigations at this site, nine surface soil samples, 21 subsurface soil samples, and nine groundwater samples were collected and submitted for laboratory analysis. Based on a risk analysis of the analytical results, arsenic, mercury, and chromium elevate the risk numbers above the site-specific action levels.

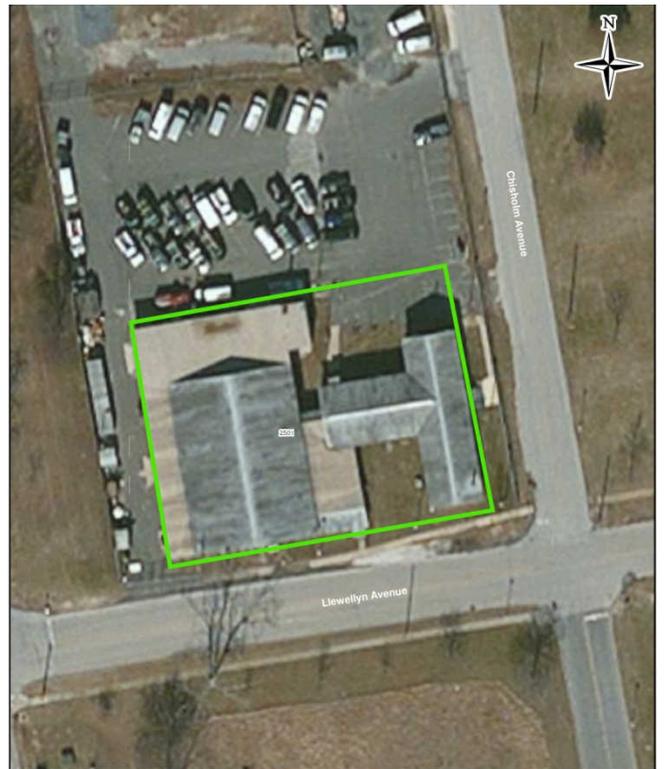
Building 2501 - Shipping and Receiving
 0 25 50 100 Feet

Previous Studies: Over the course of previous investigations at this site, 5 surface soil samples, 18 subsurface soil samples, and 1 groundwater sample were collected and submitted for analysis. Based on a risk analysis of the analytical results, arsenic elevates the risk numbers above the site-specific action levels. A sheen was observed at location SB-1.

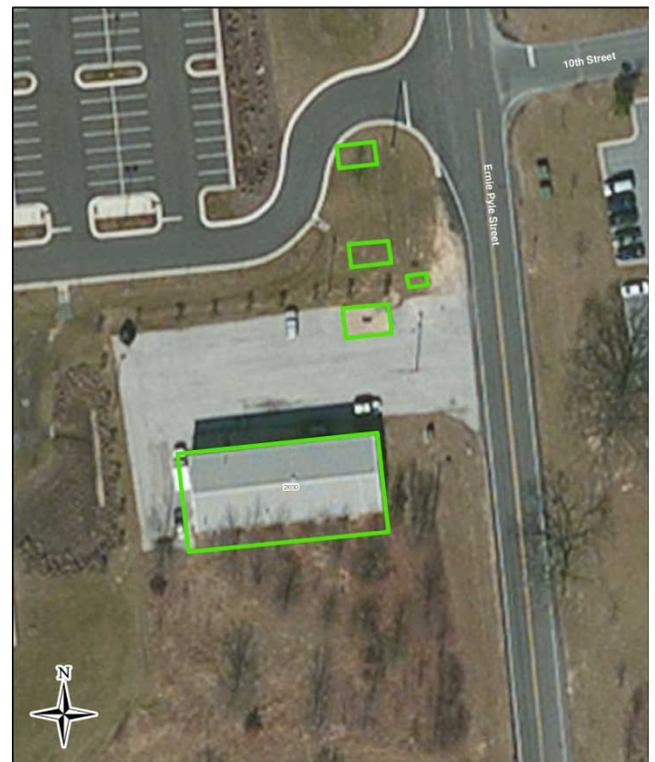
Building 2630 - Dispatch, Storage, and Parking Area for Emergency Medical Units Wash Rack
 0 25 50 100 Feet

Formerly two WRs, identified as SWMU 79, were in a former building north of Building 2630. Based on facility drawings, the former WR was constructed of a bermed concrete platform with a catch basin. It was removed sometime prior to 1999.

Previous Studies: Over the course of previous investigations at this site, 17 direct-push borings were completed; 4 surface soil, 17 subsurface soil, and 2 groundwater samples were collected and submitted for analysis. Based on a risk analysis of the analytical results, methylchlorophenoxypropionic acid (MCP) and arsenic elevate the risk numbers above the site-specific action levels.

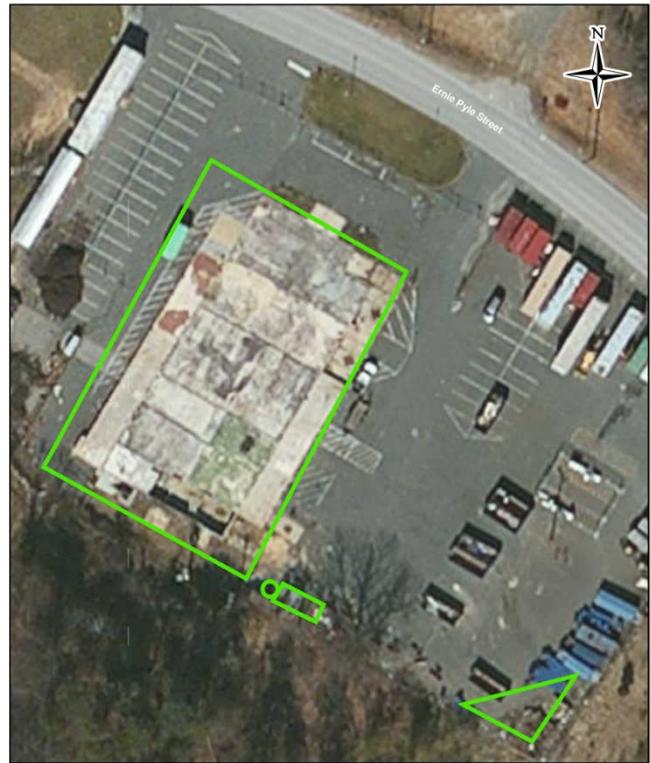
Building 3000 - Maintenance Shop
0 25 50 100 Feet

Previous Studies: Over the course of previous studies at this AOI, nine surface soil samples (plus 1 duplicate surface soil sample) and 11 subsurface soil samples were collected and submitted for laboratory analysis. Based on a risk analysis of the analytical results, the risk numbers are below site-specific action levels.

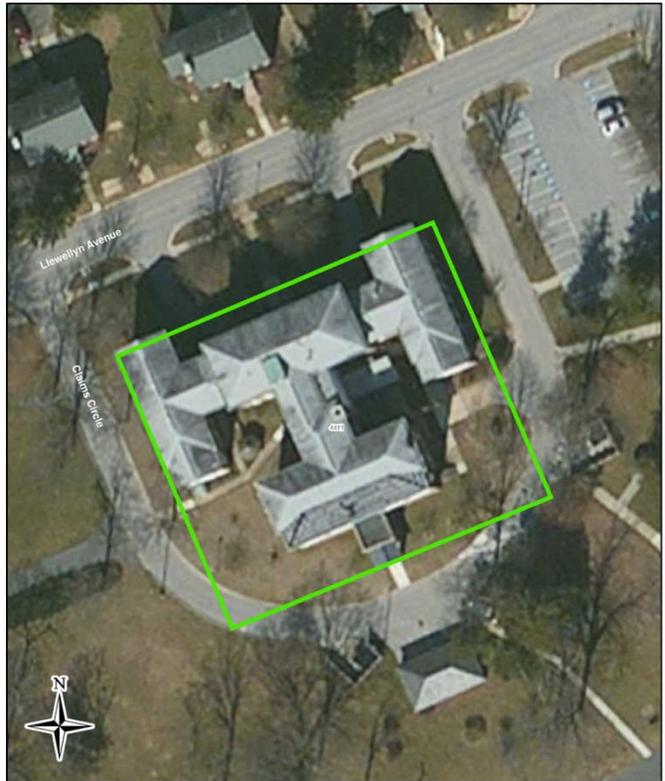
Building 4411
0 25 50 100 Feet

Site Description: Building 4411 was formerly used as a hospital from 1926 to 1974. A 1,000-gallon heating oil UST is located beneath the porch on the southern side of the building. The exact management of waste from the hospital is unknown.

Previous Studies: Over the course of previous investigations at this AOI, 16 direct push borings were advanced around Building 4411; 5 surface soil, 13 subsurface soil, and ten groundwater samples were collected and submitted for laboratory analysis. Based on a risk analysis of the analytical results, arsenic, mercury, and chromium elevate the risk numbers above the site-specific action levels.

Current Status: A PA/SI is underway with a recommendation to install 4 groundwater monitoring wells and analyze groundwater samples for SVOCs, TPH-DRO, TPH-GRO, and total metals.

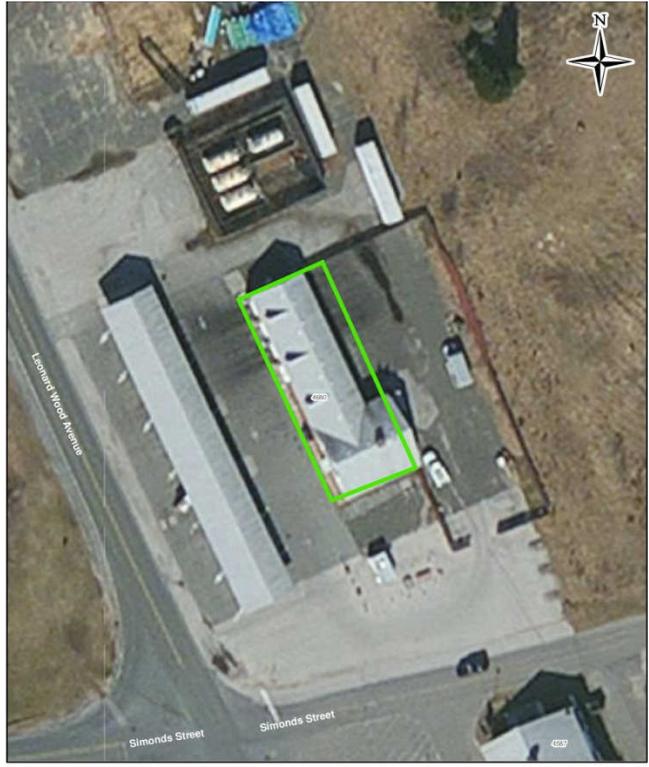
Building 4680 - Gas Station and Detailing Shop
 0 25 50 100 Feet

Site Description: Building 4680 was used as an auto-detailing shop and gas station with paved parking, gas pump islands, and an AST enclosure. The AST enclosure was a membrane-lined concrete structure which provided fuel to dispenser islands throughout the AOI. At the time of the SWMU study the AOI contained a 500-gallon used oil tank, an OWS, and a non-operable oil filter crusher. There were 12 active gasoline pumps associated with the gasoline service station. Since 1985, the USTs were removed and replaced with ASTs. Personnel at Building 4680 at the time of the SWMU study thought that several USTs that were removed had been leaking fuel oil.

Previous Studies: Over the course of previous investigations at this AOI, 4 surface soil samples, 23 subsurface soil samples, and 25 groundwater samples were collected and submitted for laboratory analysis. Based on a risk analysis of the analytical results, chromium, naphthalene, arsenic, acrolein, benzene, and 1,2,4-trimethylbenzene elevate the risk numbers above the site-specific action levels.

Current Use: Automotive detailing shop
Current Status: A PA/SI is underway with a recommendation to install 5 groundwater monitoring wells and analyze groundwater samples for VOCs, SVOCs, metals, and PCB. An additional well is planned to confirm the presence of acrolein at GW078.
Cleanup/Exit Strategy: Collect and analyze the chemical data. Based on the results, the AOI will either require NFA or be moved forward into the RI phase of CERCLA.

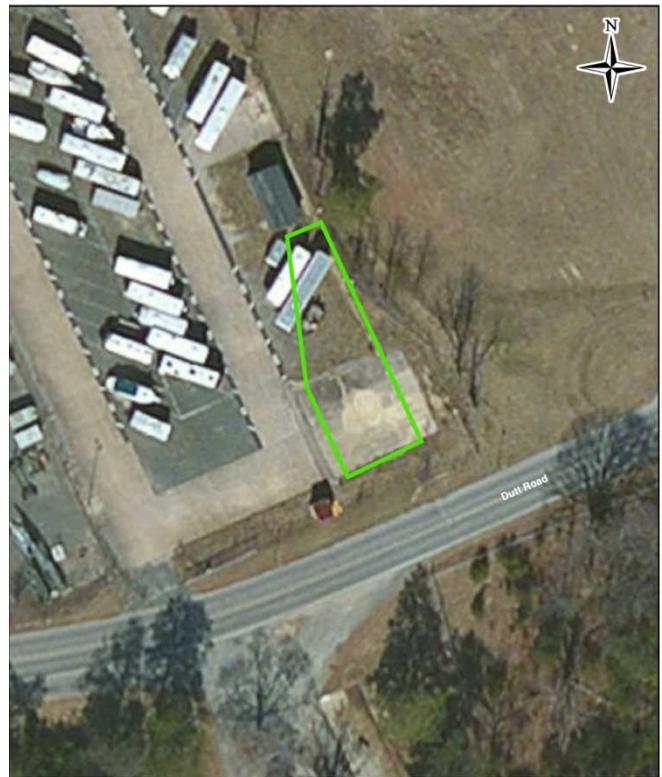
Building 8480 - Military Vehicle and Equipment Storage
 0 25 50 100
 Feet

Site Description: This AOI is comprised of a former wash rack (SWMU 111) which discharged wash water to an oil/water separator (SWMU 110), which in turn discharged to a sanitary sewer line south of the wash rack. The discharge water was treated at a wastewater treatment plant. This former wash rack and oil/water separator were located southeast of former Building 8480.

Previous Studies: Over the course of previous investigations at this AOI, 14 surface soil samples and 20 subsurface soil samples were collected and submitted for laboratory analysis. Based on a risk analysis of the analytical results, MCPP elevates the risk numbers above the site-specific action levels.

Current Status: A PA/SI is underway with a recommendation to collect 1 subsurface soil sample and analyze for herbicides.

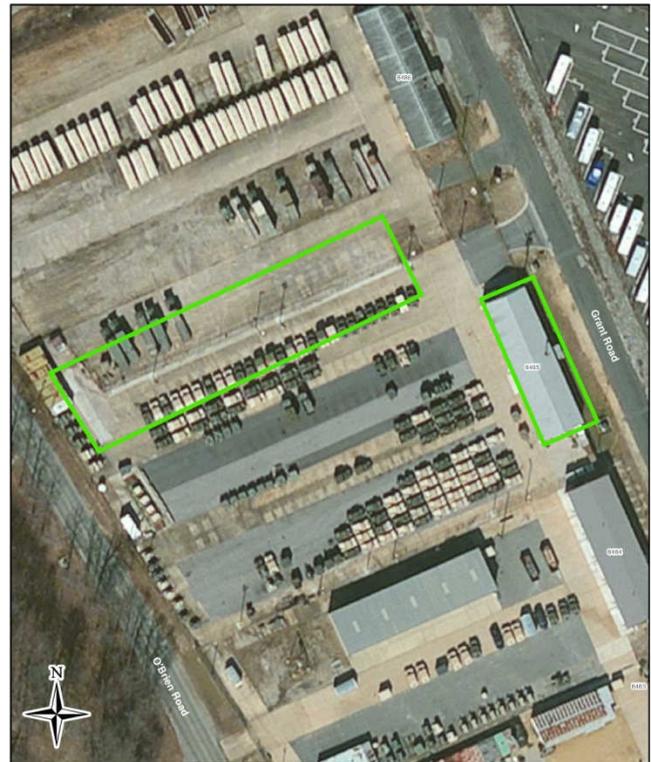
Building 8485 - Military Vehicle and Equipment Storage
0 40 80 160 Feet

A used oil AST was located on the north side of the building. A 2,000-gallon UST used to store No. 2 heating oil was formerly located on the eastern side of the building. It was removed and clean closed in 1989 and replaced by another 2,000-gallon heating oil UST that was removed and clean closed in 1999.

Over the course of previous investigations at this AOI, 5 surface soil samples, 35 subsurface soil samples (plus 3 duplicates), 23 groundwater samples (plus 5 duplicates) were collected and submitted for laboratory analysis. Based on a risk analysis of the analytical results, chromium, benzene, arsenic, naphthalene, 1,2,4-trimethylbenzene, ethylbenzene, iron, and toluene elevate the risk numbers above the site-specific action levels.

Current Status: A PA/SI is underway with a recommendation to collect 4 surface soil samples, install 13 additional groundwater monitoring wells, collect groundwater samples, and analyze both the soil and groundwater samples for VOCs, SVOCs, metals, and PCBs. In addition, the MDE OCP is requesting further analysis for LPH.

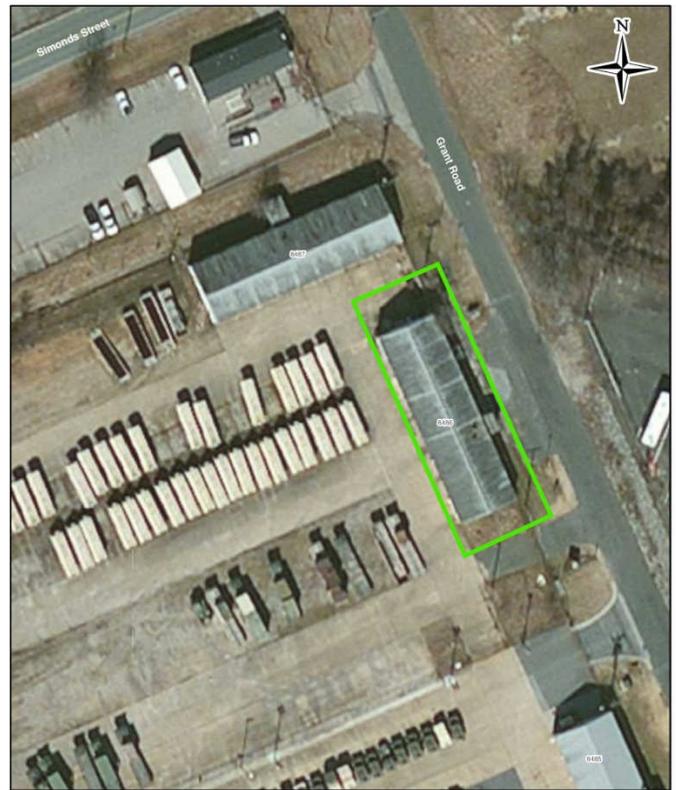
Building 8486 - Motor Pool
 0 30 60 120
 Feet

Site Description: Building 8486 (SWMUs 117 and 118) was constructed in 1950 and used as a military vehicle and equipment maintenance and repair shop.

Previous Studies: Over the course of previous investigations at this AOI, 19 subsurface soil samples and 19 groundwater samples were collected and submitted for laboratory analysis. Based on a risk analysis of the analytical results, 1,2,4-trimethylbenzene, arsenic, naphthalene, and chromium elevate the risk numbers above the site-specific action levels.

Current Status: A PA/SI is underway with a recommendation to install 5 groundwater monitoring wells and analyze groundwater samples for VOCs, SVOCs, total and dissolved metals, PCBs, TPH-DRO, and TPH-GRO. In addition, the MDE OCP is requesting further analysis for LPH.

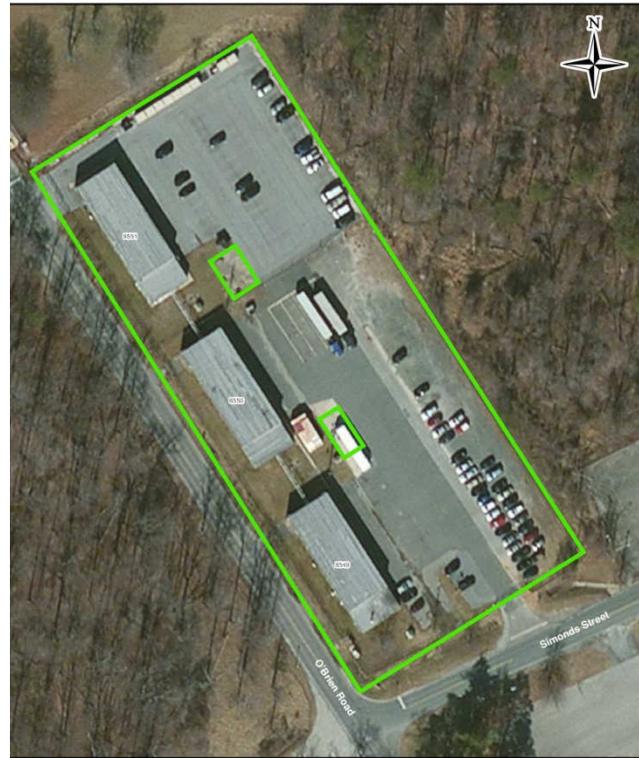
Buildings 8549 - 8550 - 8551
0 40 80 160 Feet

Building 8551 was used as a vehicle maintenance shop (SWMU 149). The wash rack (SWMU 128) and oil/water separator (SWMU 127) were identified as SWMUs because there was systematic discharge of wash water to the oil/water separator (BCM, 1996).

Previous Studies: Over the course of previous investigations at this AOI, 3 surface soil samples, 36 subsurface samples (plus 1 duplicate sample), and 29 groundwater samples (plus 1 duplicate sample) were collected and analyzed. Based on a risk analysis of the analytical results, benzo(a)pyrene, cadmium, lead, arsenic, and chromium elevate the risk numbers above the site-specific action levels.

Current Status: A PA/SI is underway with a recommendation to collect 3 surface soil samples and analyze for VOCs, SVOCs, metals, TPH-DRO, and TPH-GRO; collect 1 subsurface soil sample and analyze for SVOCs; install 6 groundwater monitoring wells, sample the wells and analyze the groundwater samples for VOCs, SVOCs, metals, TPH-DRO, TPH-GRO, cyanide, and PCBs.

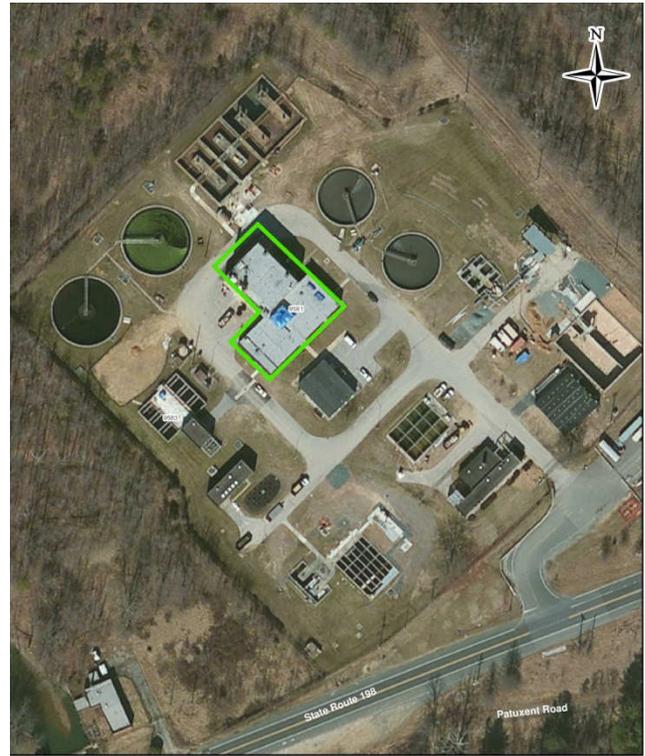
Building 9581 - Wastewater Treatment Plant
 0 60 120 240
 Feet

Site Description: Building 9581 is a sewage treatment facility that was constructed in the late 1970s or early 1980s. Building 9581 contains a 4,000-gallon hydrochloric acid AST, a lime silo, a 4,000-gallon steel UST containing heating oil that was abandoned in November 2000, a 10,000-gallon steel UST containing diesel fuel that was abandoned in 1990, and multiple open-top, below-ground wastewater treatment tanks.

Previous Studies: Over the course of previous investigations at this AOI, 1 surface soil sample, 22 subsurface soil samples, and nine groundwater samples were collected and submitted for laboratory analysis. Based on a risk analysis of the analytical results, arsenic and chromium elevate the risk numbers above the site-specific action levels.

Current Status: A PA/SI is underway with a recommendation to install 2 groundwater monitoring wells and analyze groundwater samples for VOCs, metals, and pH.

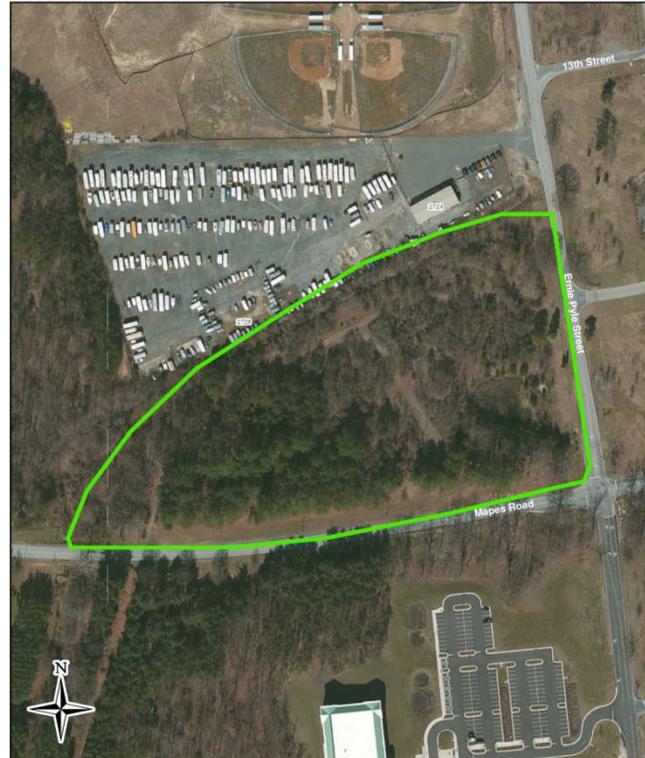
Possible Vehicle Service Area B -- 1943
0 100 200 400 Feet

Site Description: A possible vehicle service and staging area was identified at this location in a 1943 aerial photograph (EPA, 1996). The EPA (1996) study did not identify stained soils or stressed vegetation in this area in any of the historic aerial photographs. According to the 1952 land use map, Building 2722 was located on the eastern edge of this AOI and Building 2720 was located in the southern portion of the AOI. By 1988, most of this AOI is tree covered. There is little evidence to suggest that vehicles were serviced at this AOI; it was probably used as a parking lot.

Previous Studies: No previous sampling has been undertaken. The EPA (1996) study did not identify stained soils or stressed vegetation at this location.

Current Status: A PA/SI is underway with a recommendation to collect 3 surface soil samples, install 1 groundwater monitoring well, collect a groundwater sample, and analyze the soil and groundwater samples for VOCs, SVOCs, metals, TPH-DRO, and TPH-GRO.

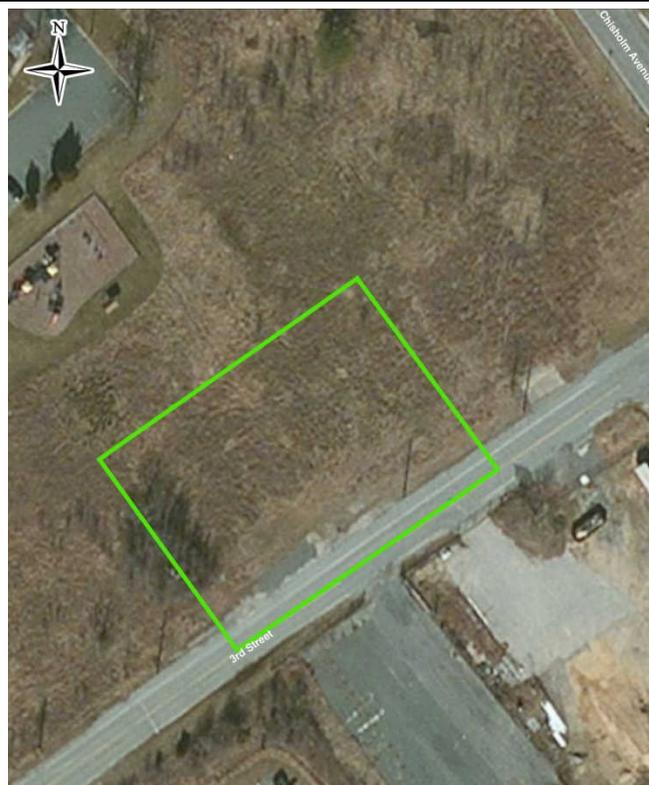
Stained Soils along 3rd Street
0 30 60 120 Feet

Site Description: Stained Soils Along 3rd Street is an AOI because on 9 March 2009, discolored soils with an unusual odor were encountered during trenching operations for a communications duct bank. The location is near former Building 2227, a former vehicle maintenance shop. Along a 30-foot section of the trench, there appeared to be areas of petroleum seepage from the trench wall at a depth of 3 feet. Approximately 160 feet of excavated soil was screened with a photoionization detector (PID).

Previous Studies: Over the course of previous investigations at this AOI, 8 subsurface soil samples (plus 1 duplicate sample) and 1 groundwater sample were collected and submitted for laboratory analysis. Based on a risk analysis of the analytical results, di(2-ethylhexyl) phthalate, iron, arsenic, chromium, and manganese elevate the risk numbers above the site-specific action levels. Di(2-ethylhexyl) phthalate was detected above its MCL.

Current Status: A PA/SI is underway with a recommendation to collect 3 surface soil samples to be analyzed for VOCs, SVOCs, and metals; install 3 groundwater monitoring wells, and collect and analyze groundwater samples for VOCs, SVOCs, and metals.

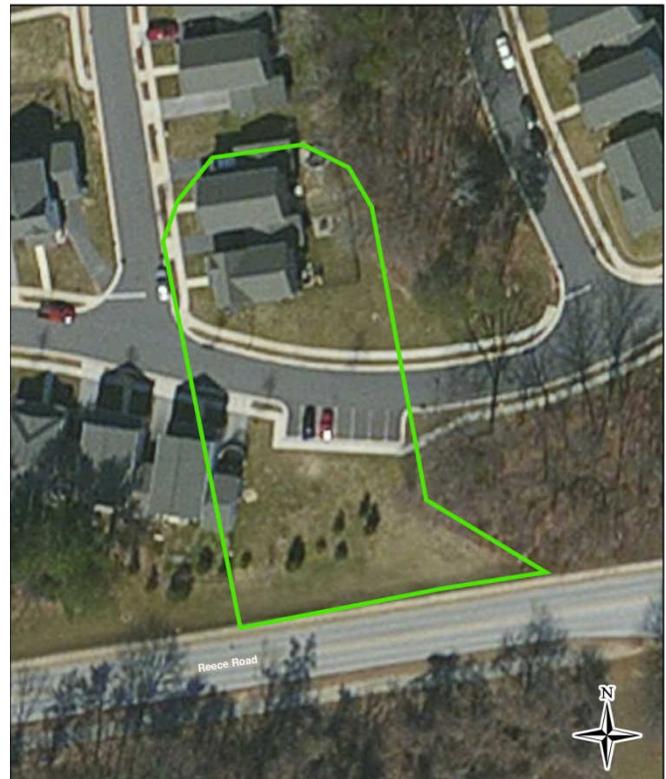
Former Incinerator Site
0 25 50 100 Feet

Map 4-6 of the Historical Records Review report (Malcolm Pirnie, 2006a) incorrectly locates the site northeast of Site M Parcel 9 at the end of Reece Road, west of Cooper Avenue. The EPA (1996) study of the installation did not identify this incinerator or stained soils or stressed vegetation in this area in any of the historic aerial photographs.

Previous Studies: Over the course of previous investigations at this AOI, 3 surface soil and 12 subsurface soil samples were collected and submitted for laboratory analysis. Based on a risk analysis of the analytical results, the risk numbers are below site-specific action levels.

Current Status: A PA/SI is underway with a recommendation to collect 6 surface soil samples to be analyzed for dioxins, furans, and metals.

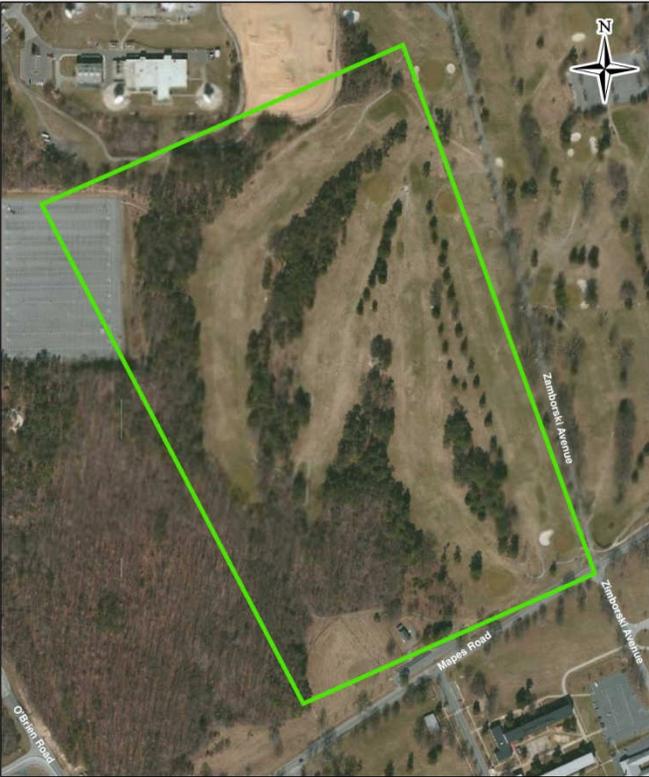
<p>FGGM-003-R-01 - Mortar Range</p> <p>0 175 350 700 Feet</p> <p>Current Use: A secure DoD facility is currently under construction on the MRS.</p> <p>Current Status: The qualitative risk evaluation performed revealed a low probability for human receptors to encounter MEC on the MRS. The low probability result of this evaluation is compatible with current and determined or reasonably anticipated future use.</p> <p>Cleanup/Exit Strategy: An FFS has been developed that evaluates no action, LUCs, and full clearance. A PP has been developed and recommends LUCs as the preferred alternative.</p>

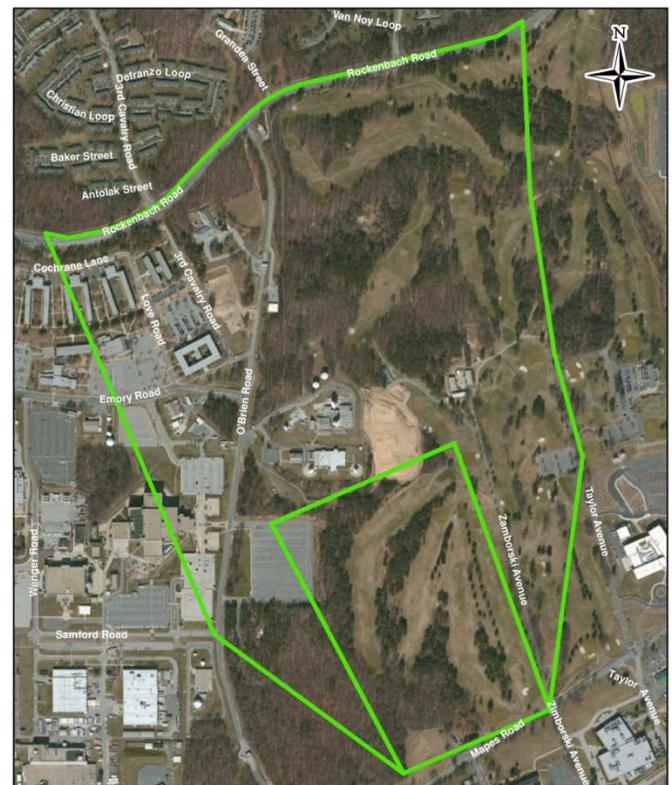
FGGM-003-R-02 - Training Area
 0 350 700 1,400
 Feet

Site Description: This AOI consists of the 260-acre Training Area MRS where five munitions debris items were found, including practice grenades, an expended flare, and a small arms ammunition casings disposal pit. The practice grenades and expended flare are indicative of general troop training, and the small arms ammunition casing disposal pit is indicative of disposal.

Previous Studies: Over the course of previous investigations at this site approximately 20 soil and 6 groundwater samples were collected in the Training Area MRS and analyzed for selected metals and explosives. NFA for MC was recommended.

Cleanup/Exit Strategy: An FFS has been developed that evaluates no action, LUCs, and full clearance. A PP has been developed and recommends LUCs as the preferred alternative.

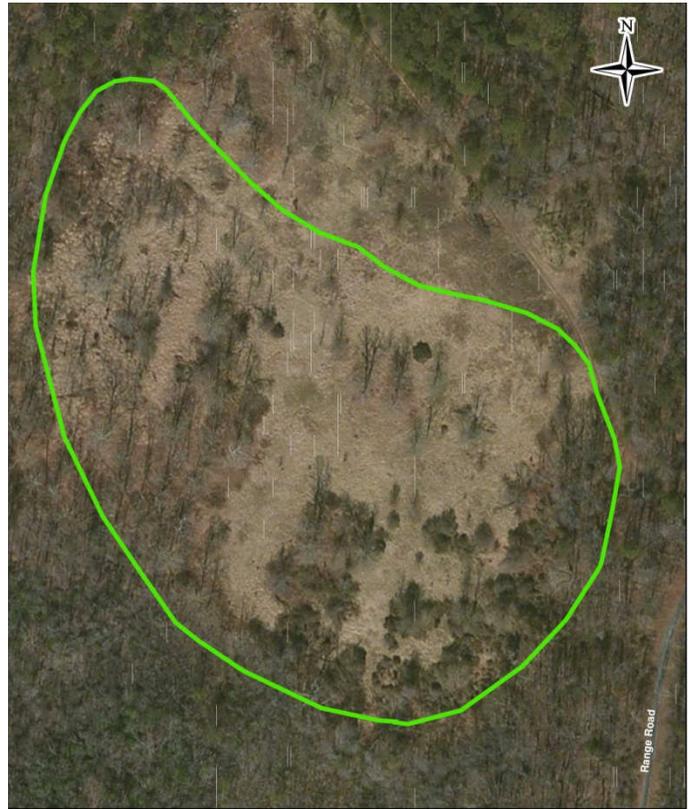
FGM 81 - Clean Fill Dump
0 60 120 240 Feet

Previous Studies: Previous studies have resulted in a ROD and LTMP with 5-year reviews.

Current Status: The ROD (U.S. Army, 2000b) identified the selected remedial alternative for the CFD OU (U.S. Army, 2000a) as “NFA with monitoring.” The Lower Patapsco aquifer is monitored on an annual basis. The ROD incorporates the 2000 *Action Memorandum Safety Precautions to be taken at Clean Fill Dump*, which includes provisions for residential use restrictions, groundwater use limitations, and UXO issues (Army, 2000b). MEC LUCs for the Military Munitions Response Program (MMRP) portion of the CFD will be addressed under the LUC RD for the HEI Area (FGM 002-R-01).

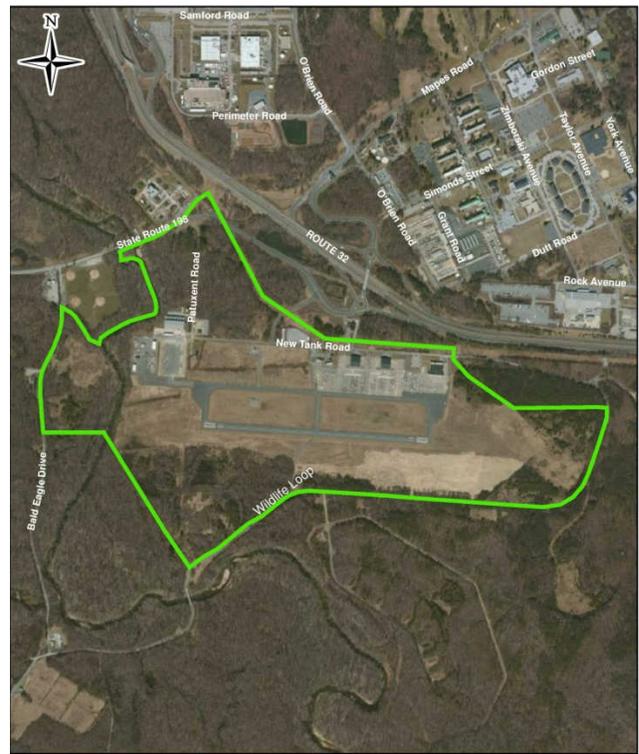
FGM 85 - UXO Tipton Army Airfield
 0 600 1,200 2,400 Feet

Previous Studies: Over the course of previous investigations at this site, an earthen MEC safety cap was installed over IAL1, a fence is installed and maintained around IAL2, and surface sweeps for MEC have been conducted in IAL3.

Current Status: Annual inspections of the earthen cap and annual sweeps of a portion of the Little Patuxent River are conducted. 5-year reviews are conducted, as well as LTM inspections of IAL1 and IAL2, and MEC sweeps of the Little Patuxent River and IAL3. The TAP Revised Draft Final Explanation of Significant Difference (ESD) will be submitted in October 2012. The Army will submit a TAP LUC RD in November 2012 to better implement, maintain, and enforce the MEC LUCs and incorporate them into the CERCLA process.

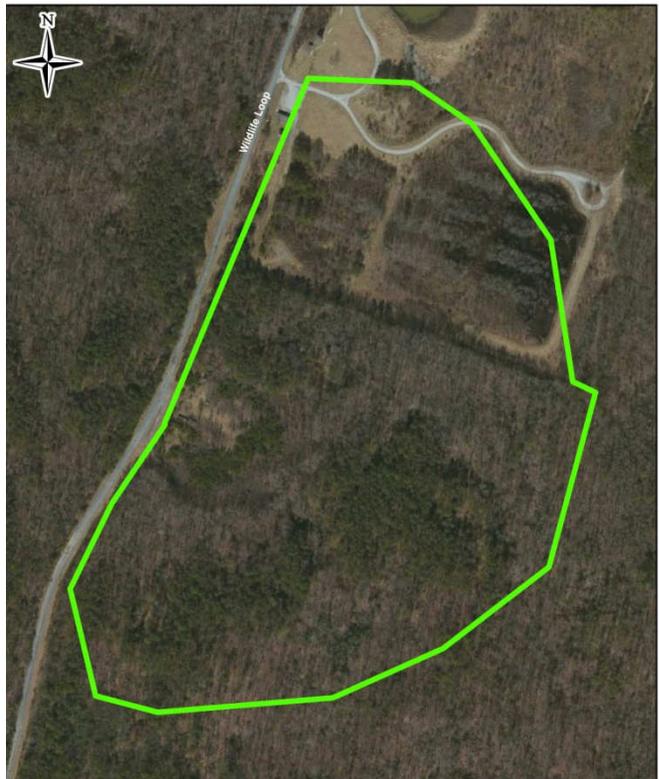
FGGM 94 - Trap and Skeet Range 17
0 150 300 600 Feet

Site Description: This AOI is comprised of the remnants of trap and skeet ranges. The skeet range was present as early as 1965, and the trap range was present as early as 1984. Features that were present include a high house, low house, cement walkways, and a rather heavily forested area.

Previous Studies: Over the course of previous investigations at this site: 74 XRF samples for Pb, As, Cu, and 10 lead shot samples were collected for analysis during the 2004 HHRA/ERA study. 237 samples were collected for Fe, As, Pb and Cu and 110 lead shot samples were collected for analysis for the 2011 draft RI/FS.

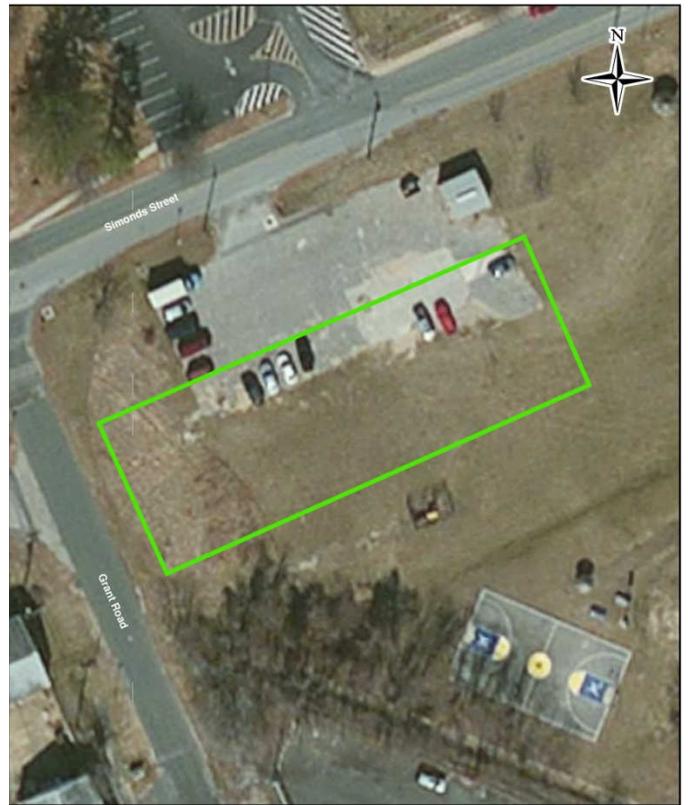
FGGM 05 - Troop Boiler Plant
0 25 50 100
Feet

In 1991, a 1,500-gallon waste oil UST and a 20,000-gallon No. 2 fuel oil tank failed precision testing. The tanks were excavated and it was determined that they had been leaking for several years.

Previous Studies: Over the course of previous investigations at this site, 29 MWs were installed, a recovery system to remove floating and dissolved product was installed and operated from 1993 to 1997, and a solar-powered oil removal skimmer system was operated from 2001 to 2003. Groundwater sampling from 8 wells occurred in March, April, August, and October 2008, and four BioSok® booms were inserted into MWs.

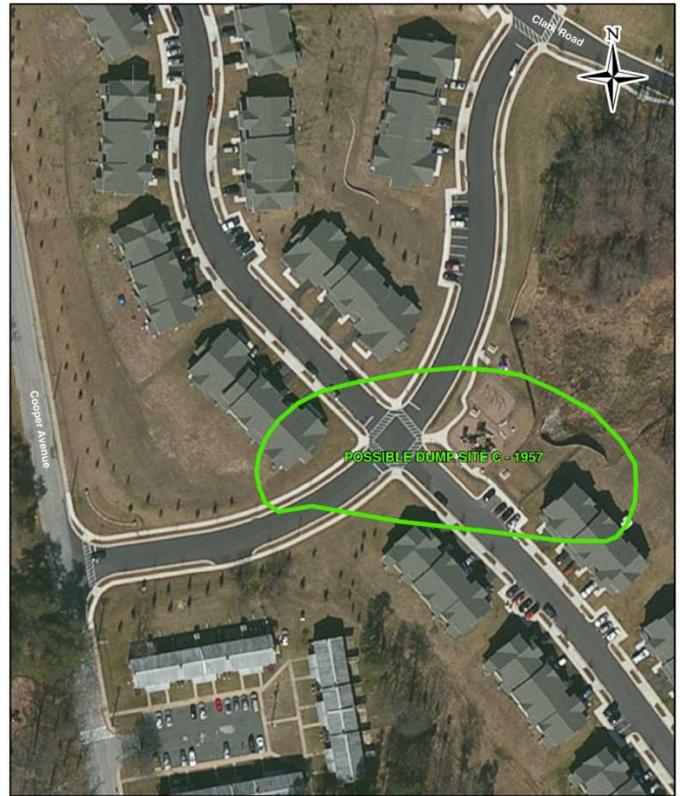
Possible Dump Site C - 1957
0 50 100 200
Feet

Site Description: Possible Dump Site C - 1957 was identified as an AOI because the EPA (1996) historic aerial photographic study of the installation listed “possible solid waste” at this location during an analysis of a 1957 aerial photograph. The EPA (1996) study did not identify stained soils or stressed vegetation in this area in any of the historic aerial photographs.

Previous Studies: A geophysical investigation of Possible Dump Site C - 1957 did not identify any geophysical anomalies on the AOI unassociated with utilities (Versar, 2004a). There is little geophysical evidence to suggest that this AOI is a former dump or landfill.
