Re: Final Amended 2012 Site Management Plan, Fort George G. Meade
Docket Number: CERC-03-2009-0207FF

**SITE MANAGEMENT PLAN
2012 ANNUAL UPDATE
FORT GEORGE G. MEADE, MD**

URS Group, Inc.
12420 Milestone Center Drive, Suite 150
Germantown, MD 20876
Project no. 15302269

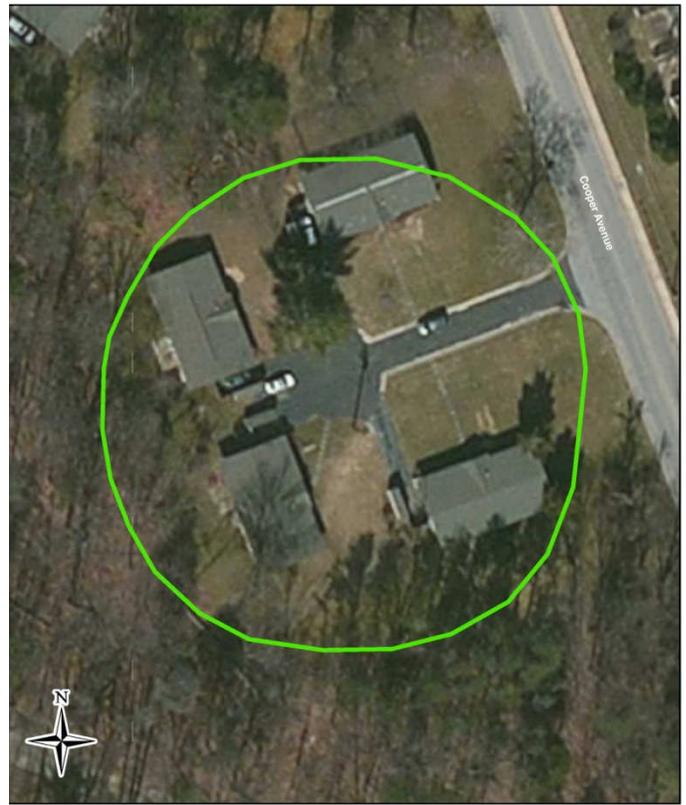
Possible Dump Site D - 1957

Site Description: Possible Dump Site D-1957 was identified as an AOI because the EPA (1996) historic aerial photographic study of the installation listed “possible solid waste” at this location during an analysis of a 1957 aerial photograph. The EPA (1996) study did not identify stained soils or stressed vegetation in this area in any of the historic aerial photographs.

Previous Studies: A geophysical investigation of Possible Dump Site D-1957 did not identify any geophysical anomalies at the AOI that were not associated with utilities or buildings (Versar, 2004).

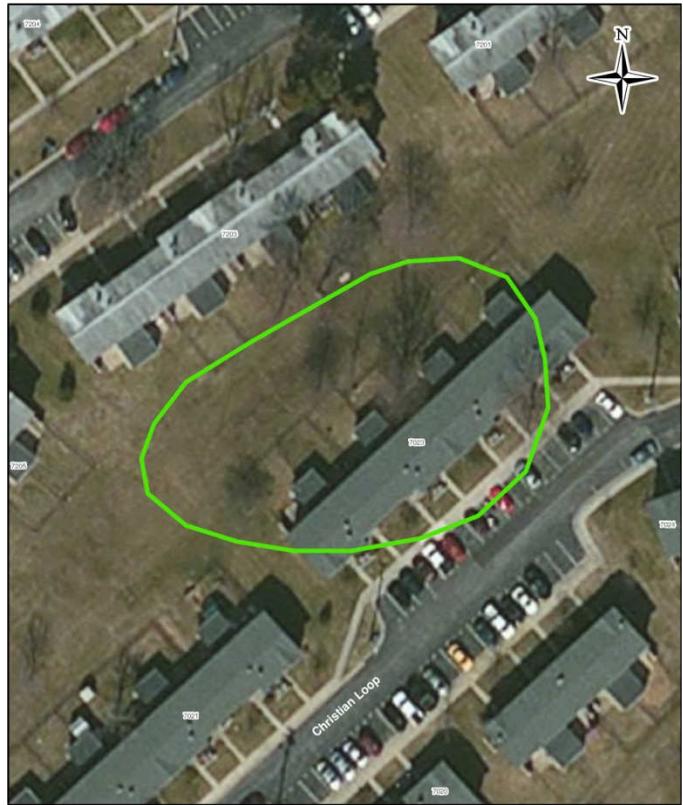
Possible Dump Site F - 1957
0 25 50 100 Feet

Site Description: Possible Dump Site F-1957 was identified as an AOI because the EPA (1996) historic aerial photographic study of the installation listed “possible solid waste” at this AOI during an analysis of a 1957 aerial photograph. In the analysis of the 1963 aerial photograph, EPA stated that “the possible accumulation of solid waste observed in 1957 is no longer present due to construction of new housing.” The EPA (1996) study did not identify stained soils or stressed vegetation in this area in any of the historic aerial photographs.

Previous Studies: A geophysical investigation of Possible Dump Site F - 1957 provided little evidence that the AOI contains metallic or conductive buried waste. There is little geophysical evidence to suggest that this AOI is a former dump or landfill (Versar, 2004).

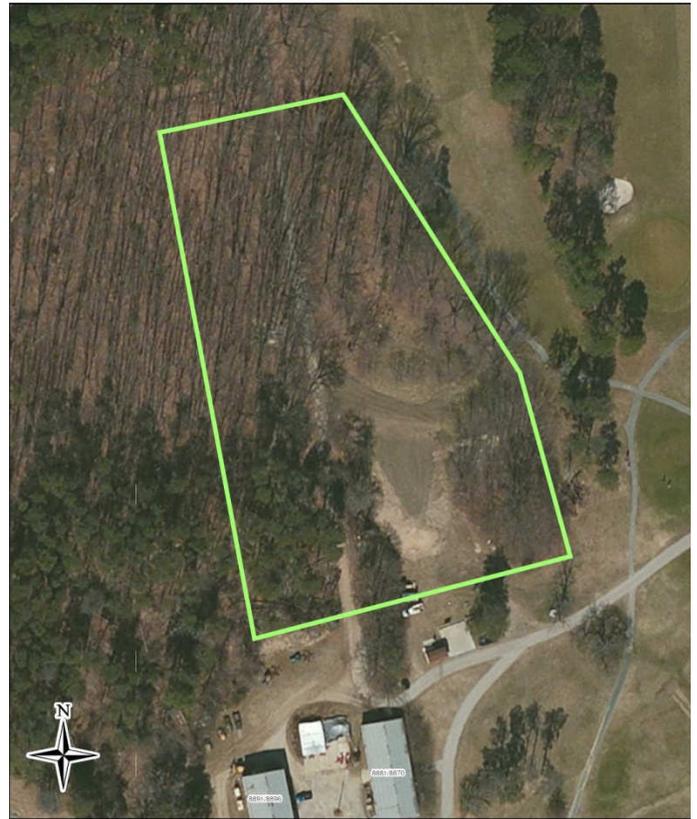
Site M - Parcel 2
0 50 100 200 Feet

Fill material containing ash was encountered at 6 of the 10 direct push locations.

As part of the 2011 SI, 4 surface soil samples were collected and analyzed for VOCs, metals, herbicides, pesticides, explosives, PAH, furans, and dioxins and 4 subsurface soil samples were collected and analyzed for metals, PAH, furans, and dioxins.

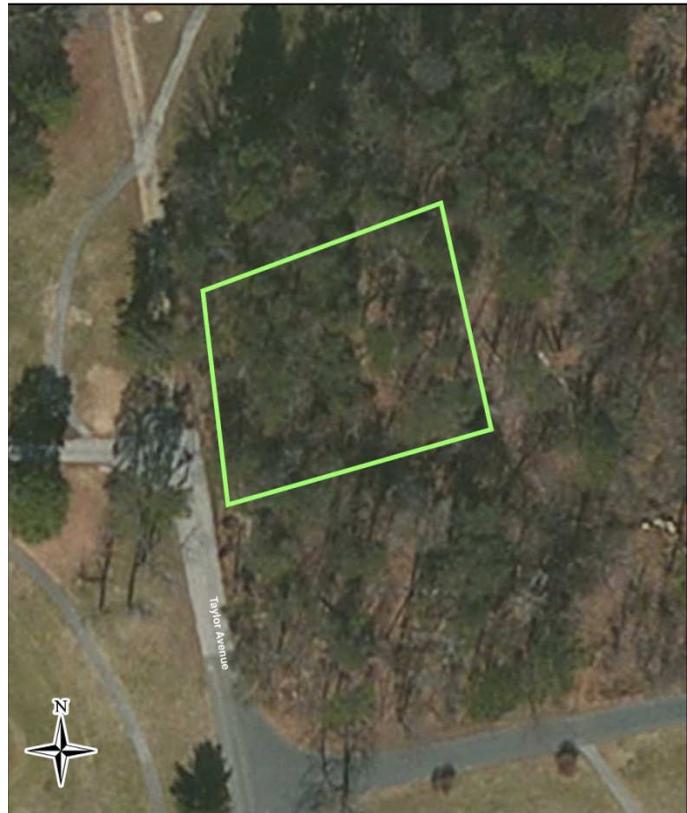
Site M - Parcel 5

Site Description: The EBS identified this location because a concrete foundation for an out building and a telephone pole were observed in a wooded area. The foundation was reportedly adjacent to a former farm house and was identified as a “pit” in the EBS. The concrete foundation and telephone pole were observed during the December 2003 Site Investigation that was conducted as part of the EBS. Upon review of the Site Investigation, the concrete foundation is probably an old out building located near a former barn. It was described as “Building 6927 Foundation” in the description of AOI 11. AOI 11 was later renamed Parcel 5.

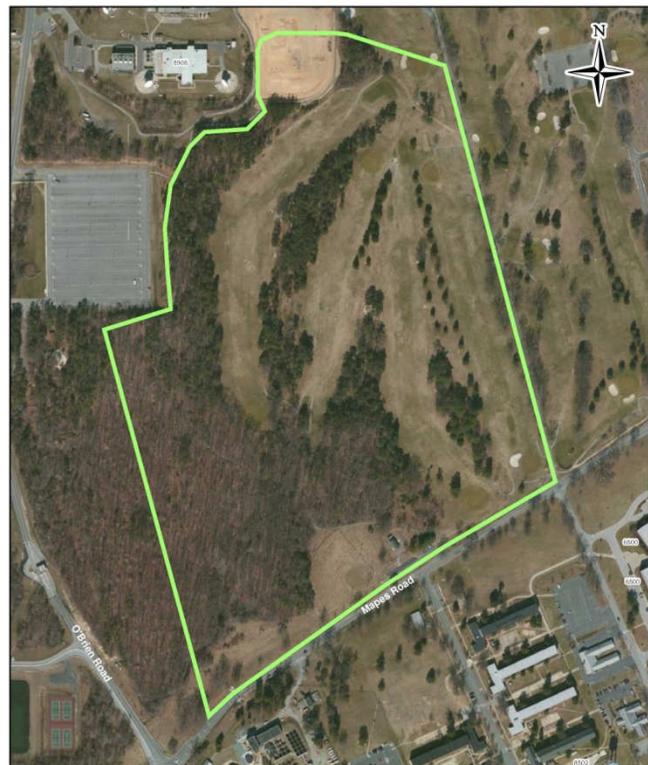
Site M - Parcel 7
0 200 400 600 Feet

Site Description: The 2004 EBS (Berger EA, 2004) suggested that a possible landfill may be located in the northern portion of this site, north of former Parks Golf Course hole 14 and east of the NSA property. This assessment is based on ground scars observed in historic aerial photographs and surficial debris (metal cans, pipes, and a fire hydrant) seen at this location during a 2004 site visit (Berger EA, 2004).

Previous Studies: Over the course of previous investigations at this site, 40 surface soil samples (and 4 duplicate surface soil samples), 21 subsurface soil samples, and 4 groundwater samples (plus 1 duplicate) were collected and analyzed. Based on a risk analysis of the analytical results, heptachlor epoxide, cobalt, and manganese elevate the risk numbers above the site-specific action levels. Methylene chloride was detected above its MCL.

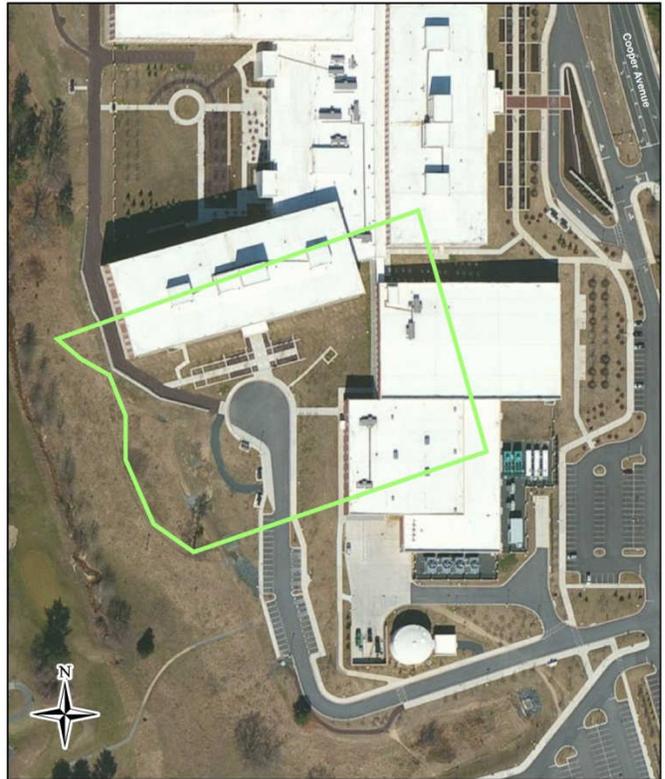
Site M - Parcel 9
0 75 150 300 Feet

Site Description: Disturbed ground was identified at this location in a 1938 historic aerial photograph and ground scarring/disturbance was identified here in a 1943 aerial (Berger EA, 2004). Ground scarring/disturbance, stressed vegetation, or staining were not identified at this location in the EPA (1996) historic aerial photographic study of the installation.

Previous Studies: A geophysical investigation (Berger EA, 2004) was conducted to investigate the disturbed ground and ground scarring. The geophysical investigations of this area revealed some anomalies. Those anomalies that could not be attributed to utilities or the cart path were investigated by 4 subsurface soil samples and 2 groundwater samples.

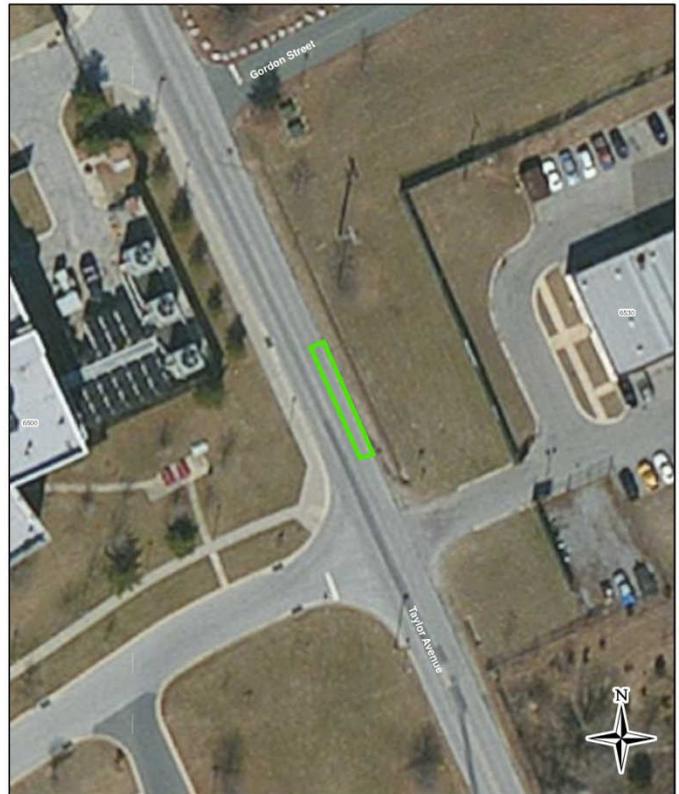
Buried Drum Site - Taylor Avenue
0 25 50 100 Feet

Site Description: Taylor Avenue Buried Drum Area of Interest was identified as an AOI on February 24, 2006, when, while mapping a gas line for Baltimore Gas & Electric, Soft Dig crews discovered a buried drum along Taylor Avenue. The drum was located between Building 6500, the Defense Information School, and Building 6530, the Auto Craft Shop. The AOI is confined to the eastern edge of Taylor Avenue.

Previous Studies: Over the course of previous investigations at this AOI, 1 drum composite sample and 3 post excavation subsurface soil samples were collected and submitted for laboratory analysis.

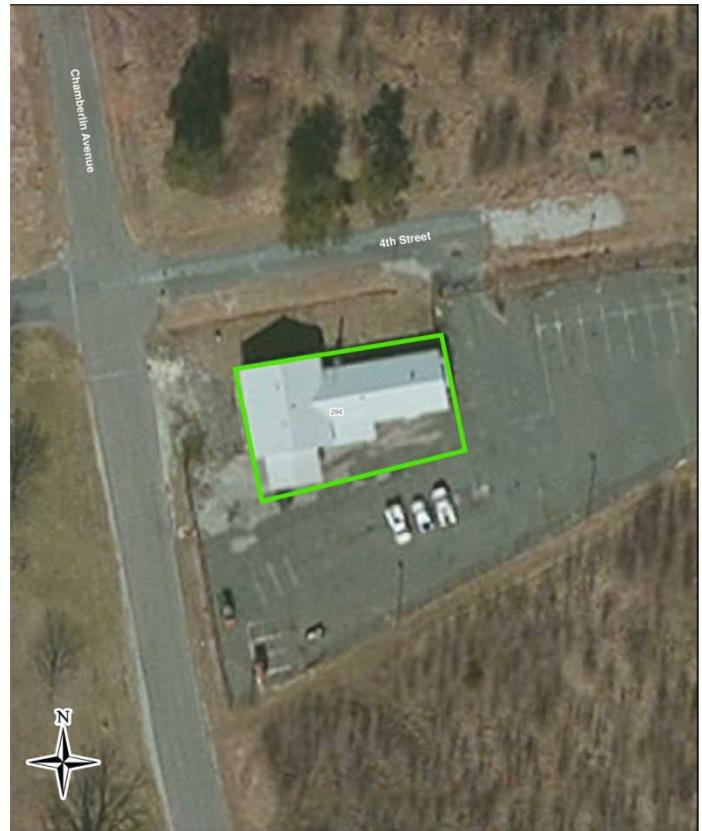
Building 294 - Entomology Department
0 25 50 100 Feet

Site Description: Building 294 was identified as a potential past SWMU in the 1996 SWMU study (BCM, 1996) because it was formerly used as a MP. Building 294 is used for administrative purposes and houses the Department of Public Works Entomology Department, where storage and mixing of pesticides takes place. Pesticides, herbicides, fungicides, and rodenticides are stored inside; an outdoor concrete slab is used for mixing chemicals. The AOI is also identified as a “vehicle service and staging area” in historic aerial photographs dated 1943 through 1988, and as a “former vehicle service and staging area” in a 1995 historic aerial photograph (EPA 1996).

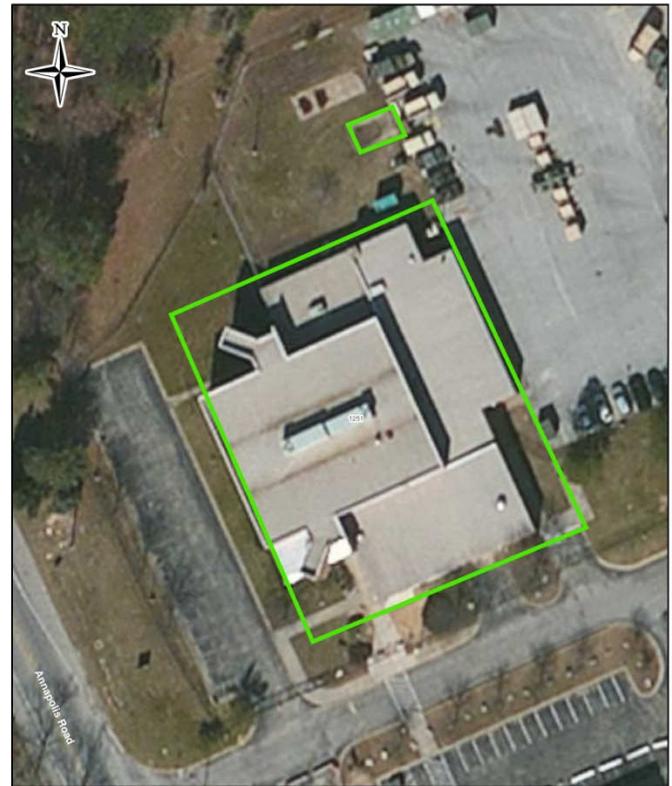
Building 1251 - Administrative and Vehicle and Equipment Storage, Wash Rack

The maintenance shop within the building utilizes and stores small quantities of lube oil, waste oil, brake fluid, and antifreeze. Four storage sheds, two formerly located near Building 1251 and two on the east side of Building 1252, were used for storage of hazardous materials and petroleum products; the sheds were removed in the late 1990s.

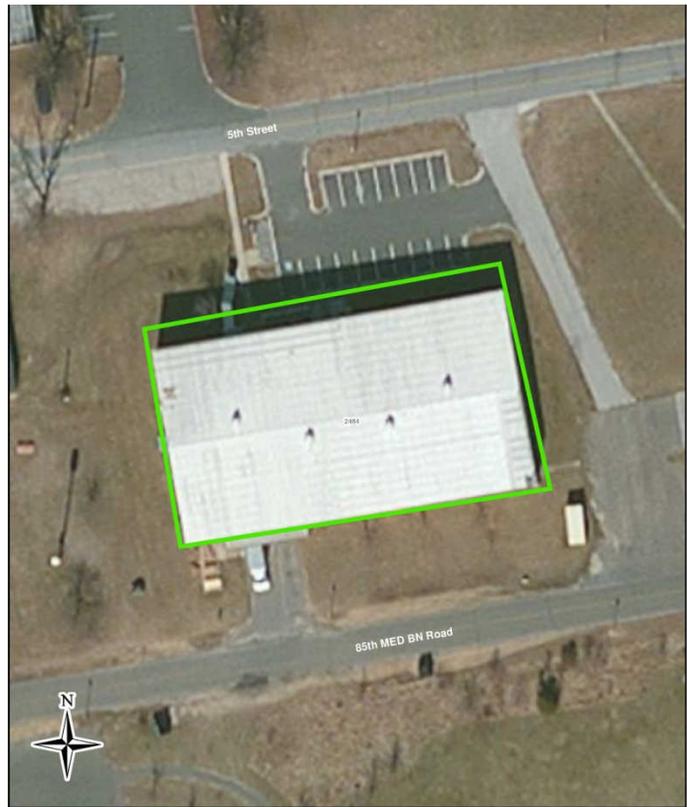
Building 2484 -- Hospital Chemical Facility

Site Description: Building 2484 was a warehouse/administrative building that served as a warehouse for receiving and storing hospital supplies. The building stored unopened containers of chemicals including cleansers, acetone, methanol, ammonia, alcohol pads, and developers and fixers for the hospital's X-ray machine. In the past, products were stored in a flammable room within the building.

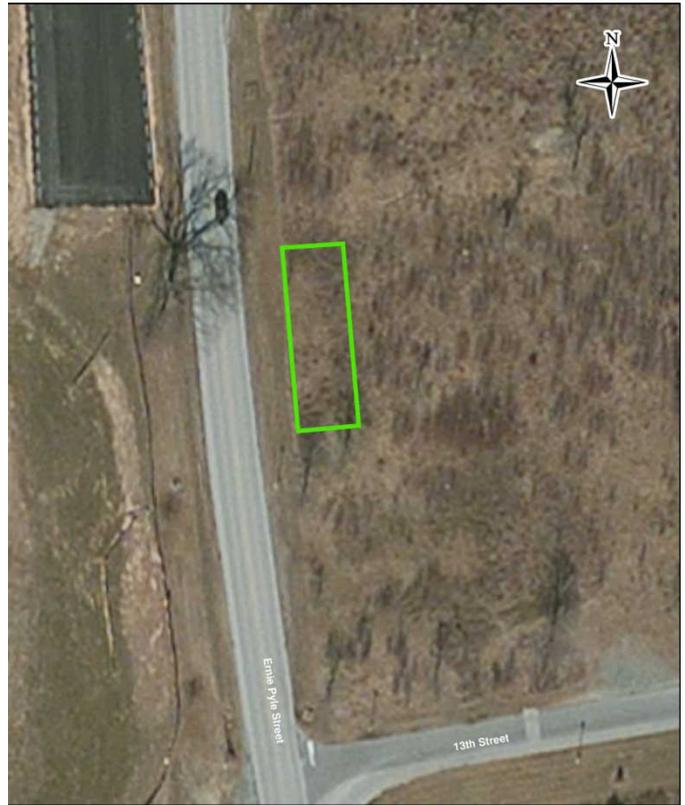
the operation of the DRMO resumed along with the newly constructed CSF.

Site Description: Building 2804 was identified as a potential former SWMU because it was formerly used as an electron microscopy laboratory. The building was used as barracks before it became a laboratory (BCM, 1996). Building 2804 was used to store chemicals in flammable cabinets, storage shelves, and in a chemical waste cabinet. Chemicals on the shelves included potassium permanganate, buffer solutions, hydrochloric acid, and uranium acetate (uranyl acetate). The amount of uranium acetate stored and used at this AOI would have been minimal.

Previous Studies: Over the course of previous investigations at this AOI, 3 surface soil samples, ten subsurface soil samples, and 3 groundwater samples were collected and submitted for laboratory analysis. Based on a risk analysis of the analytical results, the risk numbers are below site-specific action levels.

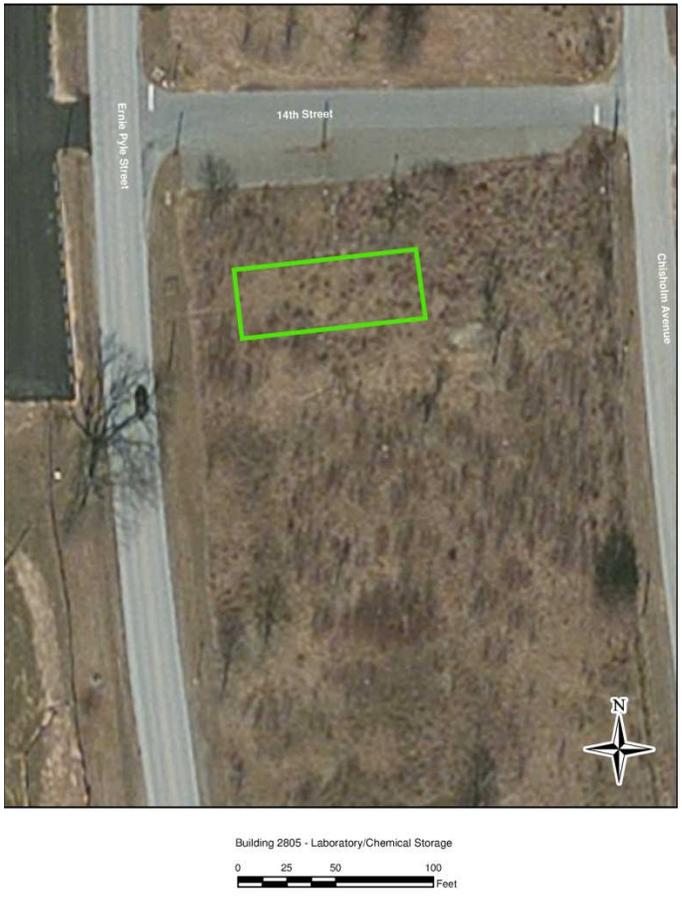
Building 2805 stored chemicals including lithium bromide, magnesium sulfate, potassium phosphate, heptane, acetonitrile, dextran, polyvinyl alcohol, and buffer solution. Prior to being used as a laboratory, the building had been used as barracks. Building 2805 was demolished in the late 1990s.

Previous Studies: Over the course of previous investigations at this site, 7 direct-push borings were advanced around Building 2805; 3 surface soil samples, 13 subsurface soil samples, and 1 groundwater sample were collected and submitted for laboratory analysis. Based on a risk analysis of the analytical results, the risk numbers are below site-specific action levels.

Current Use: Grassy field

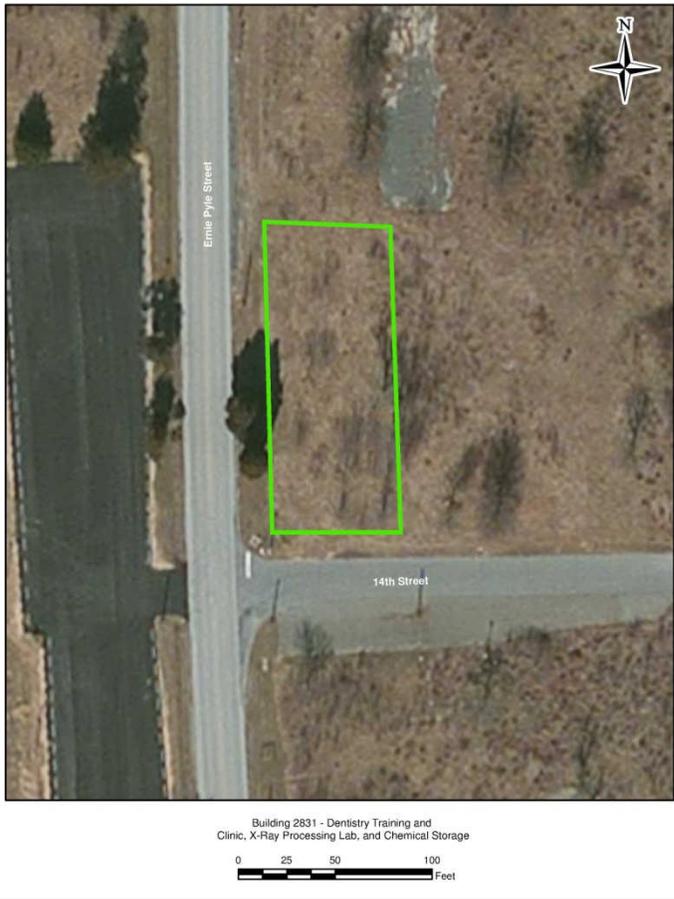
Site Description: Former Building 2831(SWMUs 96 and 97) was constructed in 1941 for administrative purposes. It was also used for dentistry training and as a dentist clinic, an x-ray processing lab, and chemical storage. There were two silver recovery units inside the building. Wastewater from the silver recovery units was flushed down the sanitary sewer, where it was treated at a wastewater treatment plant. The building was demolished in 1999.

Previous Studies: Over the course of previous investigations at this site, 6 direct-push borings were completed adjacent to Former Building 2831, and 6 subsurface soil samples were collected and submitted for laboratory analysis.

Current Use: Vacant, grass covered lot

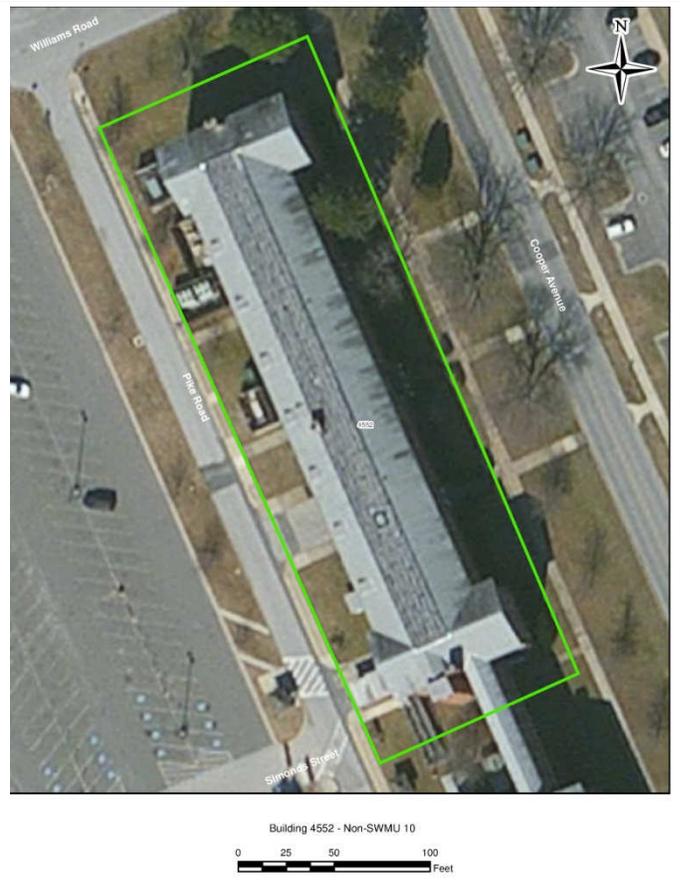
Site Description: Building 4552 – administrative and 1940 barracks (Non-SWMU 10), was not identified as a SWMU in the 1996 SWMU study (BCM, 1996) because no routine waste was stored or produced here. Current and past use of Building 4552 consisted of support facilities, primarily administrative, for intelligence agencies. It typically stored cleaners (floor wax, strippers, and detergents) and office supplies. There are no reports of pesticides being stored at this building.

Previous Studies: Building 4552 was investigated as part of the SWMU study and included in the SWMU report (BCM, 1996). BCM indicated there were no spills or reported releases in the building or the area surrounding this building during the SWMU study (BCM, 1996).

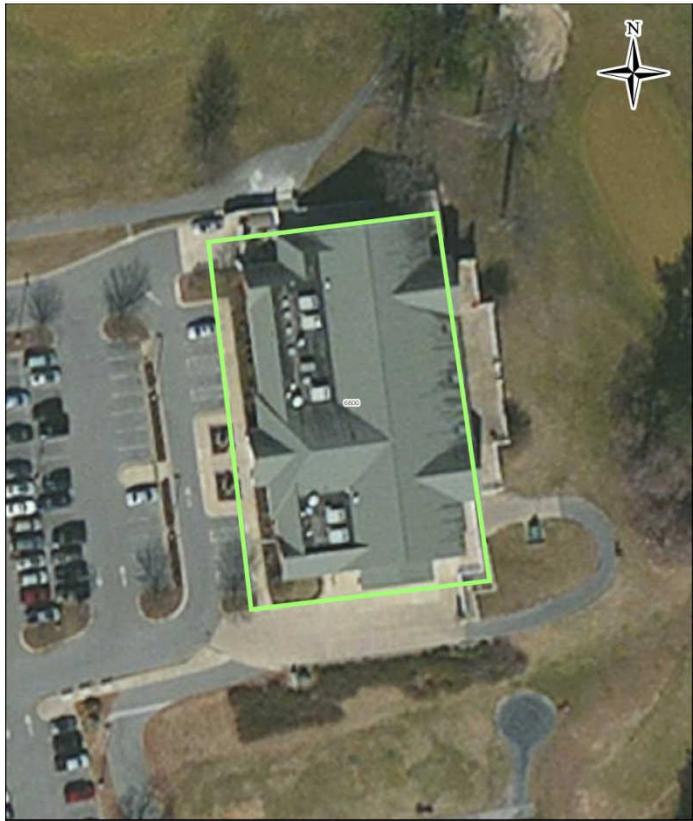
Building 6800 - WR System for Most Recent Golf Course Club House

Site Description: The SWMU study (BCM, 1996) identified an OWS (SWMU 139) and WR (SWMU 140) adjacent to and northeast of Building 6865, the former clubhouse. Building 6865 was located east of Taylor Avenue. The site of former Building 6865 was a parking lot. The SWMU Sampling Visit and Data Gap studies collected samples east of Building 6800, the site of the most recent Golf Course Club House. The WR associated with the most recent Golf Course Club House (Building 6800) off Taylor Avenue is used for rinsing and washing golf carts and golf course maintenance equipment. Building 6800 was constructed in 1993. The former Golf Course Club House, Building 6865, was located directly south of Building 6800, and is addressed as a separate site.

Previous Studies: Over the course of previous investigations at this AOI, 3 surface soil samples and 6 subsurface soil samples were collected and submitted for laboratory analysis.

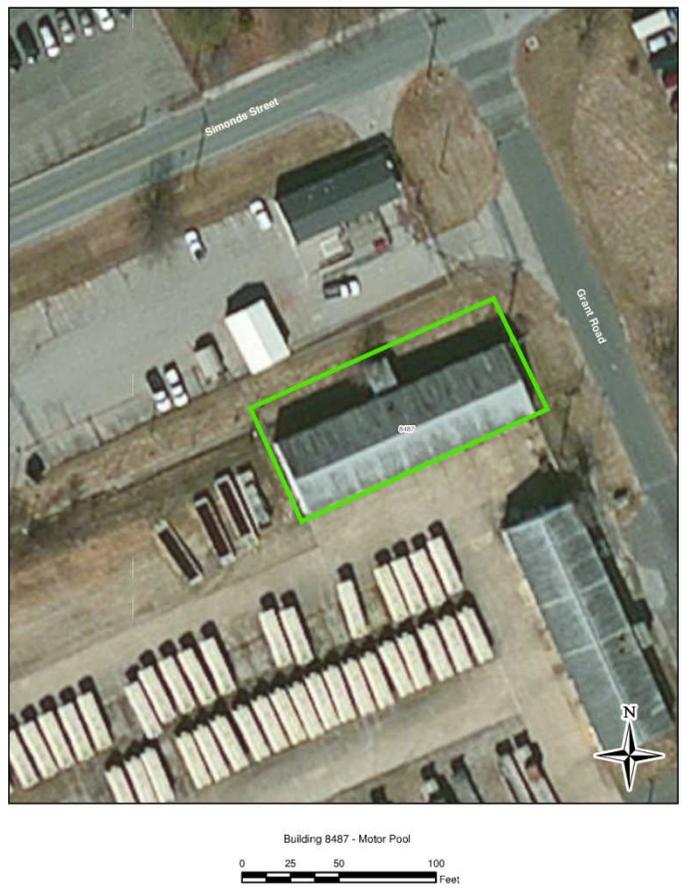
2.5.8.17 FGGM 96 (OU-46) – Vehicle Maintenance (SWMUs 119 and 120), Building 8487

Regulatory Driver: CERCLA
Previous Environmental Investigations
SWMU Study 1996
RFA 3rd Phase 1999
PA..... 2011
Contaminants of Potential Concern: TPH, VOCs, and SVOCs
Media of Concern: Soil and groundwater
Site Location: Grid F5, located in the southwest portion of the installation southwest of the intersection of O'Brien Road and Simonds Street.
Site Description: Building 8487 (SWMUs 119 and 120) has been used as a motor pool which conducts maintenance checks on military vehicles, including oil changes. This AOI also contains five sheds west of Building 8487 which stored paints, oils, antifreeze, and waste oil. Building 8487 stores acetylene and argon for welding.
Previous Studies: Over the course of previous investigations at this site, 2 surface soil and 8 subsurface soil samples were collected from 8 different borings around Building 8487. Based on a risk analysis of the analytical results, the risk numbers are below site-specific action levels.

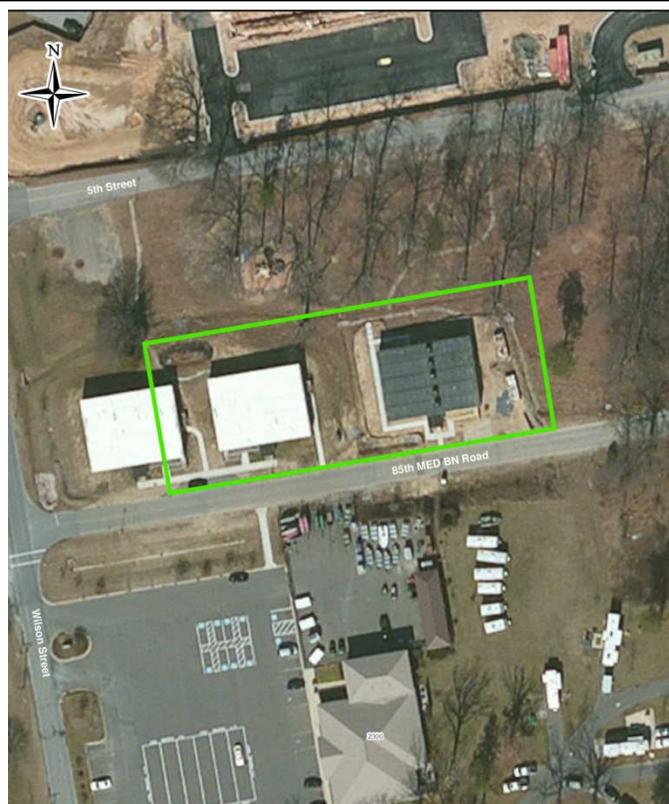
Former Buildings 2454, 2455, 2456, and 2457
0 40 80 160 Feet

Former Building 2457 later served as the eye clinic and administrative offices of Optometry Services, and they stored/used alcohol preps, acetone, office supplies, and household cleaners.

Previous Studies: No soil or groundwater samples have been collected at this AOI over the course of previous investigations. The 1996 SWMU study did not identify these AOIs as SWMUs, and it recommended NFA. The Fort Meade Environmental Partnership approved this AOI for NFA in 1999. There are no recent or historical indications of releases or contamination at these AOIs (BCM, 1996). There is no evidence of scarring, staining, or disturbance in any of the historic aerial photographs (EPA, 1996).

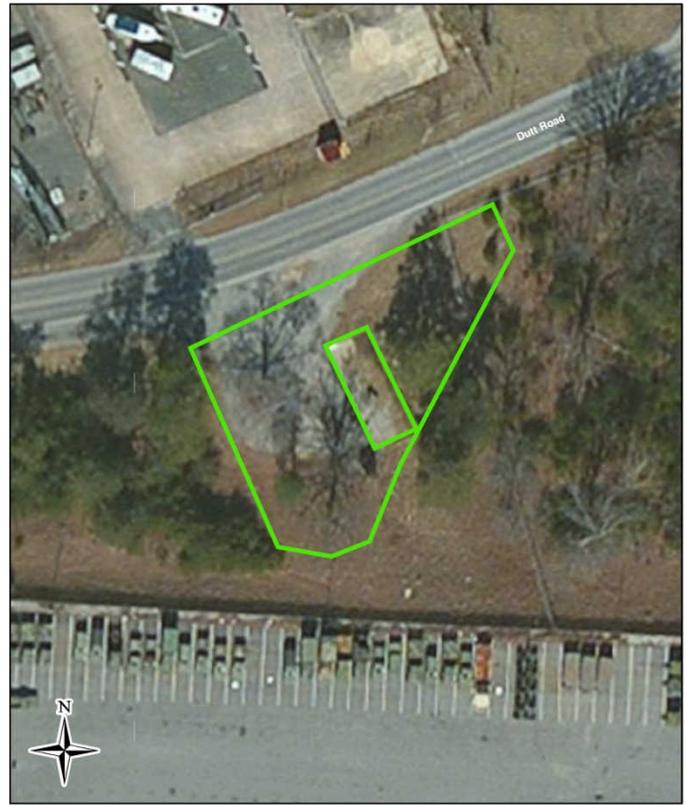
SWMUs 141 and 142 - Privately Owned Vehicles Wash Rack
 0 25 50 100 Feet

Site Description: The wash rack system located southeast of Dutt Road is not associated with any building. The system was identified as two SWMUs during a 1996 SWMU study because it routinely discharged wash water from the wash rack (SWMU 142) to the oil/water separator (SWMU 141) (BCM, 1996). The wash rack was in use during the 1999 RFA for washing of privately-owned vehicles. Its construction date is unknown, but buildings occupied the AOI from the early 1940s through the 1960s. This AOI was not identified in the EPA (1996) review of historic aerial photographs of the installation; no stains, stressed vegetation, standing liquid, or other environmental concerns were identified at this location.

Previous Studies: Over the course of previous investigations at this AOI, 6 subsurface soil samples were collected and analyzed.

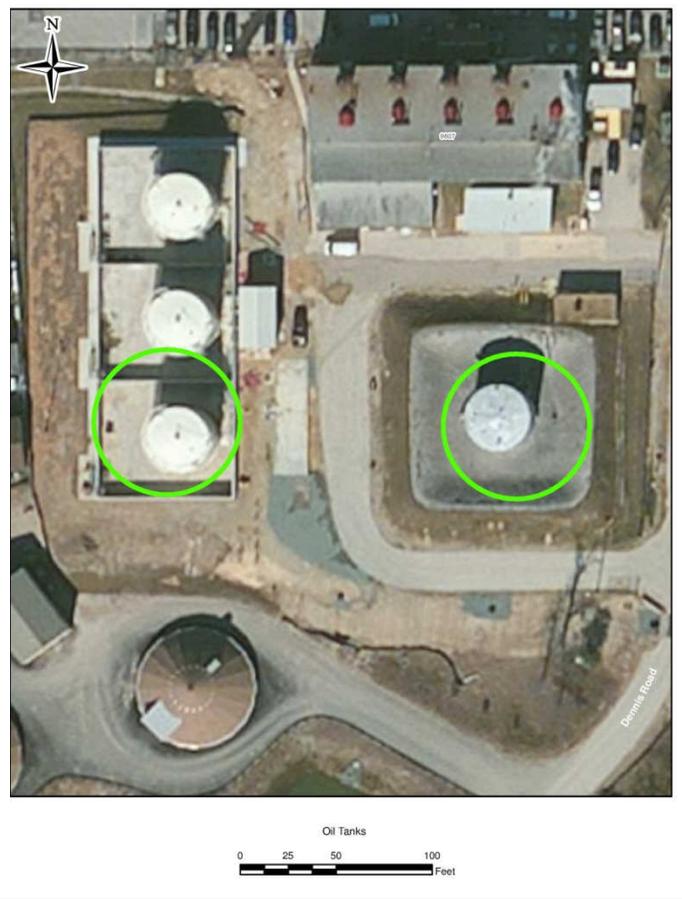
Site Description: Two oil tanks and a heating plant are located at this AOI. The oil tanks probably held heating oil for the adjacent heating plant and did not hold any hazardous material. It is unknown why these oil tanks are considered an AOI. This location was not identified as an AOI during the 1996 SWMU study (BCM, 1996) nor the EPA (1996) historic aerial photographic study of the installation. The EPA (1996) study did not identify stained soils, stressed vegetation, standing liquid, or other environmental concerns in this area in any of the historic aerial photographs.

Current Use: Oil tanks.

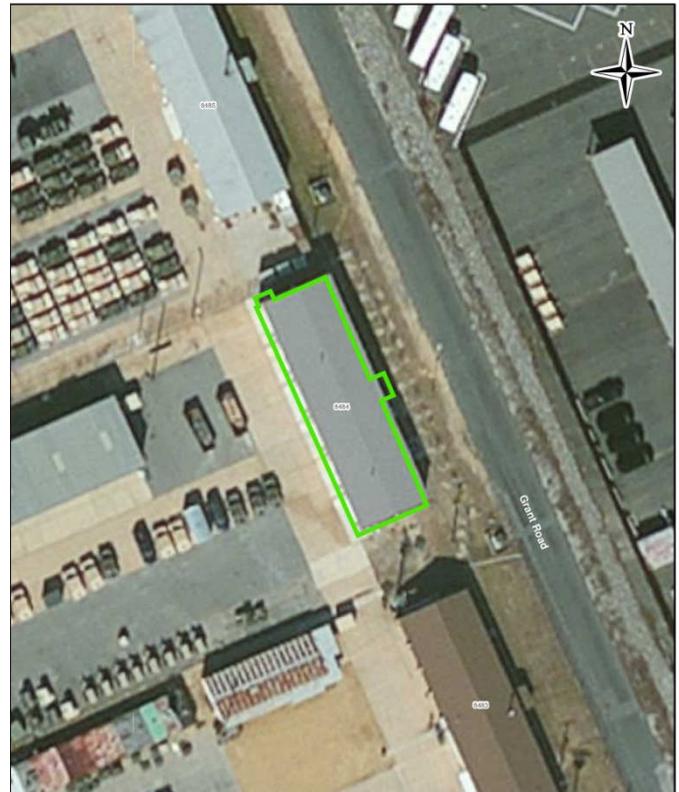
Grant Street at Building 8484
(Spill Notification, September 2009)

Site Description: A small metal box containing unlabeled paint containers was found in a duct bank trench being excavated along Grant Street at Building 8484. ED personnel observed solidified paints as well as a minor amount of liquid coming from the paint storage box.

Previous Studies: Over the course of previous investigations at this site, a maximum PID reading of 224 units was observed, and a grab sample from the bottom of the trench was collected.

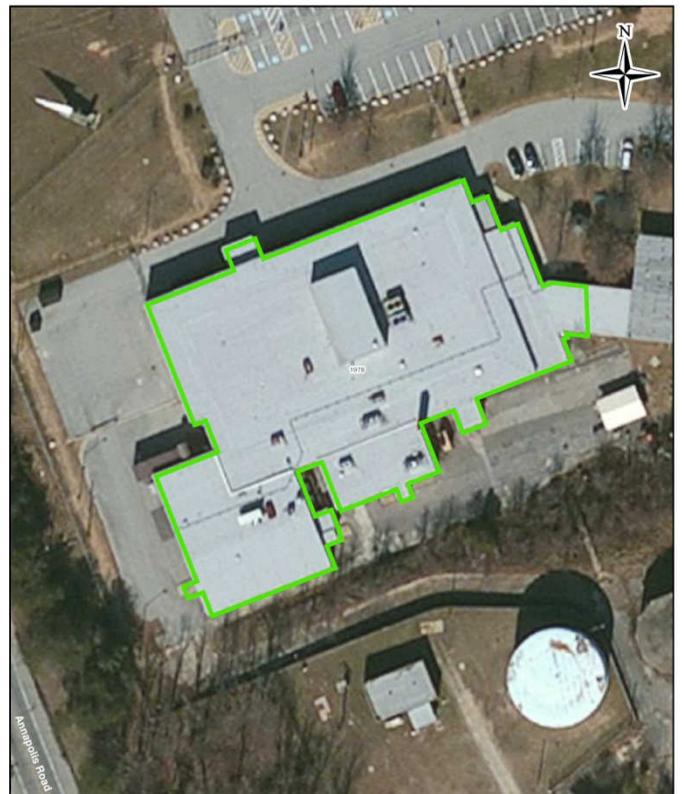
20th Street at Route 175 near Building 1978
(Spill Notification, September 2009)

Site Description: Discolored soil in a duct bank trench excavated along Route 175 and 20th Street beginning approximately 2 ft. below ground surface and extending below the depth of the trench.

Previous Studies: Over the course of previous investigations at this site the maximum PID level was 130 units, and a grab sample from the bottom of the trench was collected for analysis.

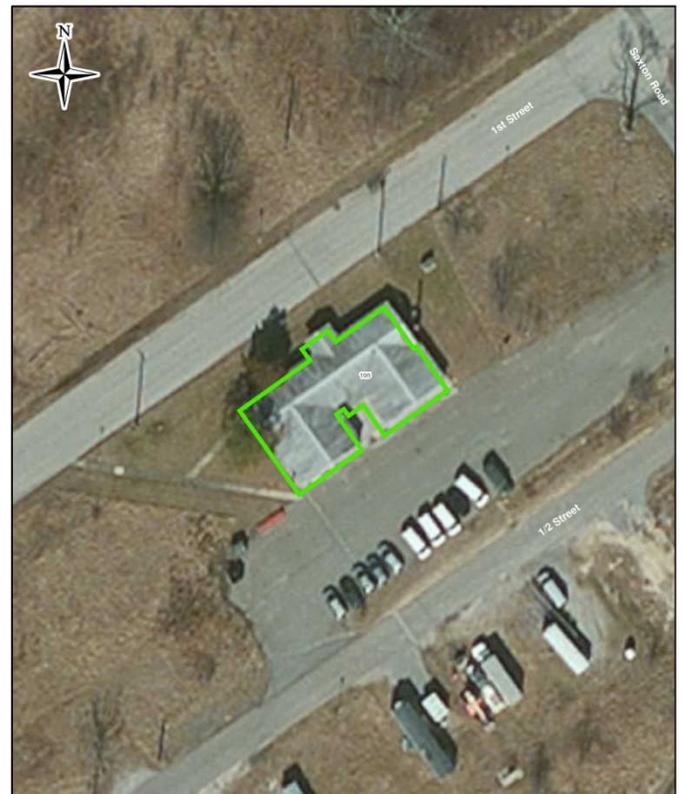
1st Street at Building 195 Release Site (September 2009)

Site Description: Discolored soil in a 2-foot deep duct bank trench being excavated along 1st Street between Chisholm Avenue and Saxton Road was discovered beginning approximately 6 inches below ground surface and extending approximately 10 inches below ground surface on both sides of the trench. The discoloration appeared to be associated with existing asphalt paving and sub-base materials.

Previous Studies: Over the course of previous investigations at this site, 1 grab sample from the bottom of the trench was collected for analysis.

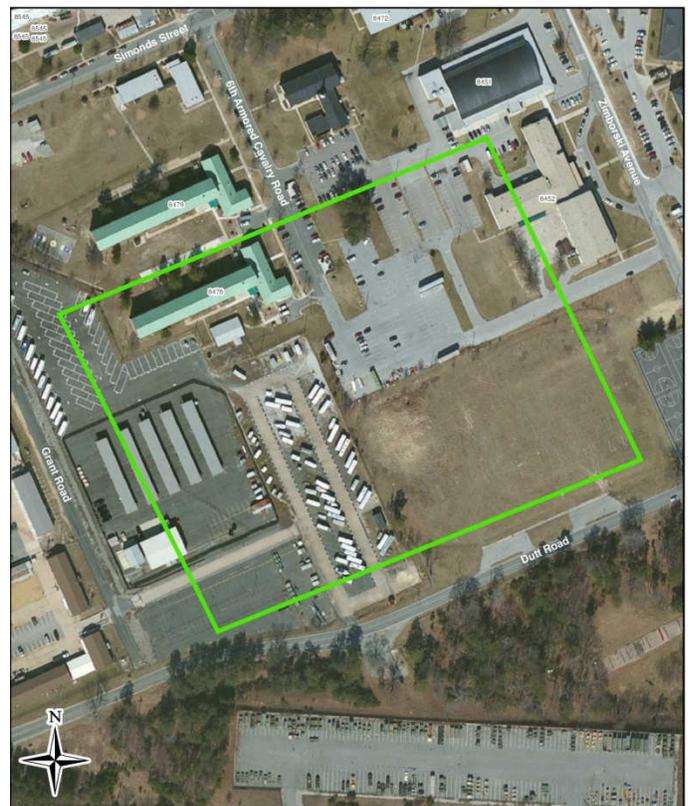
FGGM-004-R-01 - Grenade & Bayonet Range A

Site Description: This AOI is comprised of the former Grenade and Bayonet Range A, which was suspected to be used from 1924 until the late 1930s. Hand grenades are assumed to have been used onsite and could have included fragmentation and practice hand grenades. Most of the 16-acre range has been developed and is currently occupied with various buildings and associated parking lots. The buildings currently located on the MRS were constructed by 1954. They include Buildings 8474, 8452, 8451, 8465, and 8479. Parking lots and driveways surround these buildings.

Previous Studies: Over the course of previous investigations at this site 5 soil samples were collected as part of the SI and submitted for laboratory analysis. None of the 5 soil samples detected metals above the regulatory limits, and no explosives were detected.

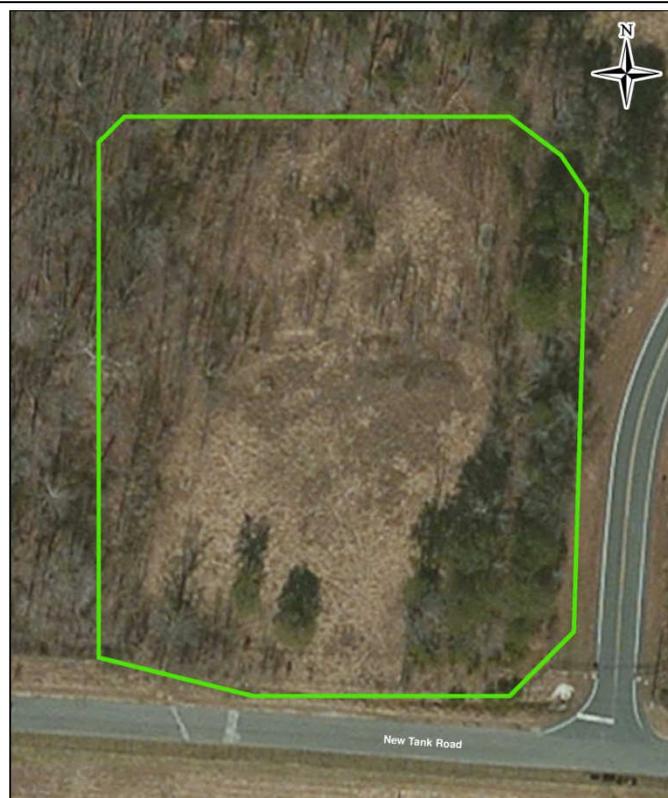
FGGM 32 - Fire Training Area
 0 30 60 120 Feet

Site Description: The FTA was constructed around 1979 for training purposes by the Fort Meade Fire Department. The northern half of the FTA is fenced off and previously enclosed the fire training pit and adjacent training areas. Fires were typically set inside the pit or in portable burn pans using gasoline or aviation fuel. The fires were then extinguished with water or aqueous foam, a synthetic extinguishing agent. Other emergency response training, such as self-contained breathing apparatus training and emergency rescues, were performed at this location. An oil-water separator located on the south side of the fire training pit was used in draining the pit. Water from the separator was transported from the site via an underground pipeline to a sanitary sewer. Both the fire training pit and oil-water separator were removed in 1998.

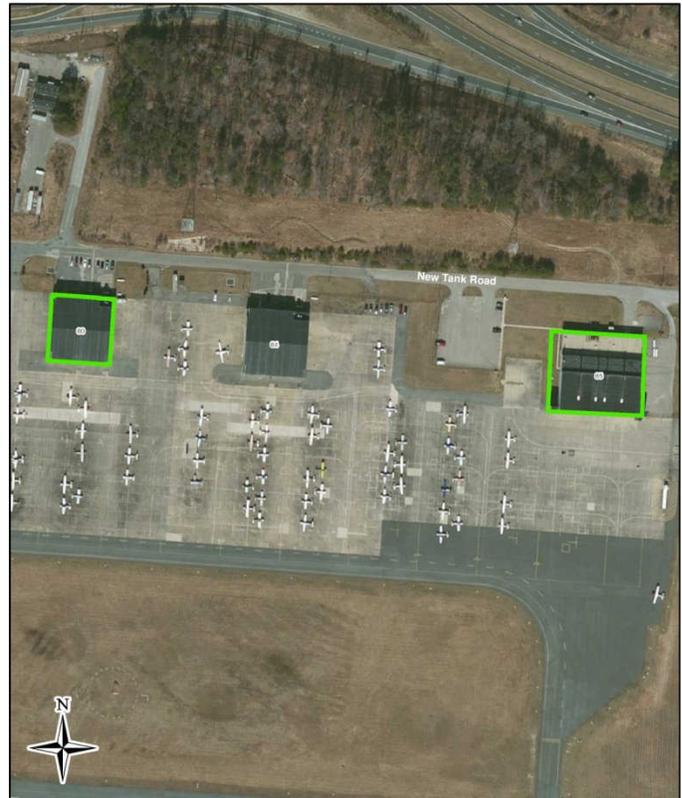
FGGM 72 (OU-27) - POL Storage Tanks, P-080 and P-085

Site Description: FGGM 72 consists of Building/Hangar 80 and Building/Hangar 85, which are both located along Airfield Service Road. A steel 4,000-gallon heating oil tank is located at Building 80 and a steel 5,000-gallon heating oil tank is located at Building 85 (Argonne, 1989). The 4,000-gallon UST at Building 80 was installed in June 1988. This tank replaced a steel-constructed, 4,000-gallon UST that failed a leak test in May 1988 and was removed by order of MDE. Contaminated soils excavated during the tank removal were disposed of at the sanitary landfill. The MDE case was closed on 21 June 1988 (EA, 1992b). The present UST is located on the north side of Building 80 and is surrounded by 3 monitoring wells.

The 5,000-gallon UST at Building 85 was installed in November 1975 (EA, 1992). The tank passed a leak test in May 1988.

These USTs stored heating oil for use in the adjacent buildings 80 and 85, respectively. This has been confirmed in the 1991 transfer assembly document and the 1998 de-registration report.

Previous Studies: Over the course of previous investigations at this site 26 soil vapor samples were obtained.

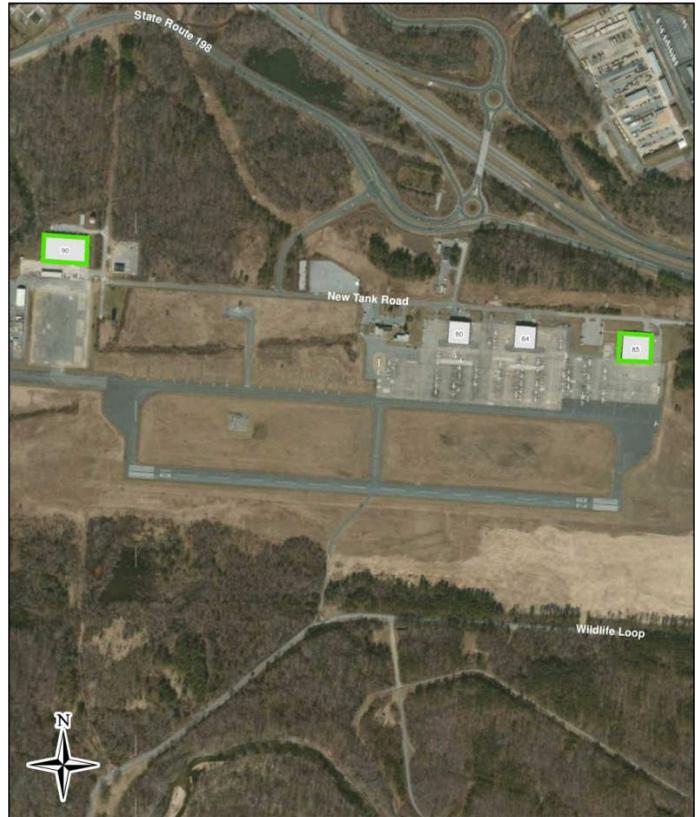
FGGM 73 (OU-28) - Maintenance Shops, Buildings 85 and 90

Site Description: This AOI is for the USTs at Buildings 85 and 90. The 5,000 gallon UST at Building 85 was installed in November 1975 (RA, 1992). The tank passed a leak test in May 1988.

Maintenance Shop Building 85 is also part of FGGM 72 – POL Storage Tanks; because the storages tanks include underground storage tanks at buildings 80 and 85. Maintenance Shop Building 90 is also part of FGGM 80 – Helicopter Hangar Area-90 because Building 90 is the Helicopter Hangar Area building.

Previous Studies: Over the course of previous investigations at these AOIs, twelve soil vapor samples were obtained around the UST at Building 85. Low level hydrocarbon contamination (e.g., maximum encountered toluene concentration, 1.6 ppm) was detected at 4 of the twelve vapor sampling locations (EA, 1992).

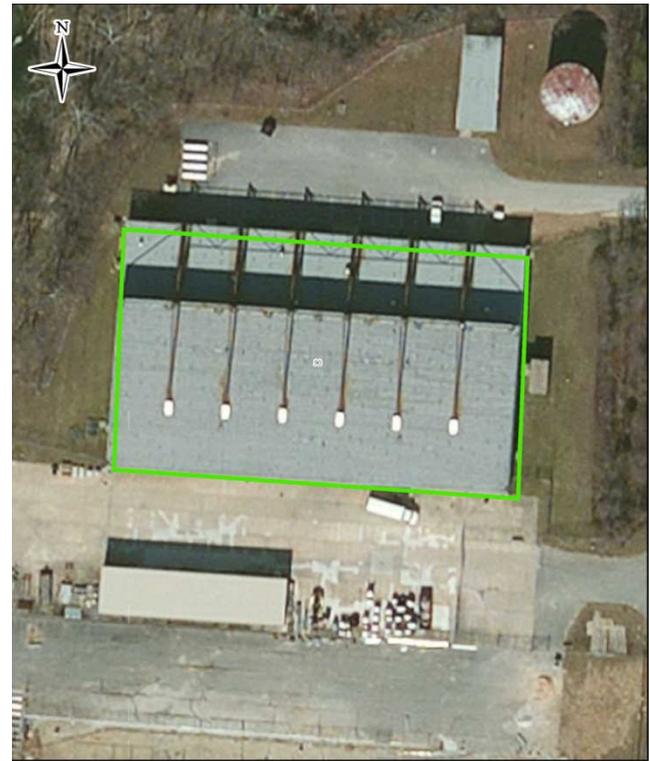
FGGM 80 - Helicopter Hangar 90
 0 30 60 120 Feet

Site Description: The HHA - Building 90 and associated structures were constructed in the early 1980s. Hangar 90 was used for the maintenance and storage of helicopters. Typical activities included washing, disassembly, repair, and painting of aircraft. Aviation and diesel fuel, hydraulic and lubricating oils, detergents, and solvents were used, handled, or stored here. Hangar 90 was cleared and taken out of service when it was decommissioned in early 1996.
